Berryessa Union School District Facilities Needs and Assessment Study

Prepared For
Berryessa Union School District

In April of 2013, Berryessa Union School District requested that Sugimura Finney Architects prepare a District-wide survey to assess the current status of the District's facilities, and to help guide upcoming decisions related to facility utilization and improvement.

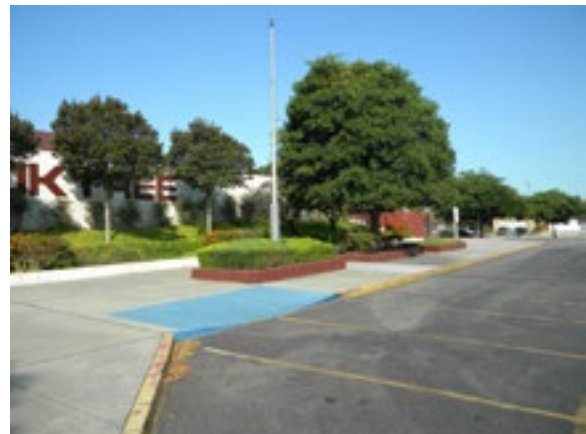
- Parking lot is too small, with insufficient spaces for staff and visitors.
- Circulation through the parking lot during pick-up and drop-off is inadequate, and creates problems with traffic congestion.
- Pick-up / Drop-off location sees considerable congestion during peak times, and does not allow traffic to flow through.
- No bus drop-off area, so busses currently add to parking lot congestion.
- Existing accessible parking does not meet current requirements.

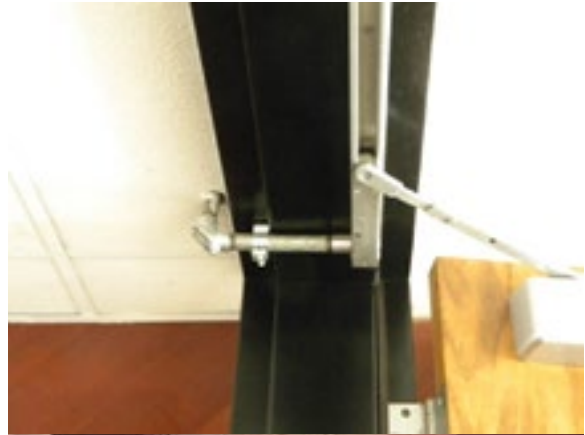
- Automatic fire door hardware has exceeded its expected lifespan, and requires regular maintenance to keep in good operating condition.
- If the proposed doors to the now-open classroom spaces are added, an exit corridor will be required from each classroom "pod".
- Existing outdoor atria spaces are underutilized.

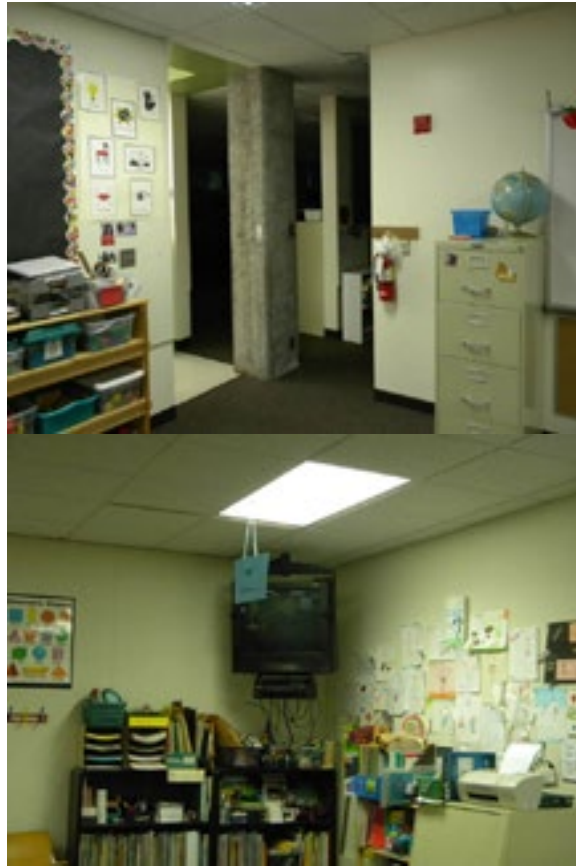
- Classrooms are generally in good condition, although many of the finishes are faded and/or dirty.
- Many classrooms do not have doors, due to original school design's open plan. Partition walls have been added over the years, but doors were never added. This causes noise to easily travel between adjacent classrooms, and also presents a security risk.
- Existing classrooms typically have a CRT television mounted in a location that does not comply with current accessibility requirements.

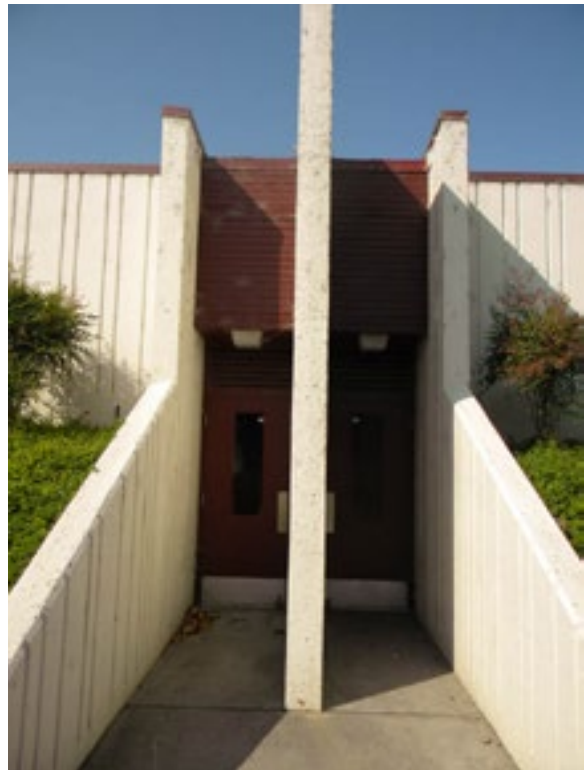
- Occasional areas of concrete or asphalt paving that have heaved or cracked cause accessibility issues.
- Three pairs of the existing exit doors do not meet access requirements.

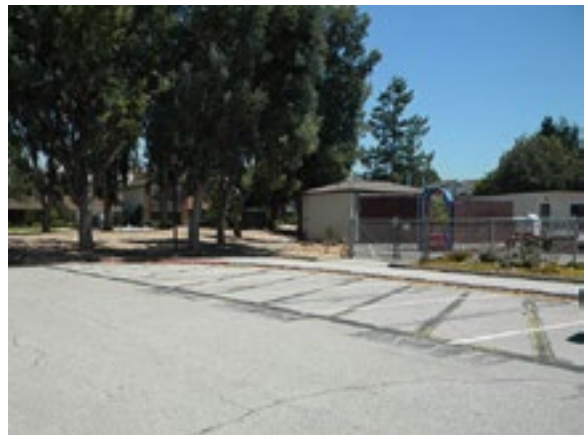
- Circulation through the parking lot during pick-up and drop-off is inadequate, and creates problems with traffic congestion.
- Pick-up / Drop-off location sees considerable congestion during peak times, and does not allow traffic to flow through.

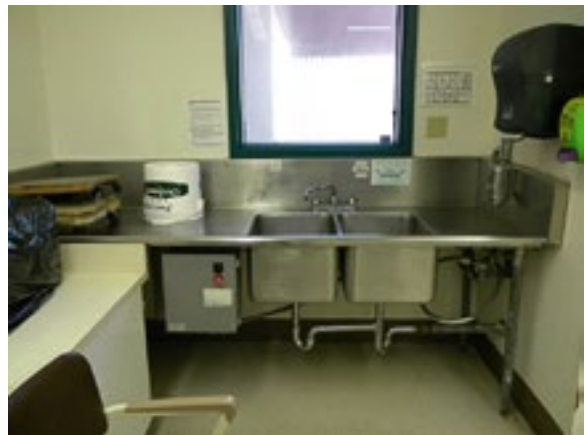
- Overall general storage capacity is limited, and existing built-in storage is worn.
- Custodial spaces in general show signs of wear and tear.

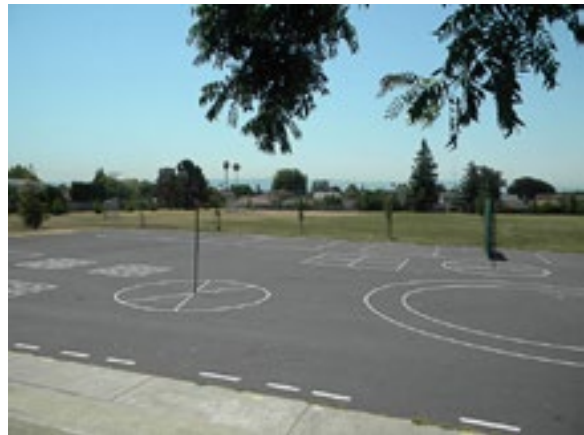
- The existing asphaltic concrete play surfaces appear to be in reasonably good condition, although some repair work is needed.
- The existing sports fields have issues with ground squirrels and gophers. Some parts of the grass fields are bare and/or more weeds than grass.
- Existing play structures appear in good condition; however, the existing shredded rubber in the play structure boxes is depleted and in need of replacement.
- The existing swing set takes up a significant amount of play box space for very few students.
- Access to the play area is limited due to a significant elevation change.

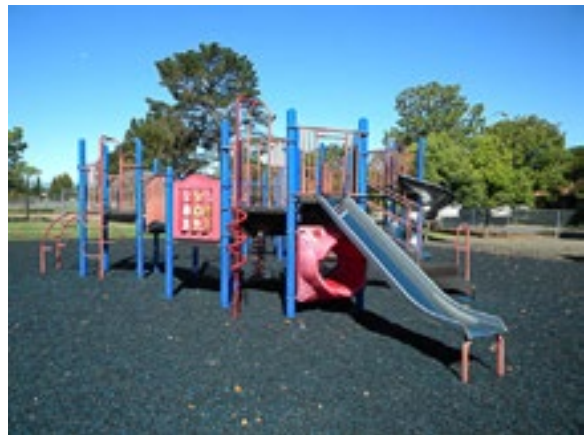
- The existing asphaltic concrete play surfaces appears to be in moderately good condition, some repair work is needed.
- The existing sports fields have issues with ground squirrels and gophers. Some parts of the grass fields are bare and/or more weeds than grass.
- Existing play structures appear in good condition; however, the existing shredded rubber in the play structure boxes is depleted and in need of replacement.
- Existing swing set appears in good condition.

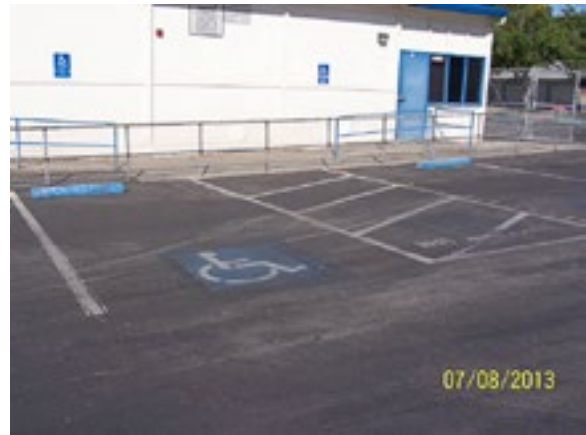
- Circulation through the parking lot during pick-up and drop-off is inadequate, and creates problems with traffic congestion.
- Pick-up / Drop-off location sees considerable congestion during peak times, and does not allow traffic to flow through.
- Existing accessible parking does not meet current requirements.
- Delivery trucks arriving and departing from the attached District Central Kitchen conflict with traffic in parking lot.

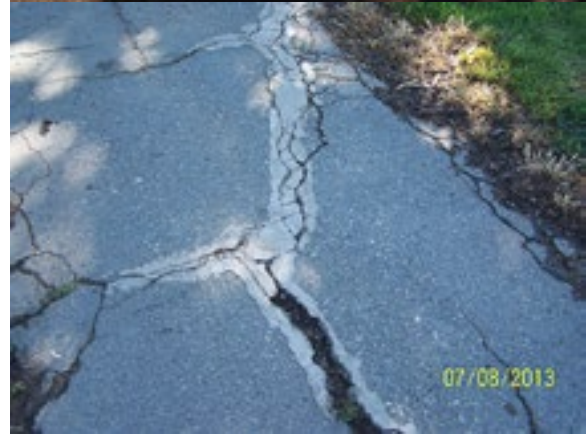
- One of the three main asphalt play surfaces is in good condition. The other two are in relatively poor condition.
- The existing sports fields have issues with ground squirrels and gophers. Some parts of the grass fields are bare and/or more weeds than grass.
- Existing play structures appear in good condition; however, the existing shredded rubber in the play structure boxes is depleted and in need of replacement.

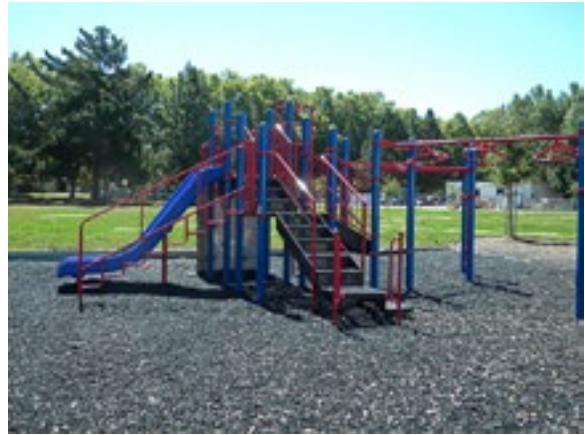
- The main asphalt play surface is in moderate condition.
- The existing sports fields have issues with ground squirrels and gophers. Some parts of the grass fields are bare and/or more weeds than grass.
- Existing play structures appear in good condition; however, the existing shredded rubber in the play structure boxes is depleted and in need of replacement.

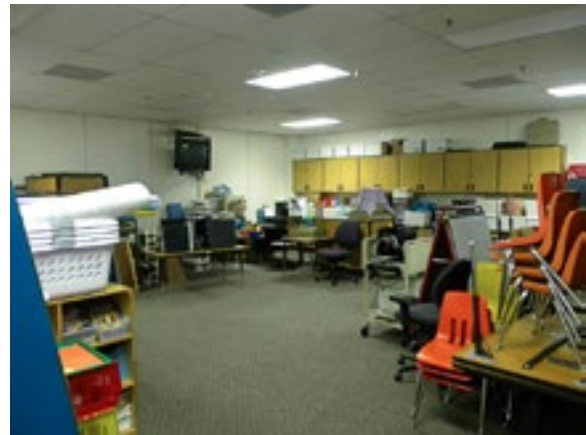
- Existing finishes are worn and faded.
- Insufficient curriculum storage available.
- Librarian desk is not accessible.

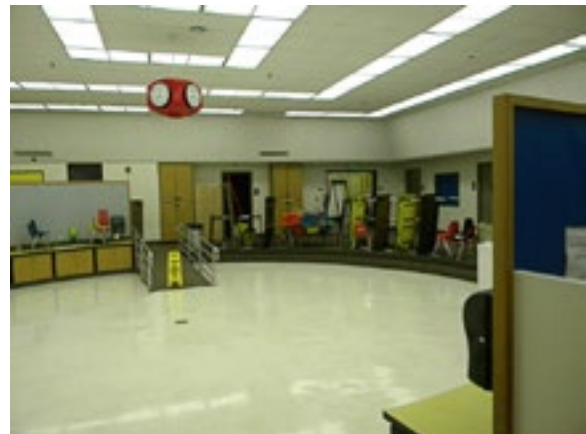
- Most finishes appear in need of replacement.
- Existing Multi-Purpose Room is too small to assemble entire student body.
- Existing sound system is inadequate for current needs.
- Existing folding lunch tables are original, and in poor condition.
