2020 FACILITIES NEEDS ASSESSMENT UPDATED MAY 2024

BERRYESSA UNION SCHOOL DISTRICT

EXECUTIVE SUMMARY

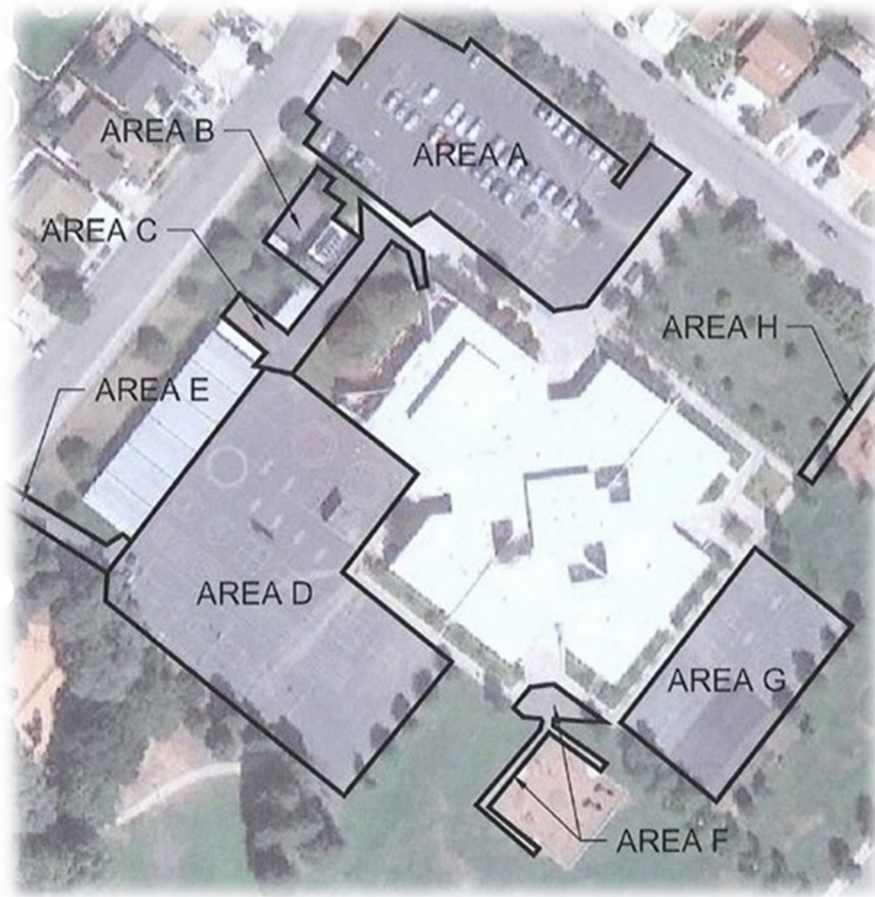
School Name	Area	Work Description	SF Area	PCI Score
Brooktree Elementary School	A	Reconstruct	29,870	60
Brooktree Elementary School	B	Reconstruct	2,504	54
Brooktree Elementary School	C	Reconstruct	4,029	59
Brooktree Elementary School	D	Reconstruct	44,740	46
Brooktree Elementary School	E	Crack Fill and Seal Coat	1,764	95
Brooktree Elementary School	F	Crack Fill and Seal Coat	1,940	95
Brooktree Elementary School	G	Reconstruct	14,850	54
Brooktree Elementary School	H	Reconstruct	984	41

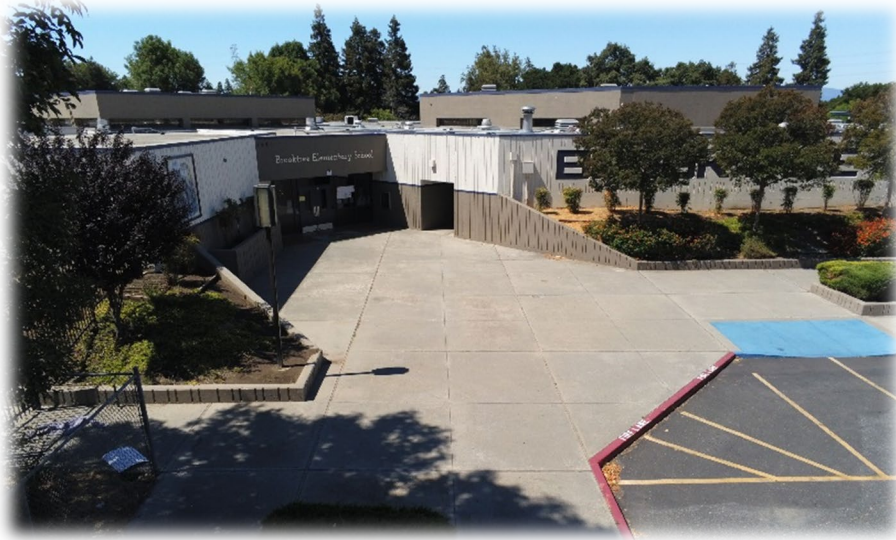
SEISMIC ASSESSMENT REPORT

The building at Brooktree Elementary is one of three identical single-story buildings with a wood framed and concrete shear walls built in 1974. The other two schools are Majestic Elementary School and Summerdale Elementary School, evaluated in separate sections of this report. The building consists of multiple attached classrooms with centralized multipurpose rooms. The building shape is irregular with the roof containing several discontinuities due to differing plate heights and openings in the roof diaphragm.

The lateral force resisting system consists of a plywood sheathed roof acting as horizontal wood diaphragm spanning between vertical concrete shear walls. Seismic loads are resisted in both directions by way of the concrete shear walls located on the interior and exterior of the structure. Our evaluation of the lateral force resisting system revealed that the concrete shear walls appear to be adequately designed, however it is not clear if the as-built condition of the out of plane wall ties are adequate to resist modern day code level forces. We recommend that further evaluation and investigation be conducted to determine the as-built condition as well as the capacity of the ties supporting the concrete walls out of plane.

- Further structural investigations/inspections of the-out-of-plane wall ties are recommended, followed by structural improvements if called for.
- See attached structural report for additional information.

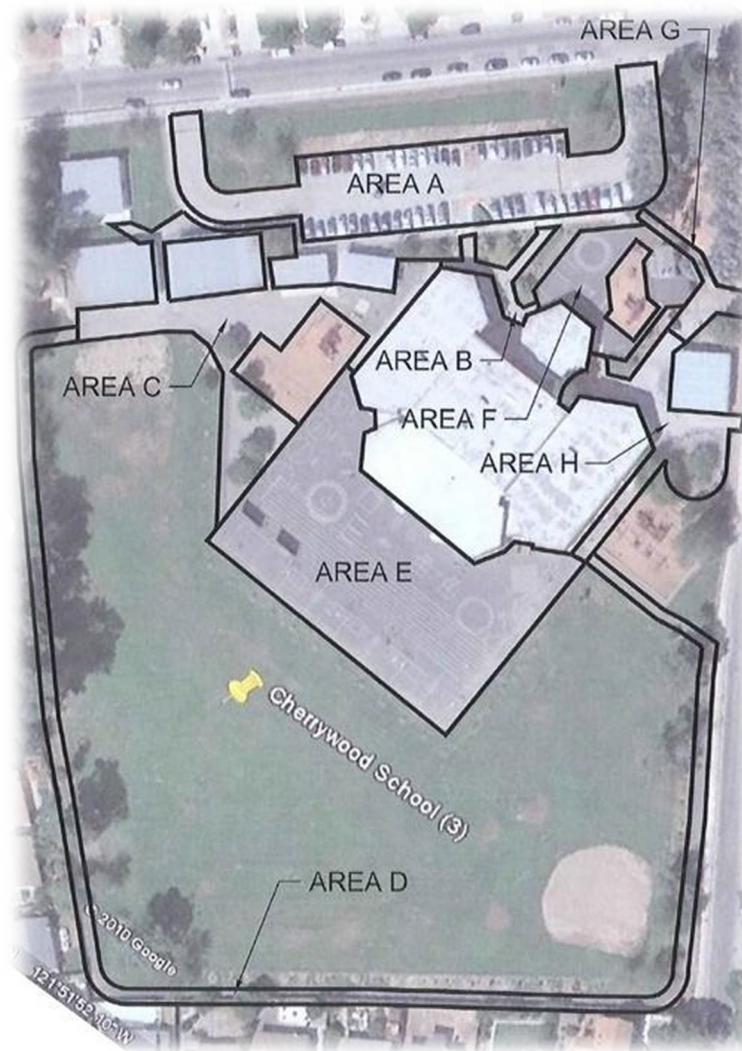
School Name	Area	Work Description	SF Area	PCI Score
Cherrywood Elementary School	A	Reconstruct	22,596	39
Cherrywood Elementary School	B	Reconstruct	1,908	56
Cherrywood School	C	Reconstruct	24,210	46
Cherrywood School	D	Reconstruct	13,050	51
Cherrywood School	E	Reconstruct	36,026	52
Cherrywood School	F	Reconstruct	4,950	38
Cherrywood School	G	Crack Fill and Seal Coat	1,490	69
Cherrywood School	H	Crack Fill and Seal Coat	8,994	69

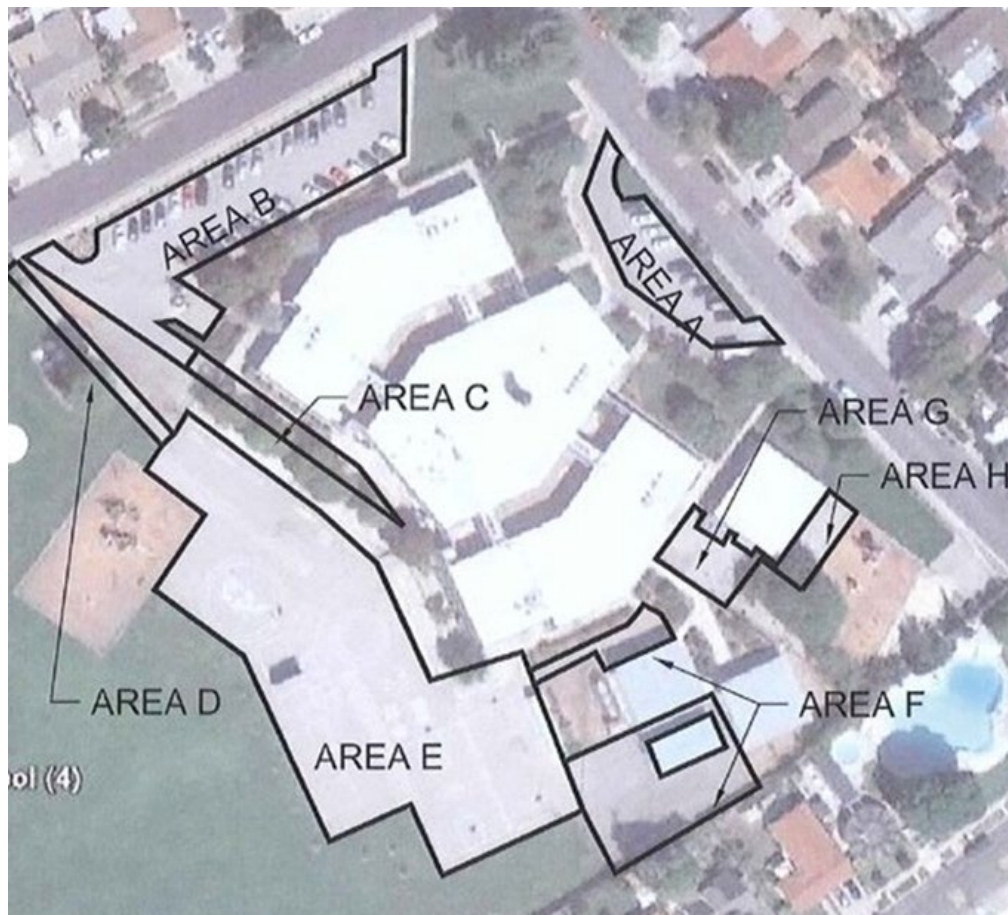
School Name	Area	Work Description	SF Area	PCI Score
Laneview School	A	Reconstruct	8,000	38
Laneview School	B	Reconstruct	15,308	23
Laneview School	C	Seal Coat	2,898	95
Laneview School	D	Remove & Replace	1,550	67
Laneview School	E	Reconstruct	35,740	52
Laneview School	F	Digout, Crack Fill & Seal Coat	7,763	59
Laneview School	G	Remove & Replace	2,173	48
Laneview School	H	Remove & Replace	1,684	61

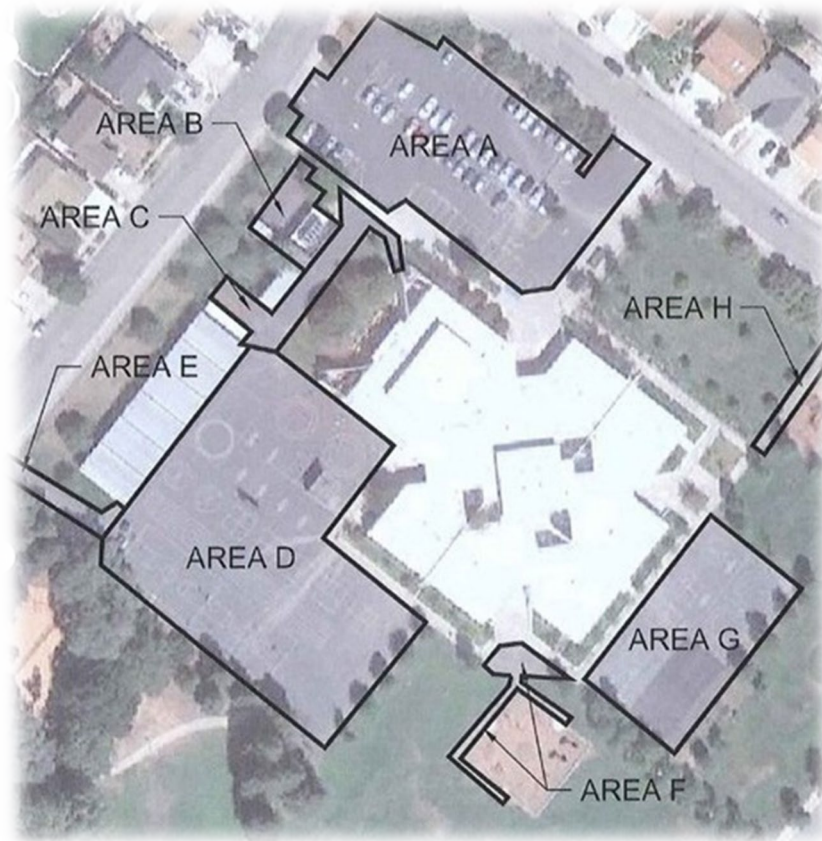
School Name	Area	Work Description	SF Area	PCI Score
Majestic Way School	A	Reconstruct	36,556	32
Majestic Way School	B	Reconstruct	5,305	49
Majestic Way School	C	Reconstruct	800	62
Majestic Way School	D	Reconstruct	41,335	58
Majestic Way School	E	Remove & Replace	11,333	46
Majestic Way School	F	Remove & Replace	995	47
Majestic Way School	G	Crack Fill and Seal Coat	599	76

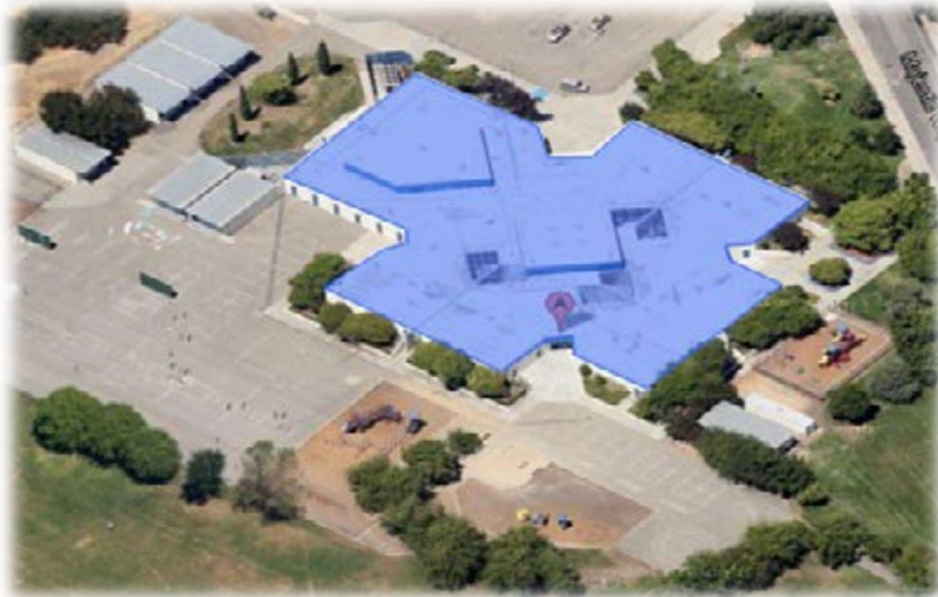
SEISMIC ASSESSMENT REPORT

The building is one of three identical single-story building with a wood framed roof with concrete walls built in 1974. Please refer to the evaluation written for Brooktree Elementary for specific recommendations for this building type.

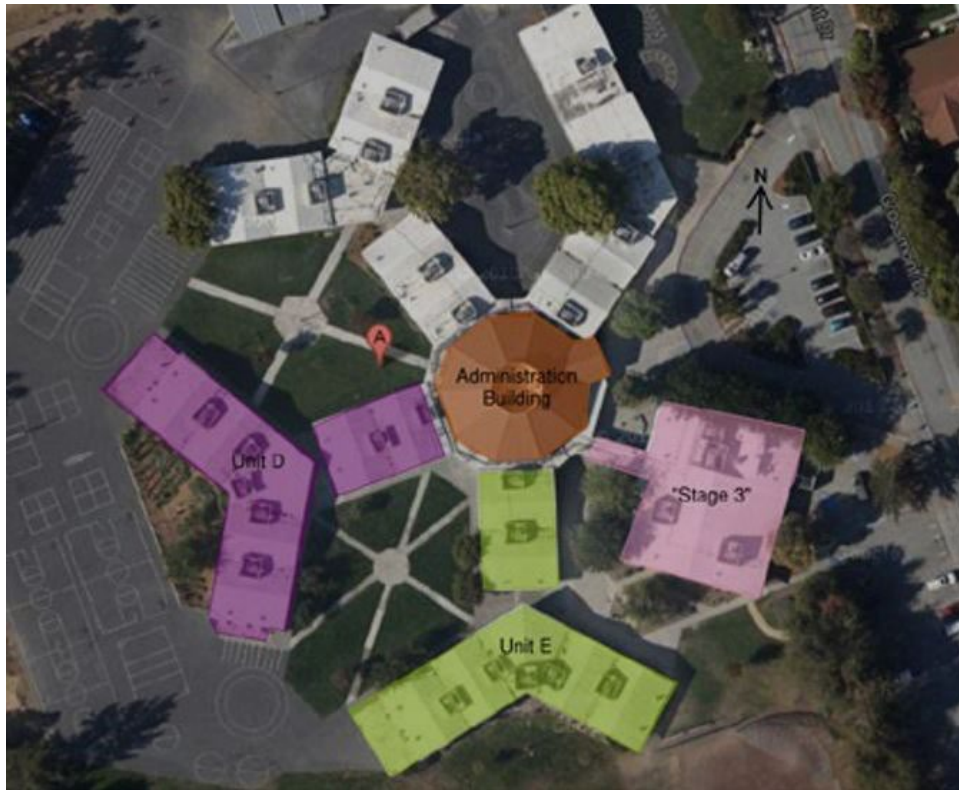
SEISMIC ASSESSMENT REPORT

Noble Elementary School consists of multiple buildings oriented in a "hub" configuration. Structural drawings were not made available for the original construction; however, it is assumed to be early 1960s. Structural drawings were available for the design of Unit D, Unit E, Stage 3 and the Administration Building.

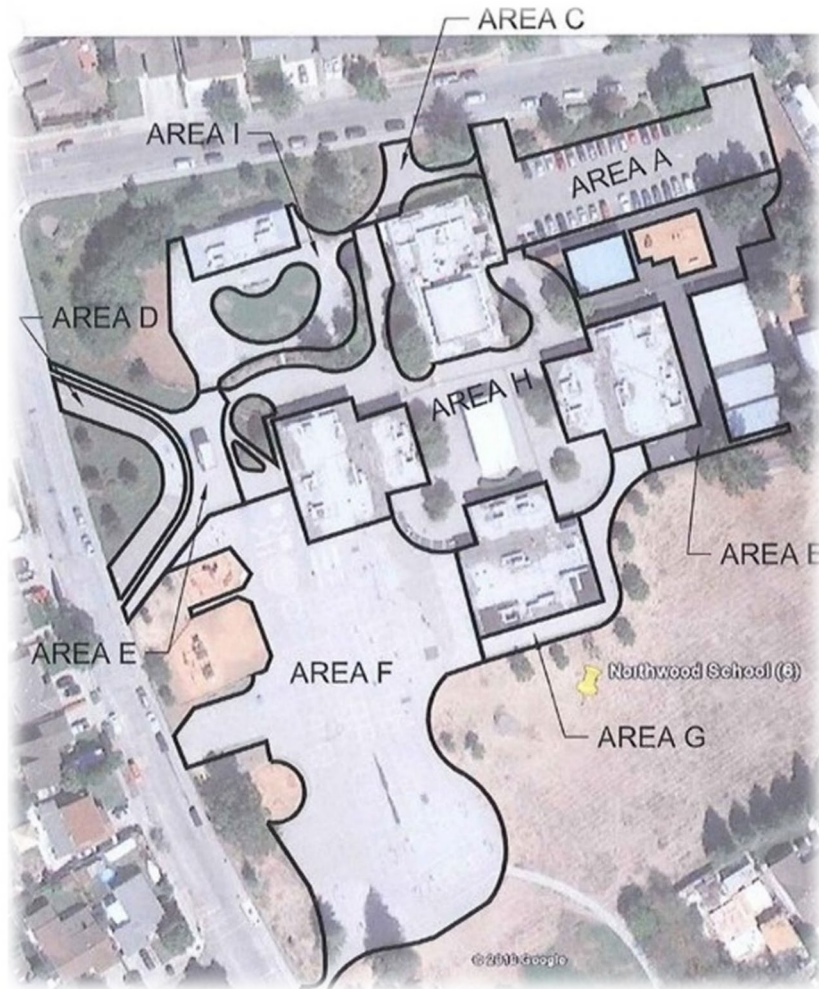
School Name	Area	Work Description	SF Area	PCI Score
Northwood School	A	Seal Coat	18,179	95
Northwood School	B	Reconstruct	15,131	61
Northwood School	C	Crack Fill & Seal Coat	2,530	93
Northwood School	D	Reconstruct	3,696	18
Northwood School	E	Reconstruct	6,320	60
Northwood School	F	Reconstruct	64,426	53
Northwood School	G	Reconstruct	5,292	57
Northwood School	H	Reconstruct	30,534	35
Northwood School	I	Reconstruct	10,831	23

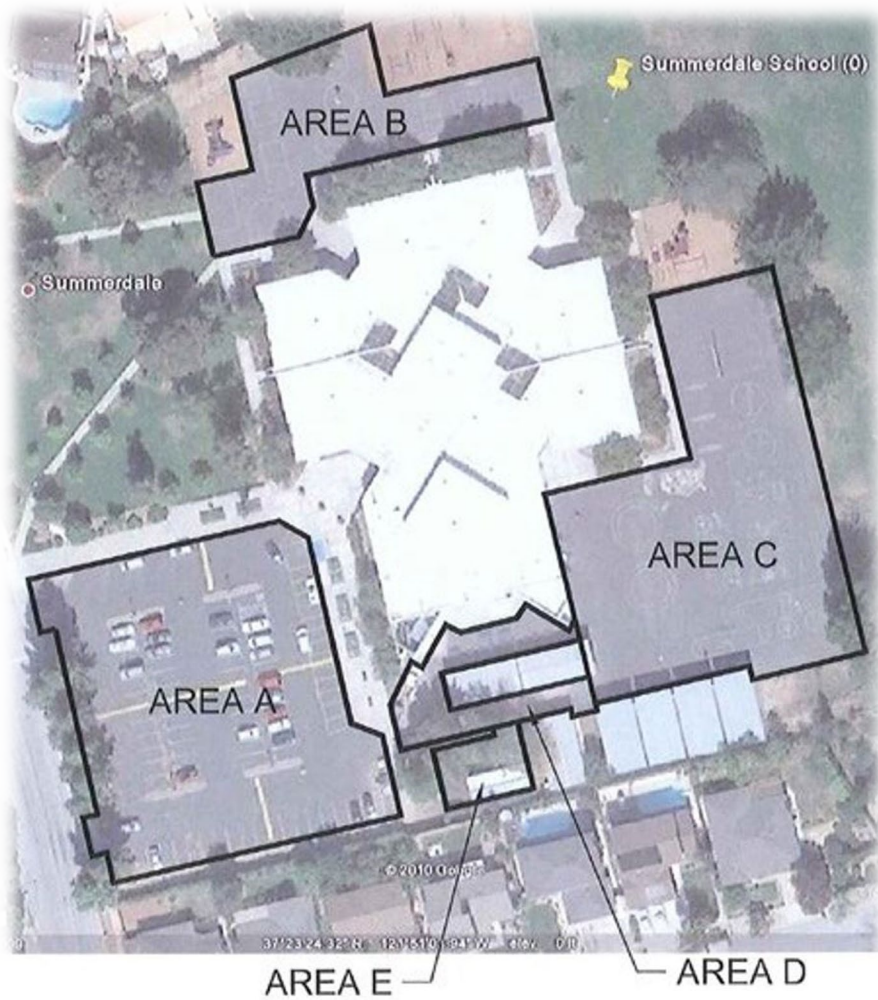
School Name	Area	Work Description	SF Area	PCI Score
Summerdale School	A	Seal Coat	34,696	85
Summerdale School	B	Reconstruct	14,544	56
Summerdale School	C	Crack Fill and Seal Coat	33,725	85
Summerdale School	D	Reconstruct	5,808	57
Summerdale School	E	Reconstruct	2,435	62

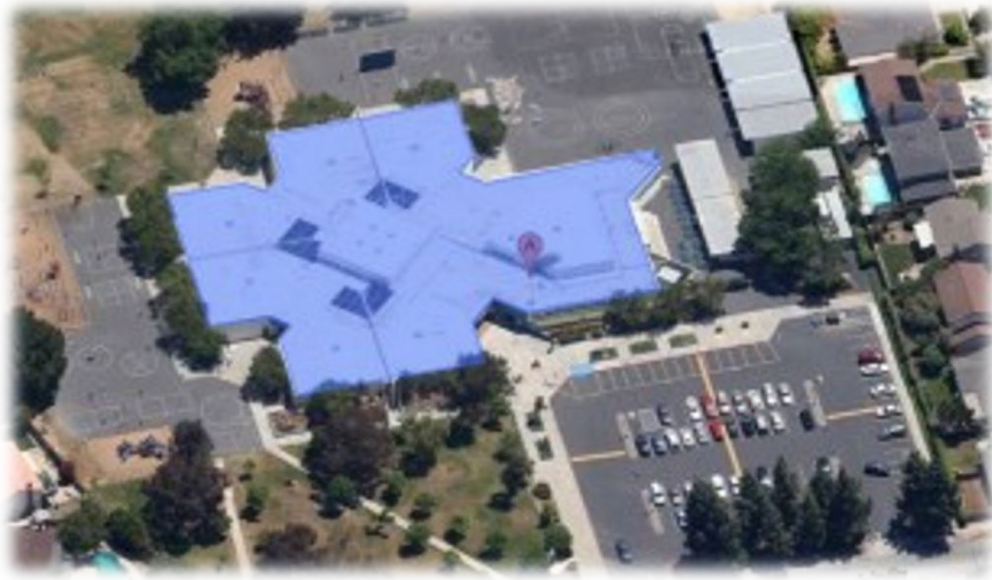
SEISMIC ASSESSMENT REPORT

The building is one of three identical single-story building with a wood framed roof with concrete walls built in 1974. Please refer to the evaluation written for Brooktree Elementary for specific recommendations for this building type.

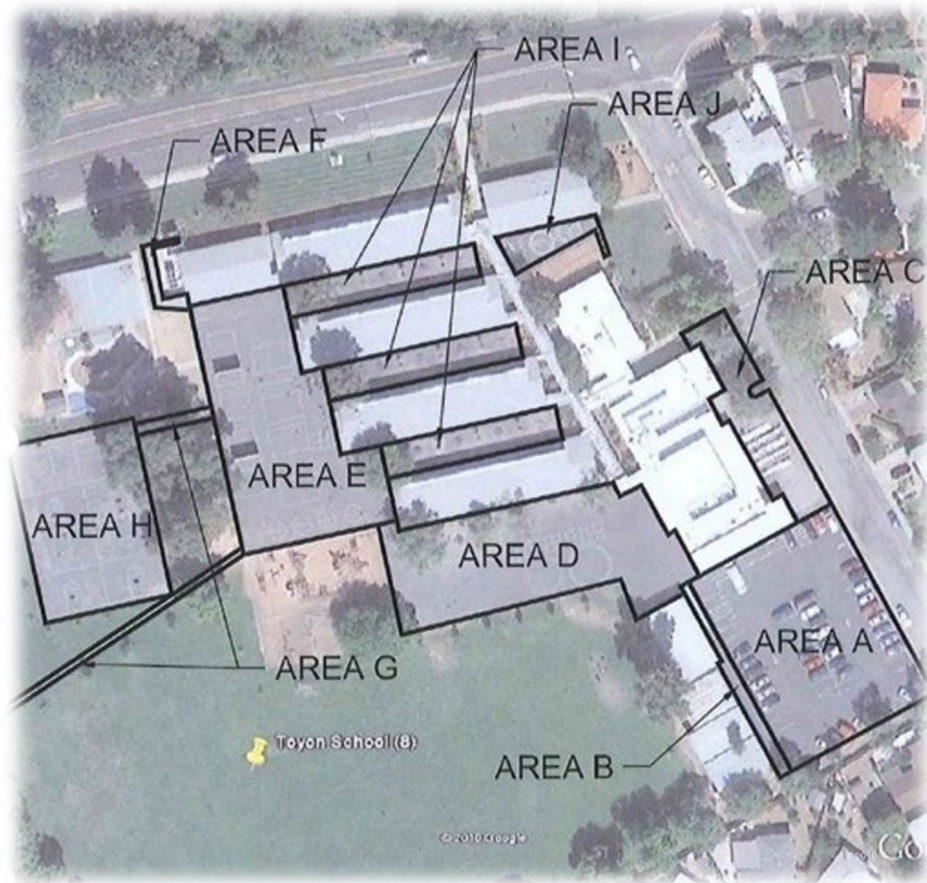
School Name	Area	Work Description	SF Area	PCI Score
Toyon School	A	Reconstruct	21,336	41
Toyon School	B	Reconstruct	1,909	47
Toyon School	C	Crack Fill and Seal Coat	4,644	72
Toyon School	D	Reconstruct	17,479	55
Toyon School	E	Crack Fill and Seal Coat	19,556	85
Toyon School	F	Reconstruct	1,087	59
Toyon School	G	Crack Fill and Seal Coat	2,145	85
Toyon School	H	Crack Fill and Seal Coat	14,140	85
Toyon School	I	Digout, Crack Fill & Seal Coat	9,089	85
Toyon School	J	Crack Fill and Seal Coat	1,970	85

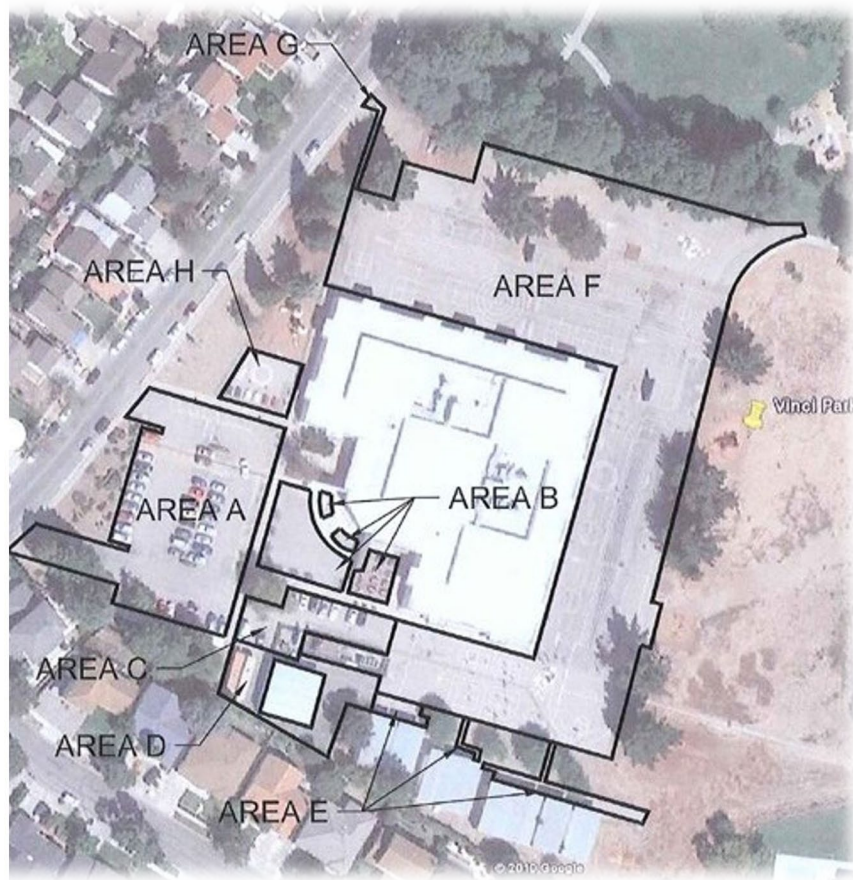
School Name	Area	Work Description	SF Area	PCI Score
Vinci Park School	A	Reconstruct	25,252	40
Vinci Park School	B	Reconstruct	6,604	63
Vinci Park School	C	Reconstruct	5,112	49
Vinci Park School	D	Crack Fill & Seal Coat	4,135	74
Vinci Park School	E	Crack Fill & Seal Coat	3,964	74
Vinci Park School	F	Reconstruct	83,630	47
Vinci Park School	G	Crack Fill & Seal Coat	632	79
Vinci Park School	H	Crack Fill & Seal Coat	2,744	75

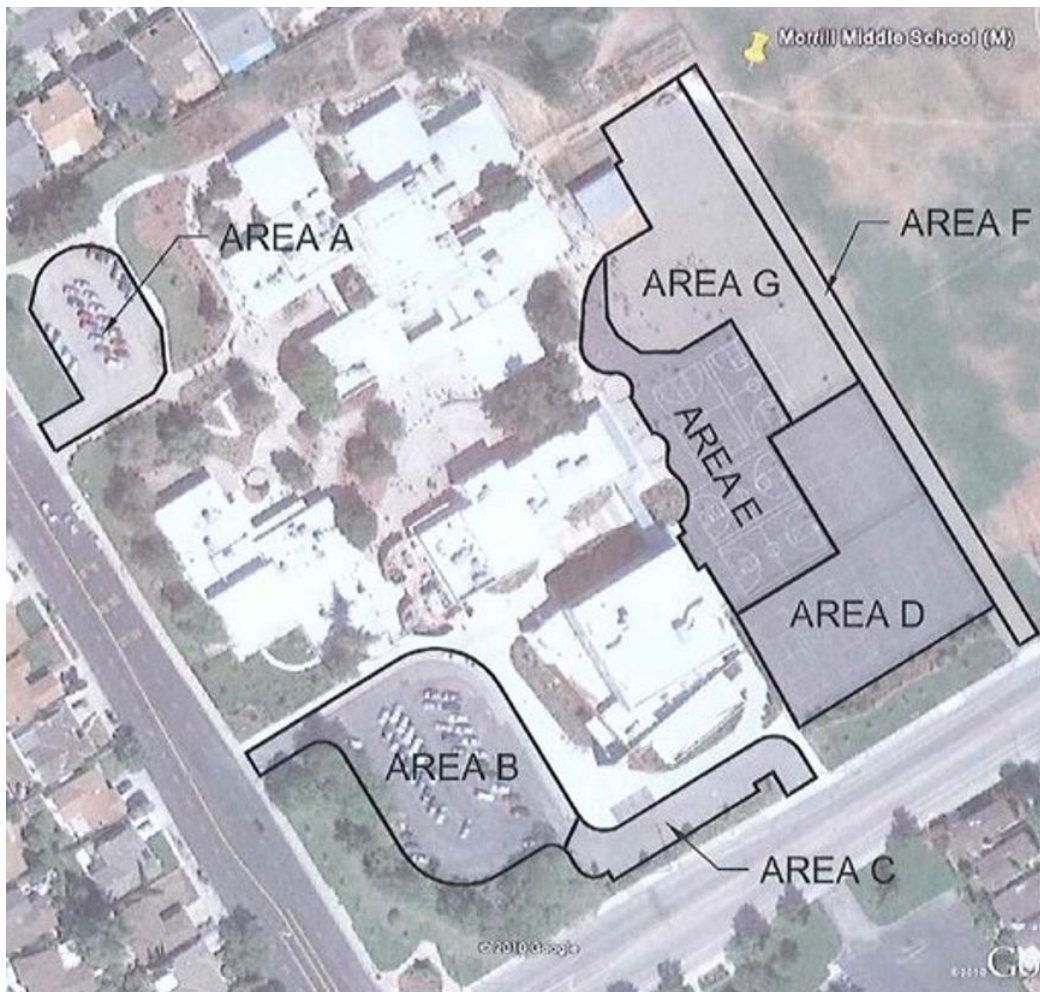
School Name	Area	Work Description	SF Area	PCI Score
Morrill Middle School	A	Reconstruct	14,832	28
Morrill Middle School	B	Reconstruct	30,172	26
Morrill Middle School	C	Crack Fill & Seal Coat	10,709	82
Morrill Middle School	D	Acrylic Seal Coat	35,636	95
Morrill Middle School	E	Crack Fill & Seal Coat	27,118	90
Morrill Middle School	F	Crack Fill & Seal Coat	12,000	82
Morrill Middle School	G	Crack Fill & Seal Coat	34,118	81

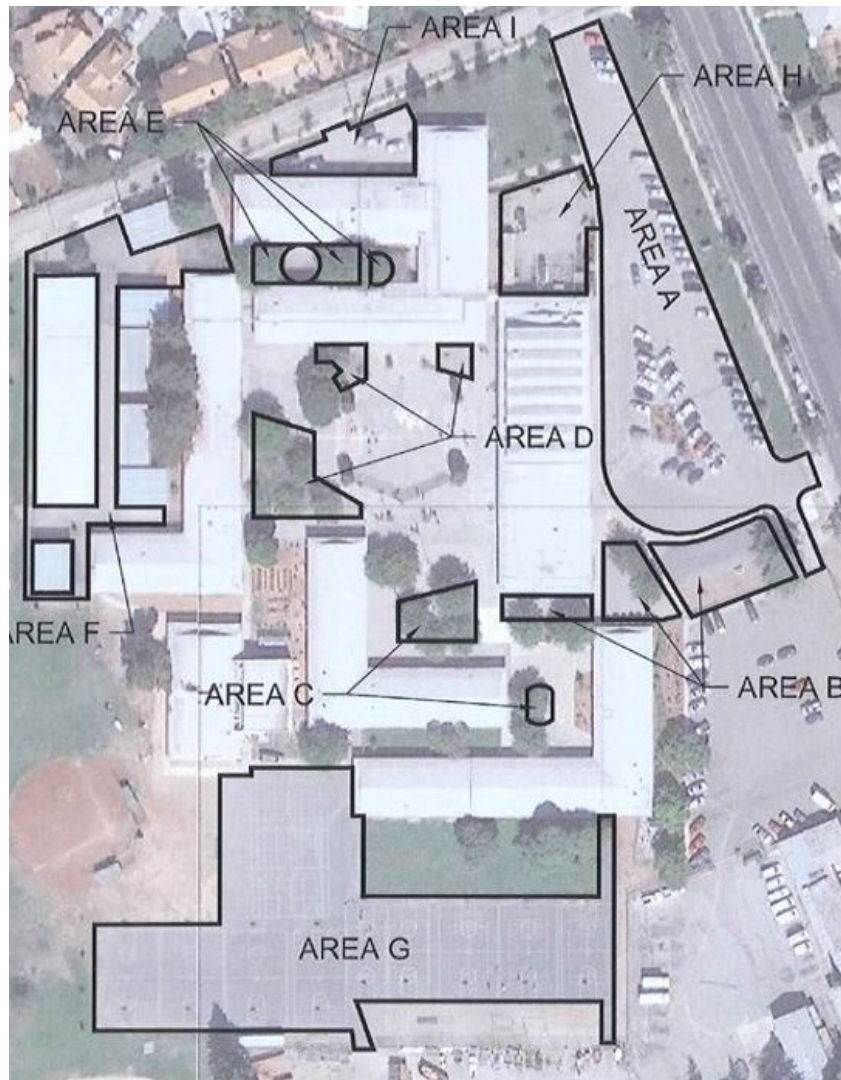
School Name	Area	Work Description	SF Area	PCI Score
Piedmont Middle School	A	Seal Coat	38,560	95
Piedmont Middle School	B	Crack Fill and Seal Coat	6,690	86
Piedmont Middle School	C	Remove & Replace	5,334	52
Piedmont Middle School	D	Remove & Replace	6,432	52
Piedmont Middle School	E	Remove & Replace	3,583	46
Piedmont Middle School	F	Remove & Replace	8,481	59
Piedmont Middle School	G	Reconstruct	50,196	43
Piedmont Middle School	H	Reconstruct	6,750	37
Piedmont Middle School	I	Reconstruct	4,900	45

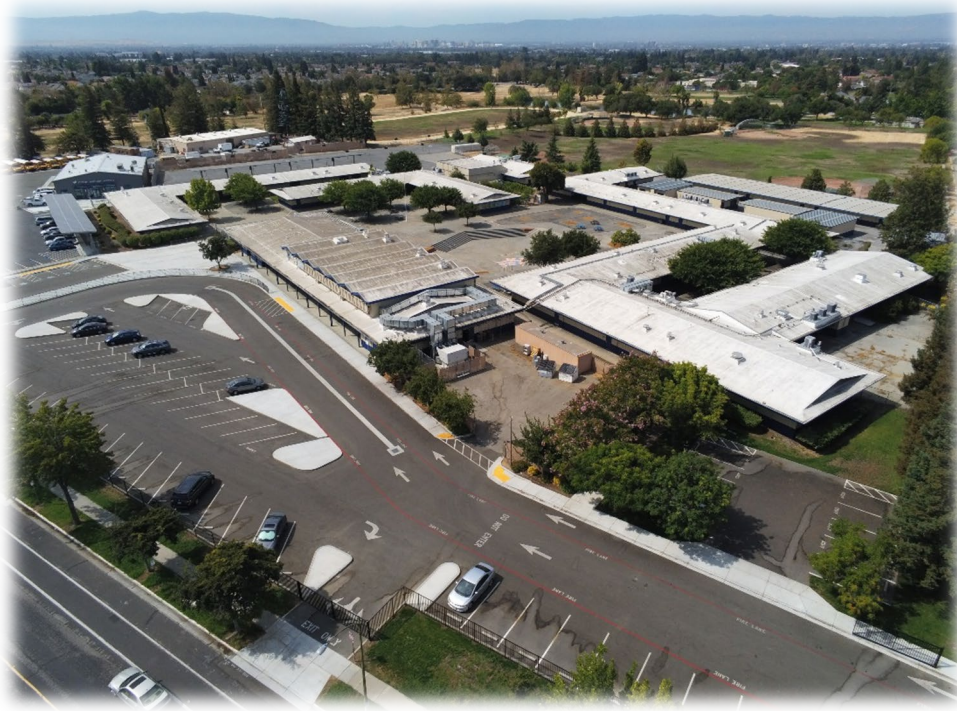
SEISMIC ASSESSMENT REPORT

Piedmont Middle School consists of multiple buildings for which the original construction dates are unknown. Structural drawings were not available for the original campus construction. Based on the structural drawings that were available, we have the following understanding: 1) several building additions (shaded orange above) were constructed in 1973 to include a new classroom, new shop and expanded shower/locker room, and 2) the campus was "modernized" in 1995. The "modernization" appears to only include infill of several walls and creation of new wall openings and does not appear to include any seismic retrofit/rehabilitation items.
