Berryessa Union School District Facilities Needs and Assessment Study

Prepared For
Berryessa Union School District

In April of 2013, Berryessa Union School District requested that Sugimura Finney Architects prepare a District-wide survey to assess the current status of the District's facilities, and to help guide upcoming decisions related to facility utilization and improvement.

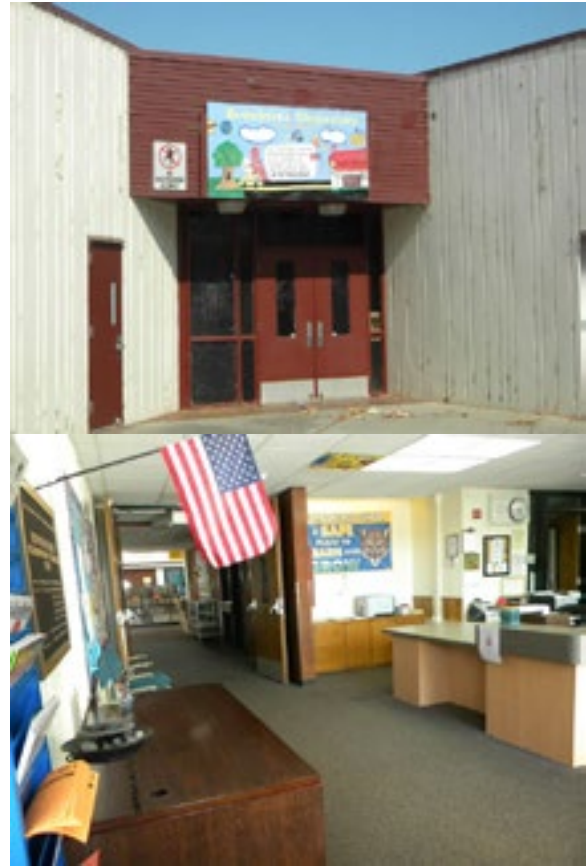
- While significant portions of this site have a perimeter fence in place, the site is largely open in the front; and because the site abuts a city park, there is an unfenced boundary at the rear of the site also.
- Building exterior lighting is insufficient.
- There is direct access without intervening obstacles from the main entry to interior building spaces.
- Existing doors often have windows in them, and not all doors have modern security hardware.
- Not all classrooms have doors that can be secured, due to original open plan of site.
- This site has a handful of windows below door height.

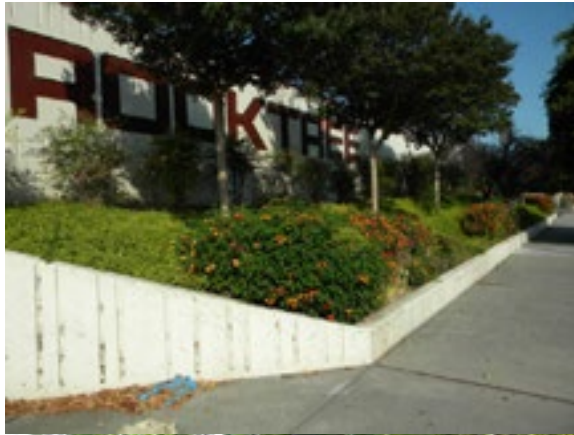
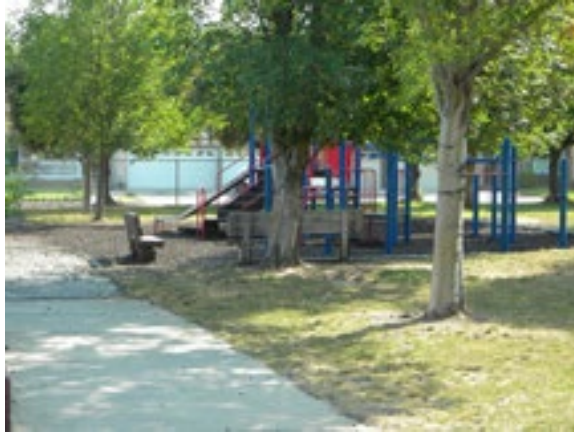
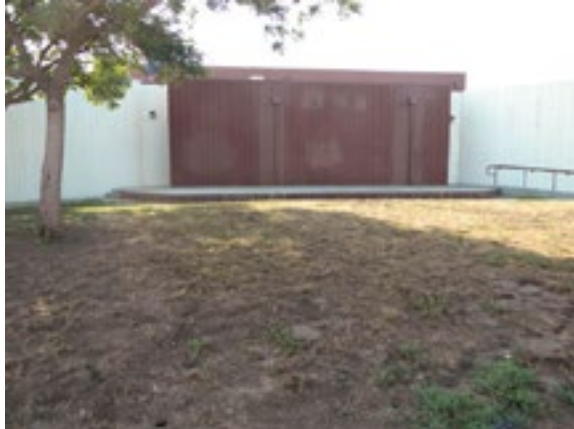
Play Surface / Fields / Play Structures:

- The existing asphaltic concrete play surfaces appears to be in reasonably good condition, although some repair work is needed.
- The existing sports fields have issues with ground squirrels and gophers. Some parts of the grass fields are bare and/or more weeds than grass.
- Existing play structures appear in good condition; however, the existing shredded rubber in the play structure boxes is depleted and in need of replacement.

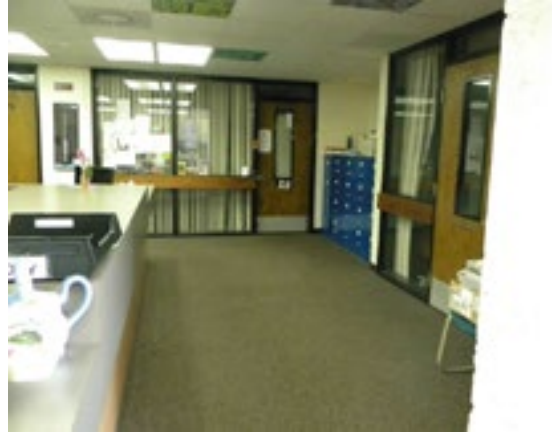
- Building entry visibility is acceptable, but could be improved.

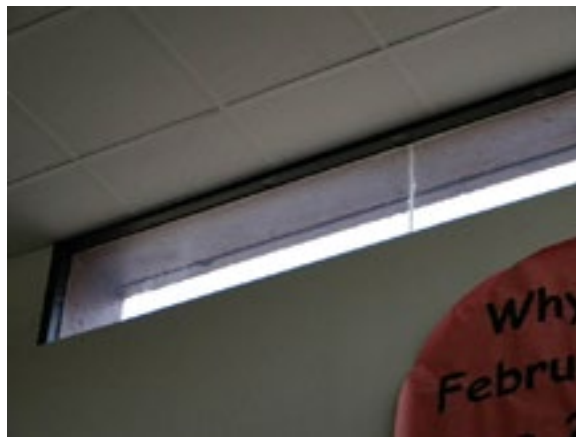
- Existing book stack capacity is insufficient for current needs.
- Existing clerestory windows are in need of replacement.
- Existing integral media center space is insufficient for current needs.

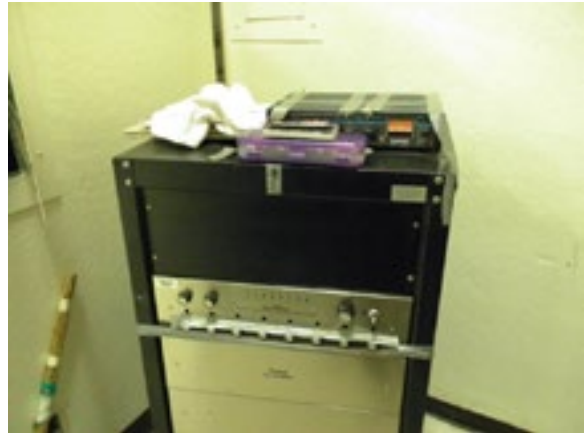
- Most finishes appear in need of replacement.
- Existing clerestory windows are in need of replacement.

- Existing sound system is inadequate for current needs.
- Existing original folding cafeteria tables are in need of replacement.

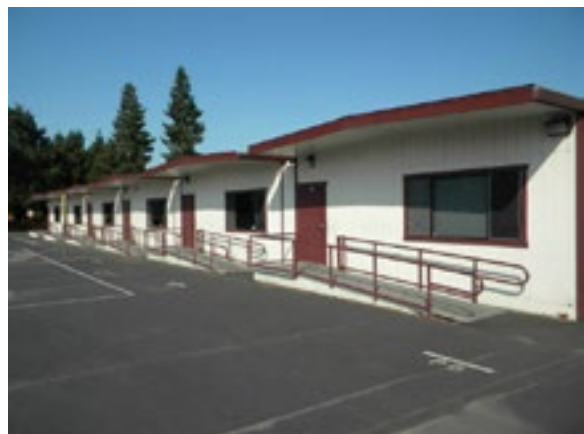
- Special Education classrooms are distributed around site due to lack of a centralized location.
- The site currently has no dedicated Science Lab.
- The existing Media Center / Computer Lab space is adjacent to the library in an open and unsecure area without sufficient infrastructure support for the program requirements.

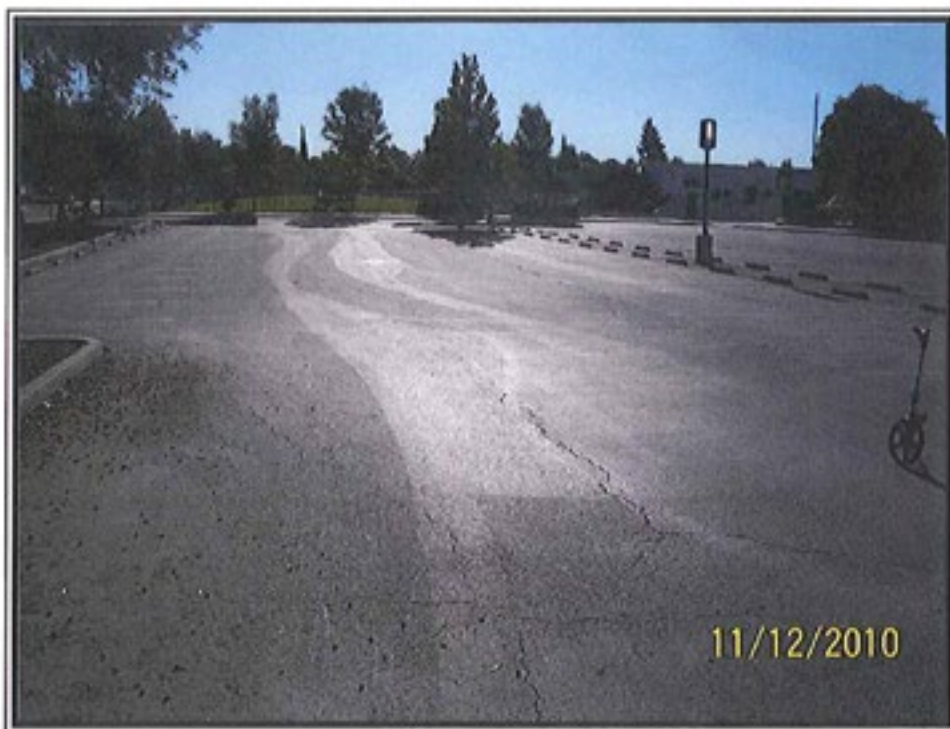
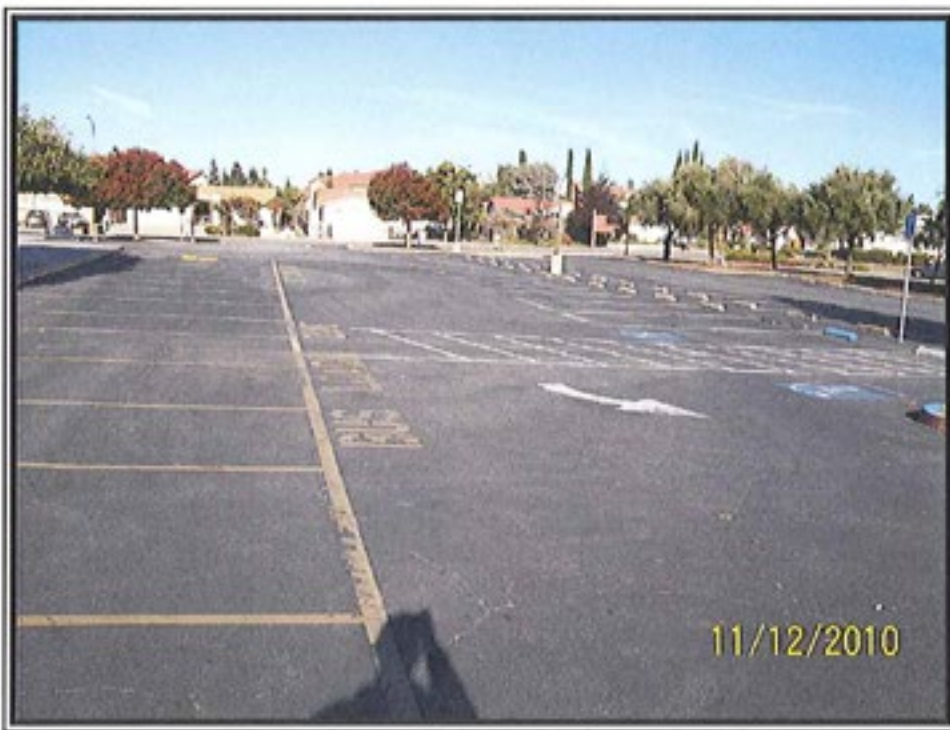
BROOKTREE SCHOOL - AREA A

Defect Score: 53

Visual Description: Pavement exhibits moderate raveling with a previous seal (approximately 4 years old) and moderate shrinkage cracking.

Recommended Treatment: Dig out/ Crack Fill/ Seal Coat

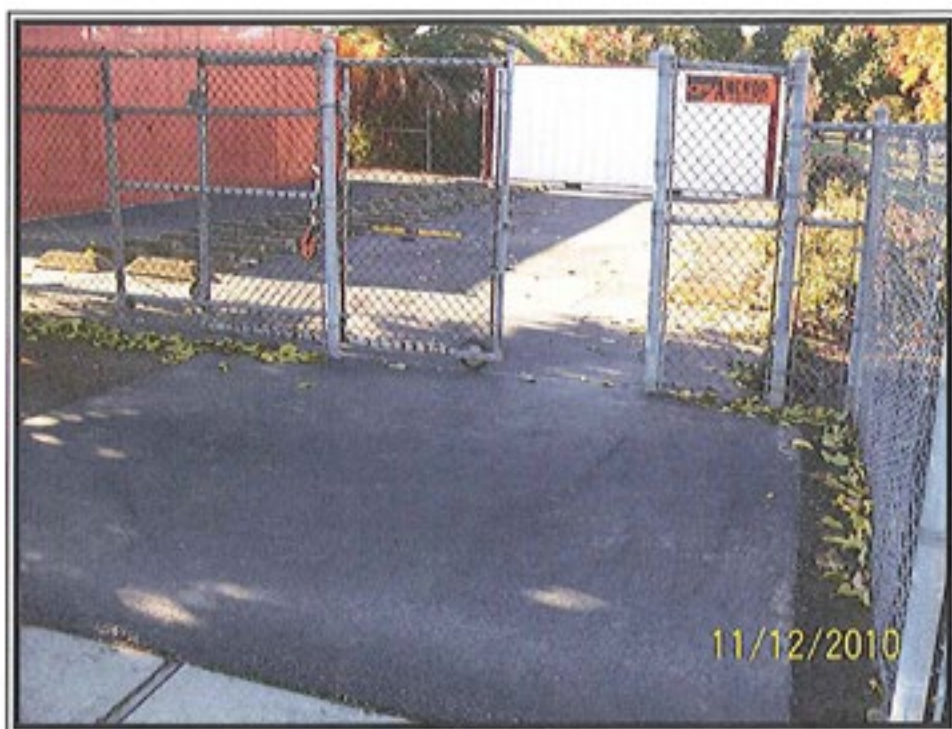
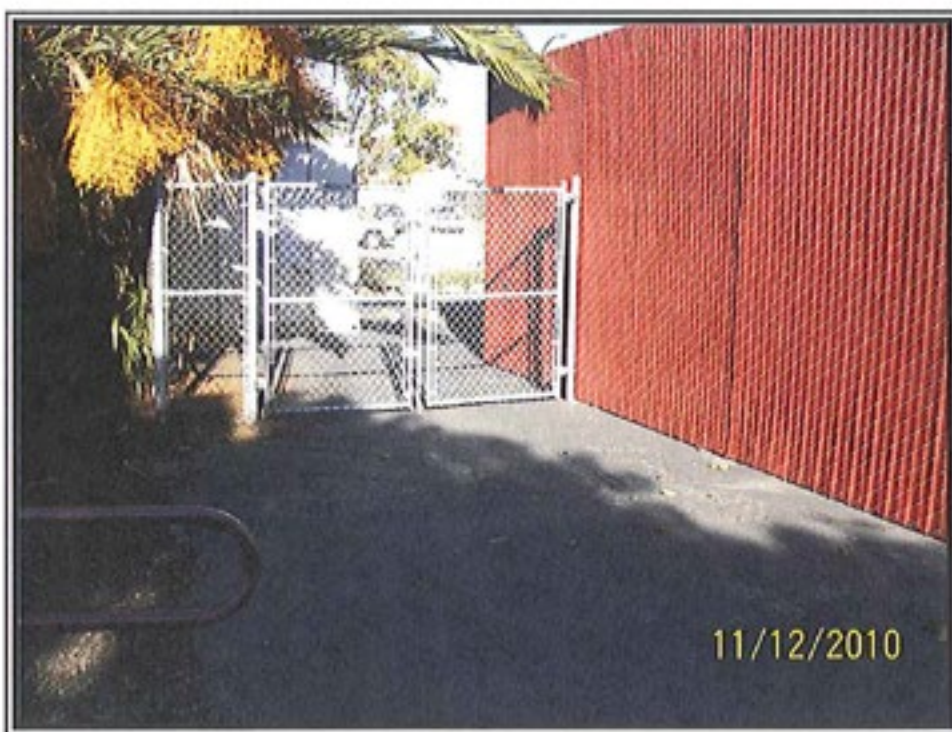
BROOKTREE SCHOOL - AREA B

Defect Score: 29

Visual Description: Pavement exhibits moderate shrinkage cracking, previously sealed, in fair condition, with some tree root damage.

Miscellaneous: Slope = 2.7, Bike rack area; pavement adjacent to sidewalk is uplifted and is a trip hazard.

Recommended Treatment: Remove & Replace

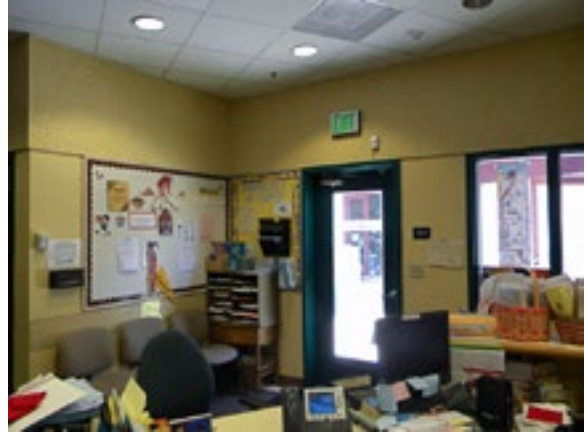
- While significant portions of this site have a perimeter fence in place, the site is largely open in the front; in addition, there are existing access openings in the fence that need lockable gates added.
- Exterior lighting is insufficient.
- The current administration space is located adjacent to the entries to the main school building, with no direct access control.
- Existing doors often have windows in them, and not all doors have modern security hardware.
- This site has a several windows below head height.

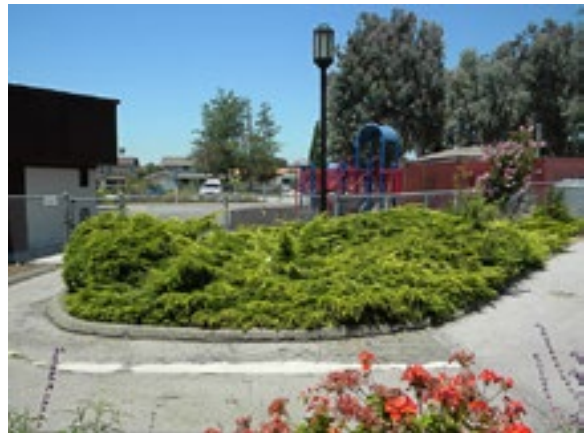
- The existing landscaping is dated, non-existent in some places, and overgrown in others. The bare areas face erosion issues, and the overgrown areas trap debris as well as providing a home to nuisance pests.

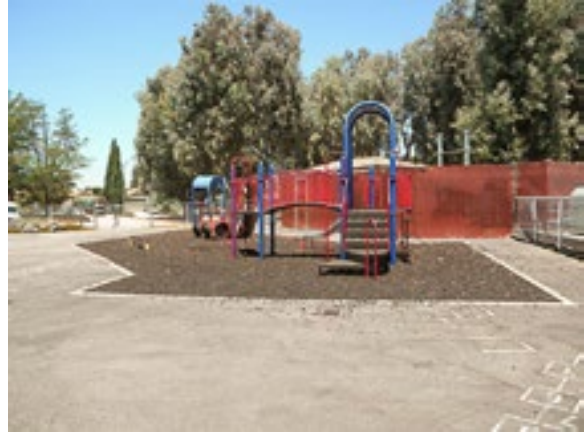
Play Surface / Fields / Play Structures:

- The existing asphaltic concrete play surfaces appear to be in reasonably good condition, although some repair work is needed.
- The existing sports fields have issues with ground squirrels and gophers. Some parts of the grass fields are bare and/or more weeds than grass.
- Existing play structures appear in good condition; however, the existing shredded rubber in the play structure boxes is depleted.

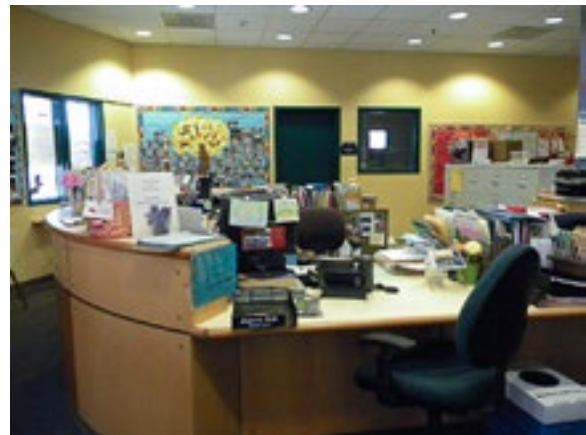
- The center of the main building consists of a large common area with a very high ceiling space. This space is under-utilized; and with the high ceiling, takes considerable amounts of energy to heat and cool.

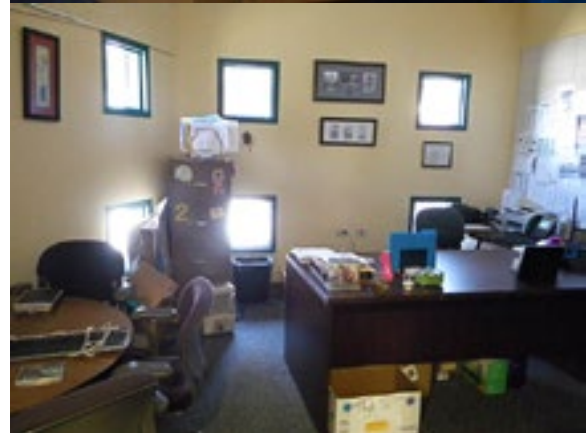
Classrooms:

- Classrooms are generally in good condition, although many of the finishes are faded and/or dirty.
- Hexagonal-shaped classrooms have irregular ceiling heights.

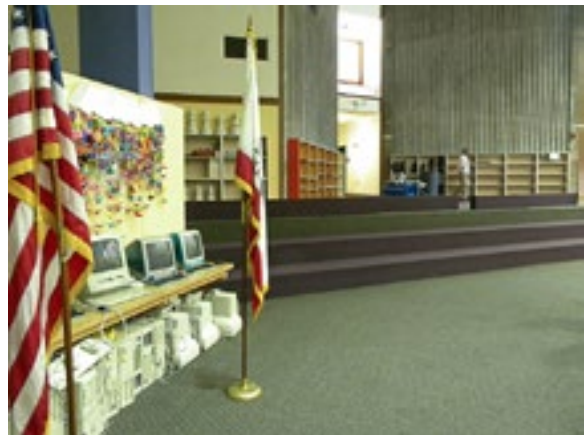
Staff Work Areas:

- The staff work area appears to be in good condition. The existing casework appears to be aging, although still serviceable.

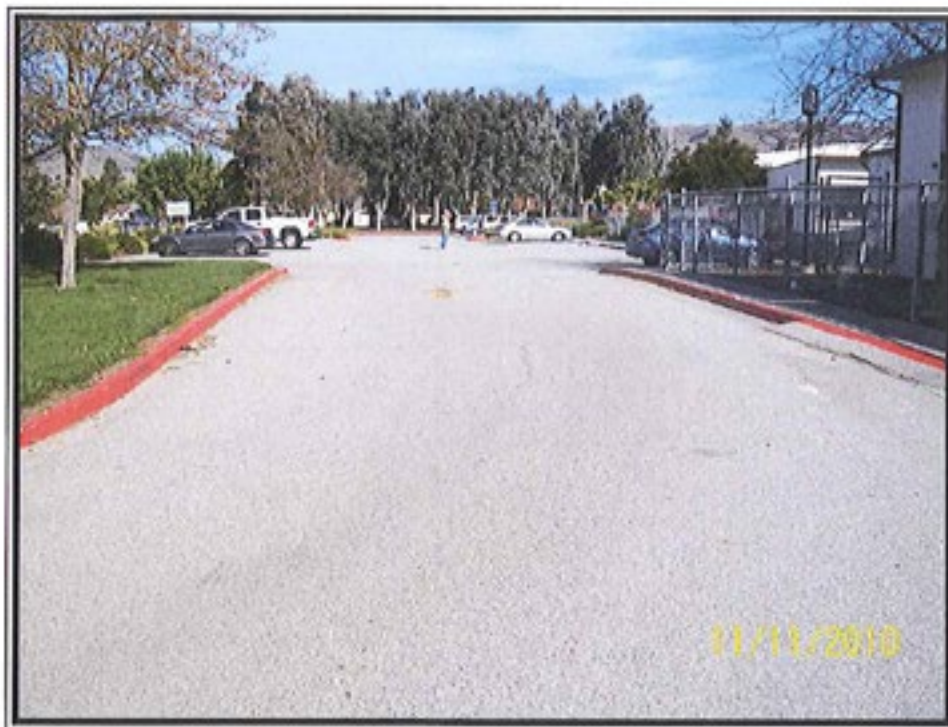
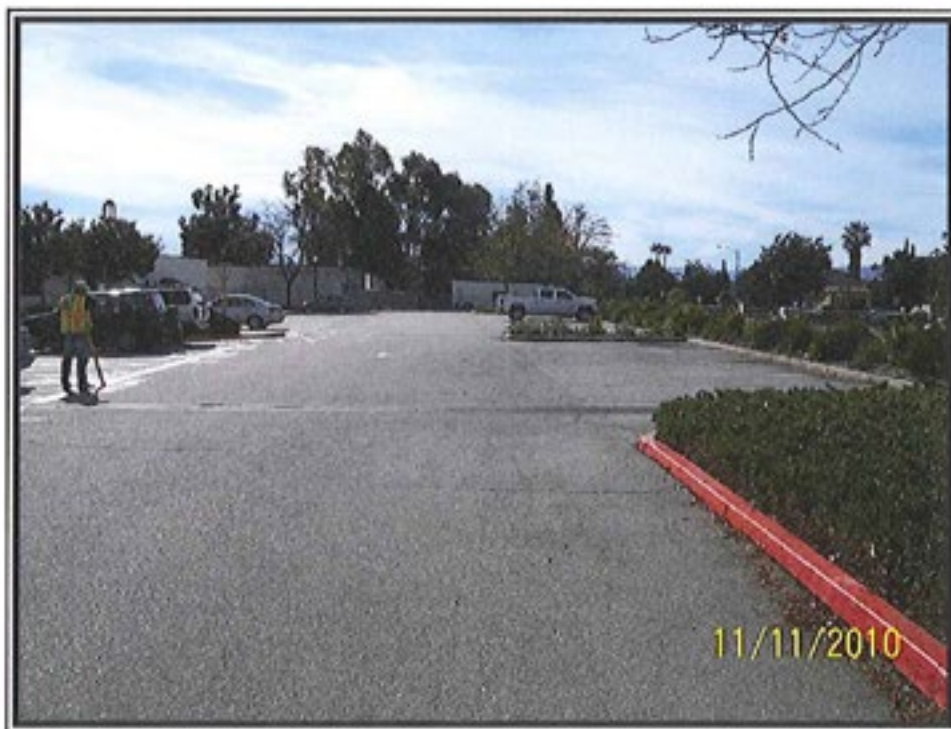
CHERRYWOOD SCHOOL - AREA A

School Name: Cherrywood School **Area (sf):** 22,596
Area Notation: A **Buses:** Yes
Surface Type: AC **Garbage Trucks:** No
Use: Parking Lots or Areas
Defect Score: 44
Recommended Treatment: Crack Fill and Seal Coat
Year: 2011
Visual Description: Pavement exhibits moderate raveling and moderate block shrinkage cracking.
Miscellaneous: Slope = 0.1, ADA - needs signage and ramp needs to be replaced (8x25), pavement drains to curb and gutter.

Misc. AC Fill	Base Failure (%)	Alligator Cracking (%)	Crack Factor	Ravel
0	0%	0.0%	0.111	M
		Crack Width	1/8 - 1/4"

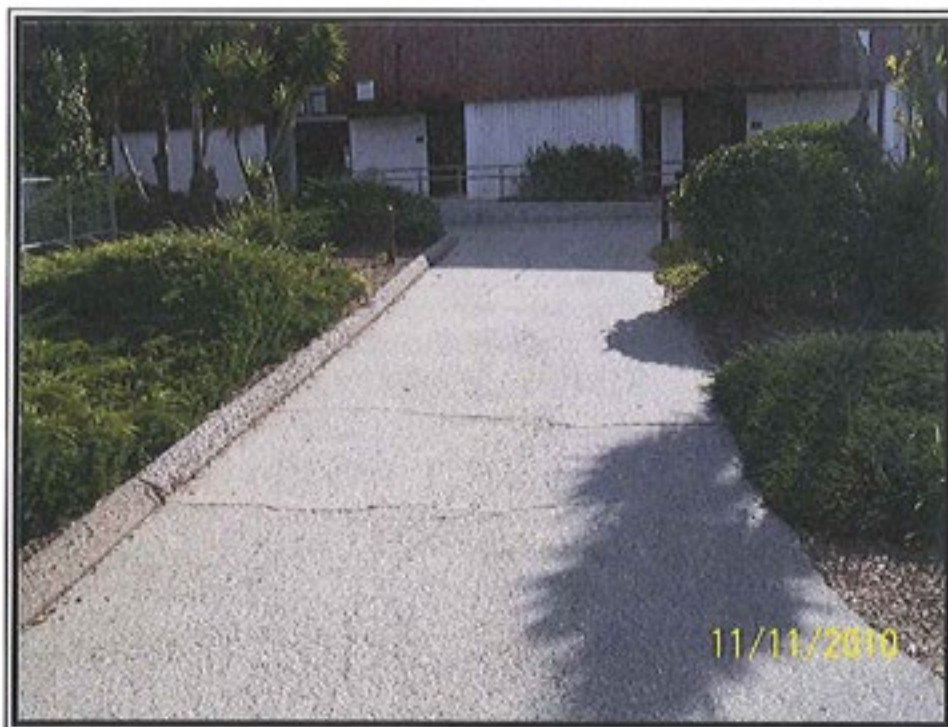
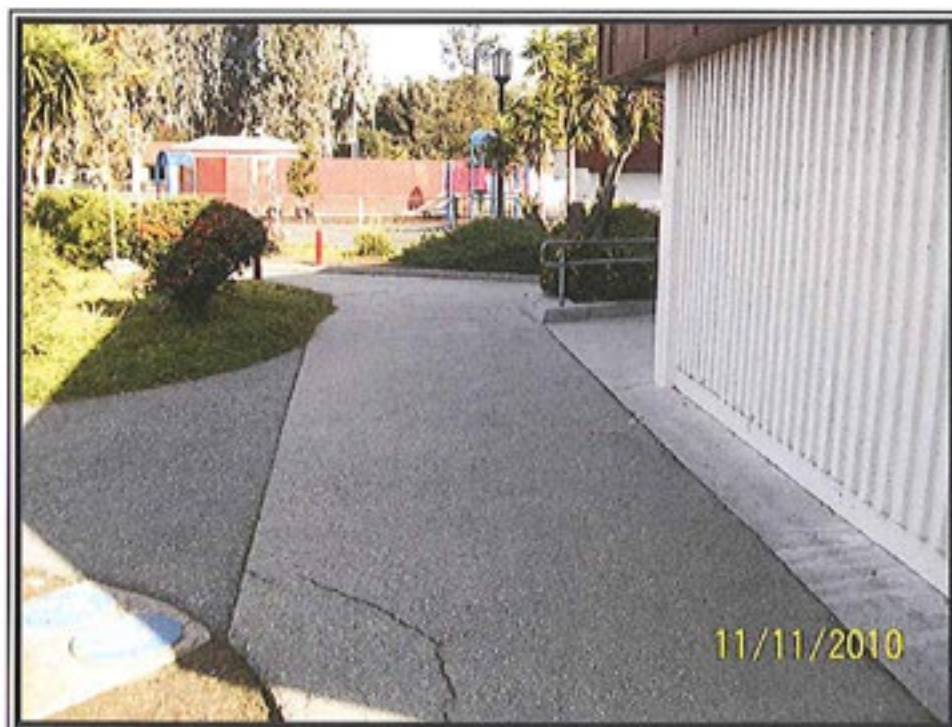
CHERRYWOOD SCHOOL - AREA B

School Name: Cherrywood School **Area (sf):** 1,908
Area Notation: B **Buses:** No
Surface Type: AC **Garbage Trucks:** No
Use: Pedestrian Areas
Defect Score: 25
Recommended Treatment: Crack Fill and Seal Coat
Year: 2011
Visual Description: Pavement exhibits slight raveling, AC edge east of planter failing, needs headerboard.
Miscellaneous: Slope = 2.7/ 7.5, Drains to planters.

Misc. AC Fill	Base Failure (%)	Alligator Cracking (%)	Crack Factor	Ravel
0	0%	0.0%	0.058	S
Crack Width		1/8 - 1/4"

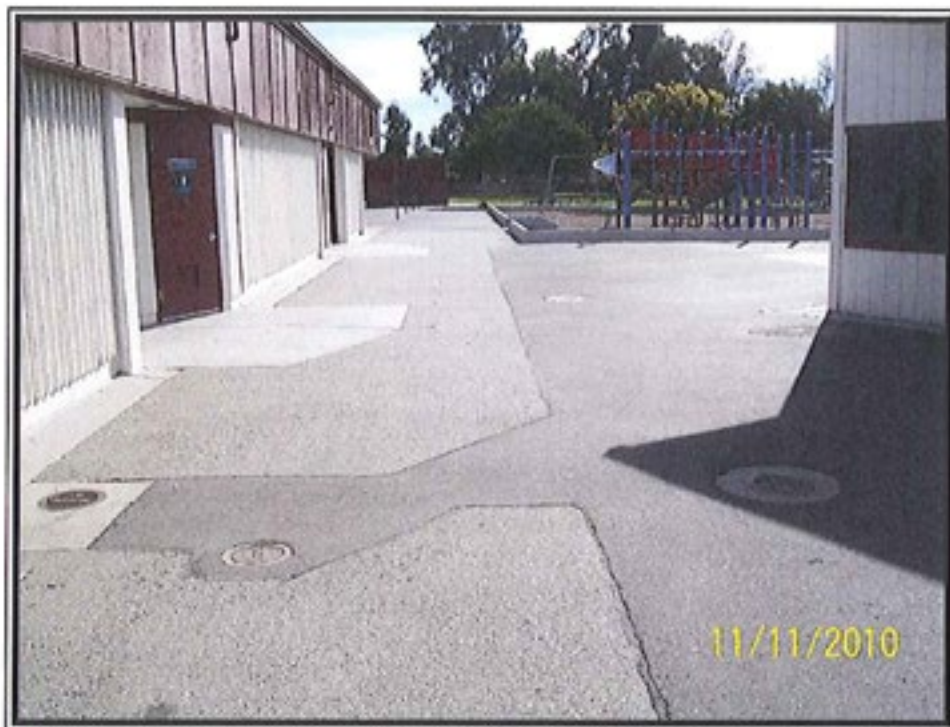
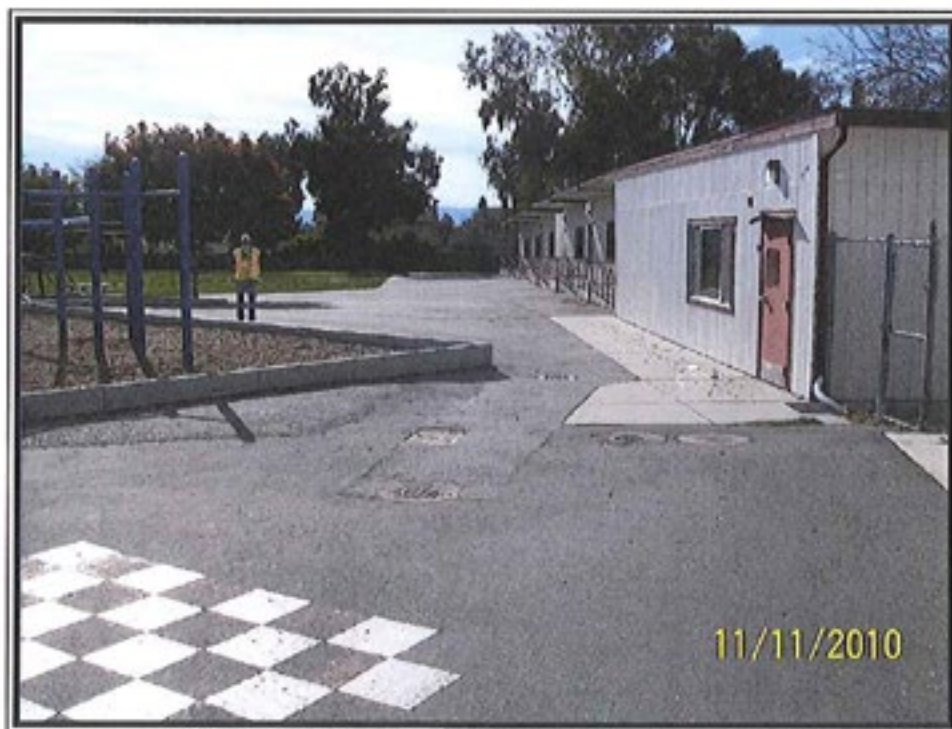
CHERRYWOOD SCHOOL - AREA C

School Name:	Cherrywood School	Area (sf):	24,210
Area Notation:	C	Buses:	No
Surface Type:	AC	Garbage Trucks:	No
Use:	Pedestrian Areas		
Defect Score:	10		
Recommended Treatment:	Double application Emulsion Seal Coat		
Year:	2012		
Visual Description:	Pavement is newer with slight raveling and has never been sealed.		
Miscellaneous:	Slope = 3/ 3.8/ 9.3, Pavement drains to drop inlets located within the area.

Misc. AC Fill	Base Failure (%)	Alligator Cracking (%)	Crack Factor	Ravel
0	0%	0.0%	0.000	S
Crack Width		0

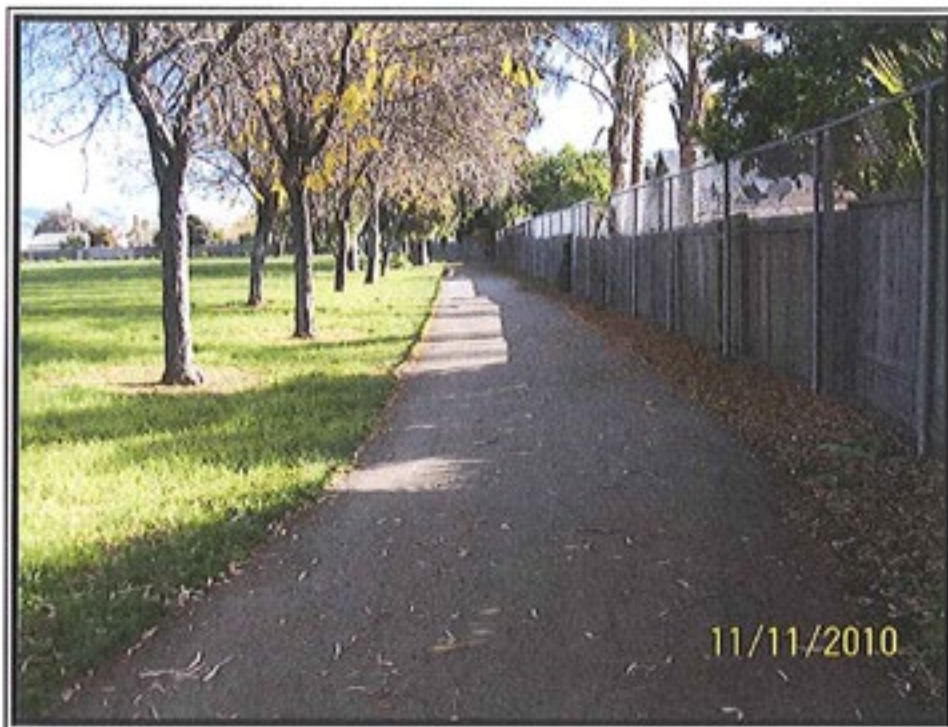
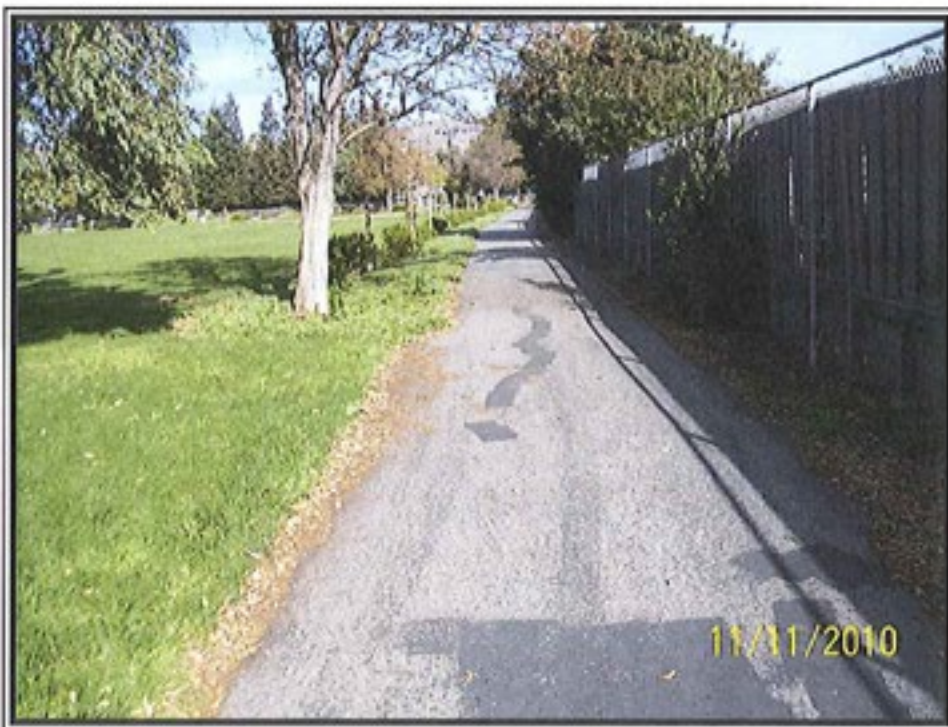
CHERRYWOOD SCHOOL - AREA D

Defect Score: 19

Visual Description: Pavement exhibits slight raveling with slight expansion cracking.

Miscellaneous: Slope = 3.1/ 0.3, Drains to adjacent field and planters, minor tree root damage.

Misc. AC Fill	Base Failure (%)	Alligator Cracking (%)	Crack Factor	Ravel
0	0%	0.0%	0.044	S
Crack Width		<1/8"

Recommended Treatment: Crack Fill and Seal Coat

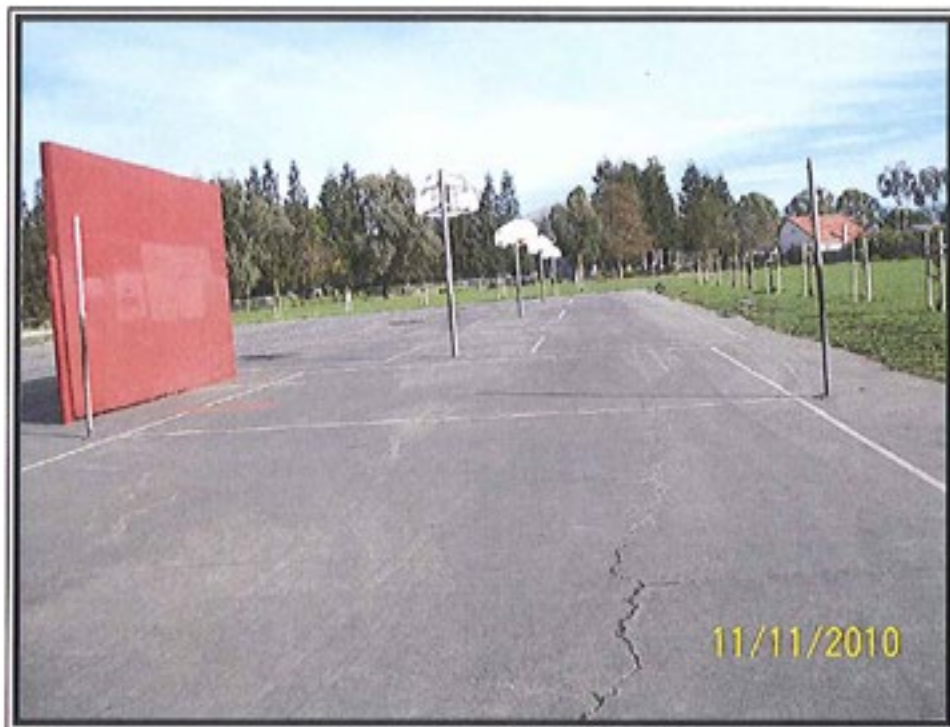
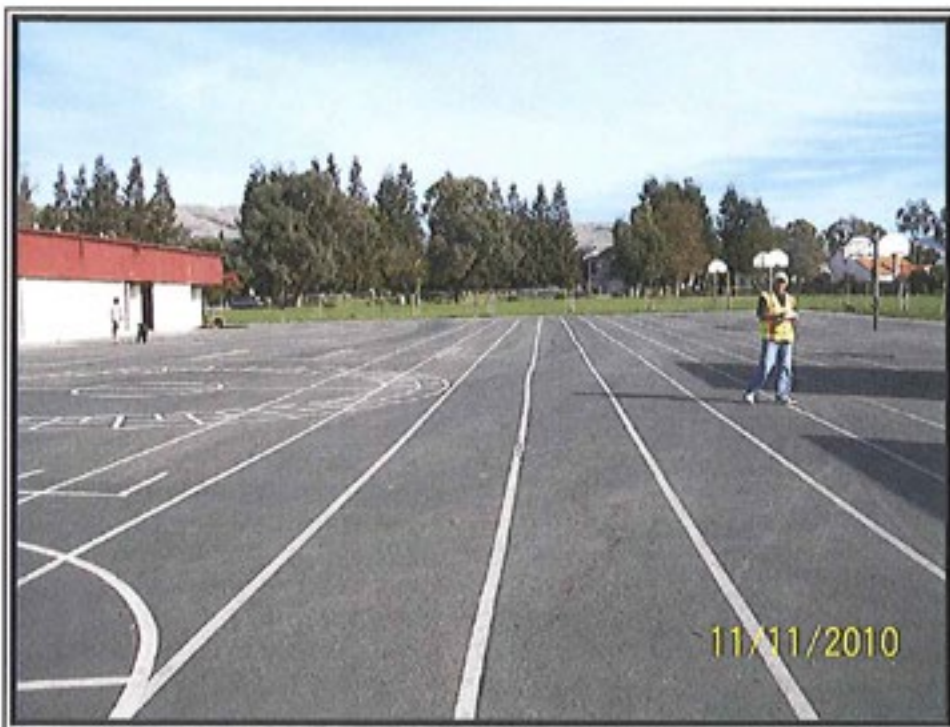
CHERRYWOOD SCHOOL - AREA E

School Name: Cherrywood School **Area (sf):** 36,026
Area Notation: E **Buses:** No
Surface Type: AC **Garbage Trucks:** No
Use: Playground
Defect Score: 33
Recommended Treatment: Crack Fill and Seal Coat
Year: 2012
Visual Description: Pavement exhibits slight raveling, previously sealed (approximately 4 years old), slight shrinkage cracking.
Miscellaneous: Pavement drains to the adjacent field.

Misc. AC Fill	Base Failure (%)	Alligator Cracking (%)	Crack Factor	Ravel
0	0%	0.0%	0.101	S
		Crack Width	<1/8"

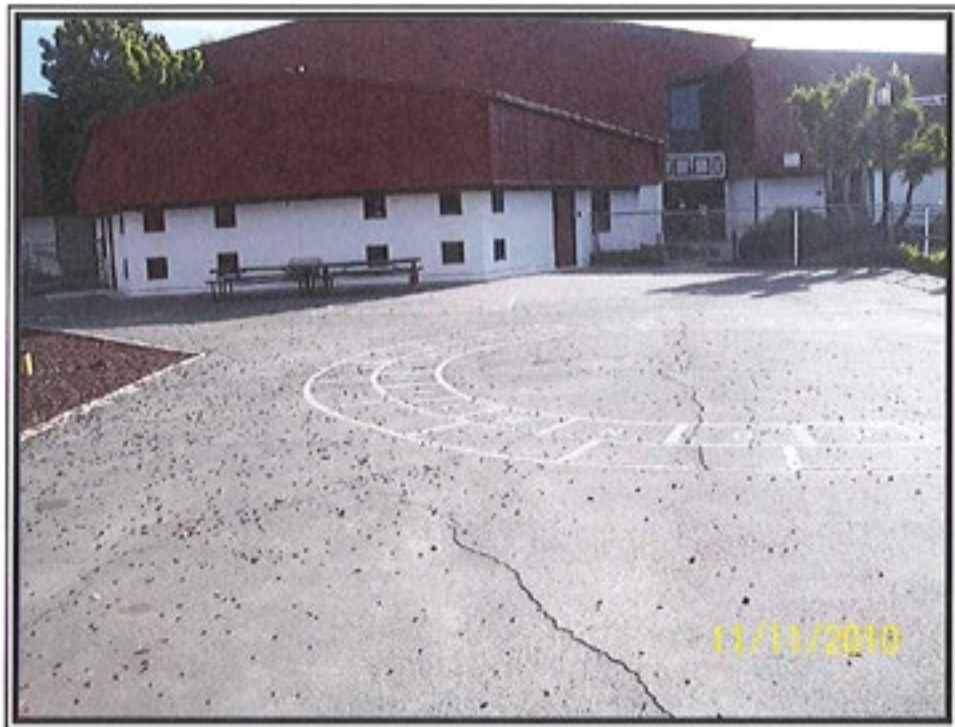
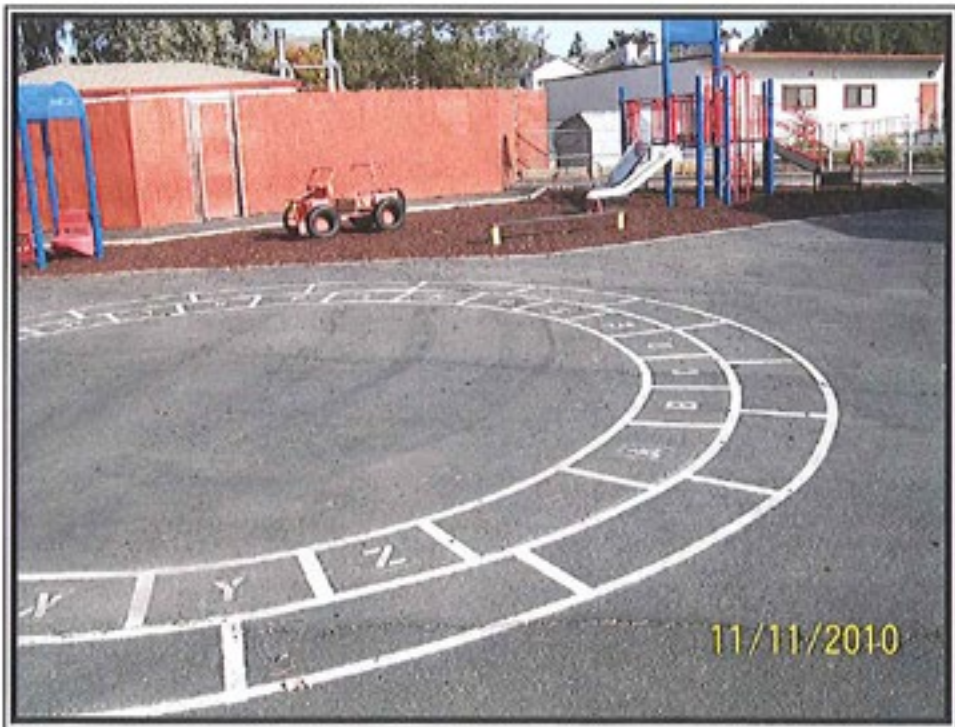
CHERRYWOOD SCHOOL - AREA F

School Name: Cherrywood School **Area (sf):** 4,950
Area Notation: F **Buses:** No
Surface Type: AC **Garbage Trucks:** No
Use: Playground
Defect Score: 34
Recommended Treatment: Crack Fill and Seal Coat
Year: 2012
Visual Description: Pavement exhibits slight raveling, previously sealed (3 years old).
Miscellaneous: Slope = 0.6/ 2.4, Pavement drains to drop inlets in area.

Misc. AC Fill	Base Failure (%)	Alligator Cracking (%)	Crack Factor	Ravel
0	0%	0.0%	0.080	S
		Crack Width	1/8 - 1/4"

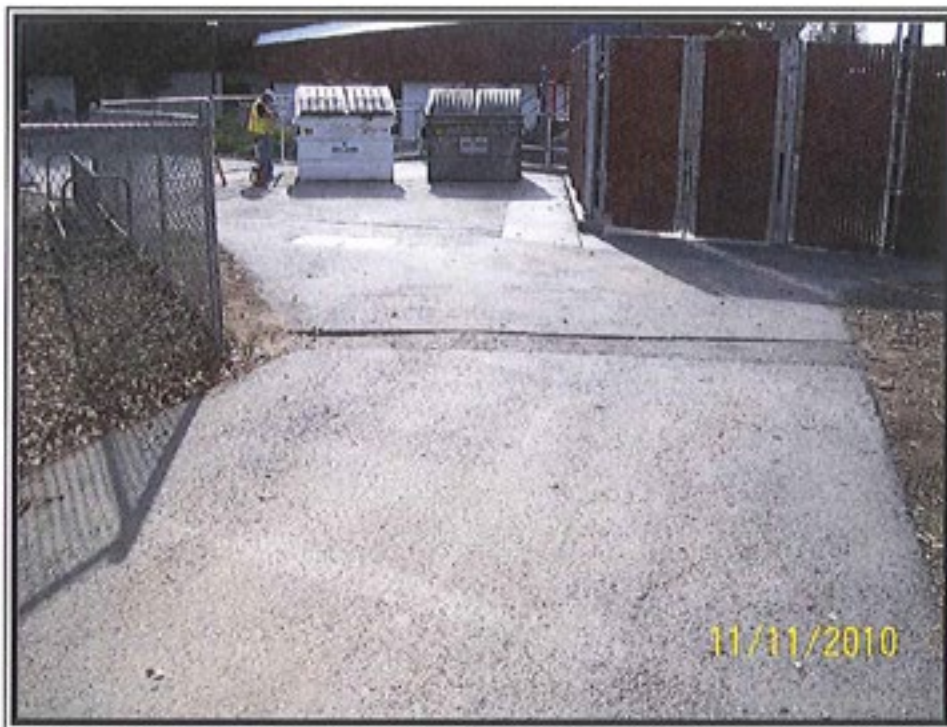
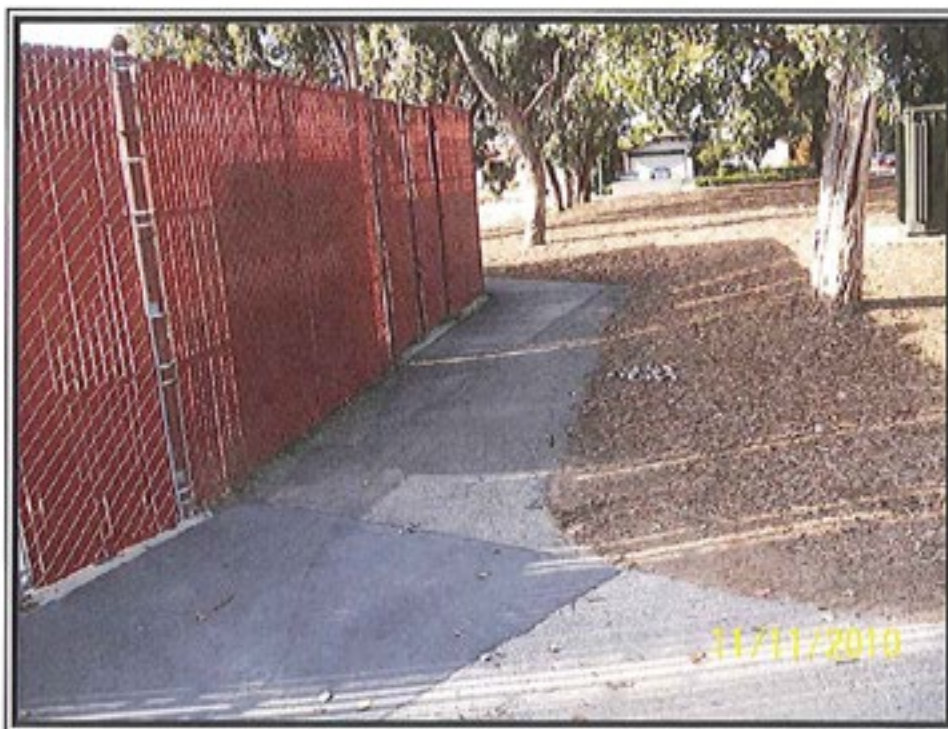
CHERRYWOOD SCHOOL - AREA G

Defect Score: 44

Misc. AC Fill	Base Failure (%)	Alligator Cracking (%)	Crack Factor	Ravel
0	0%	0.0%	0.052	M
		Crack Width	1/8 - 1/4"

Recommended Treatment: Double application Emulsion Seal Coat

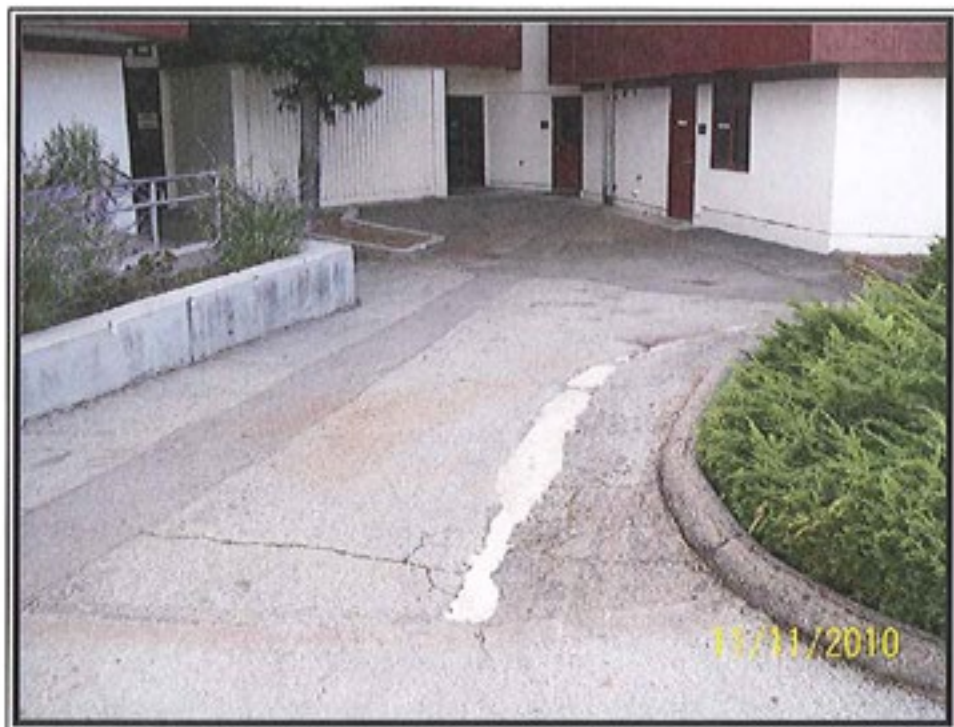
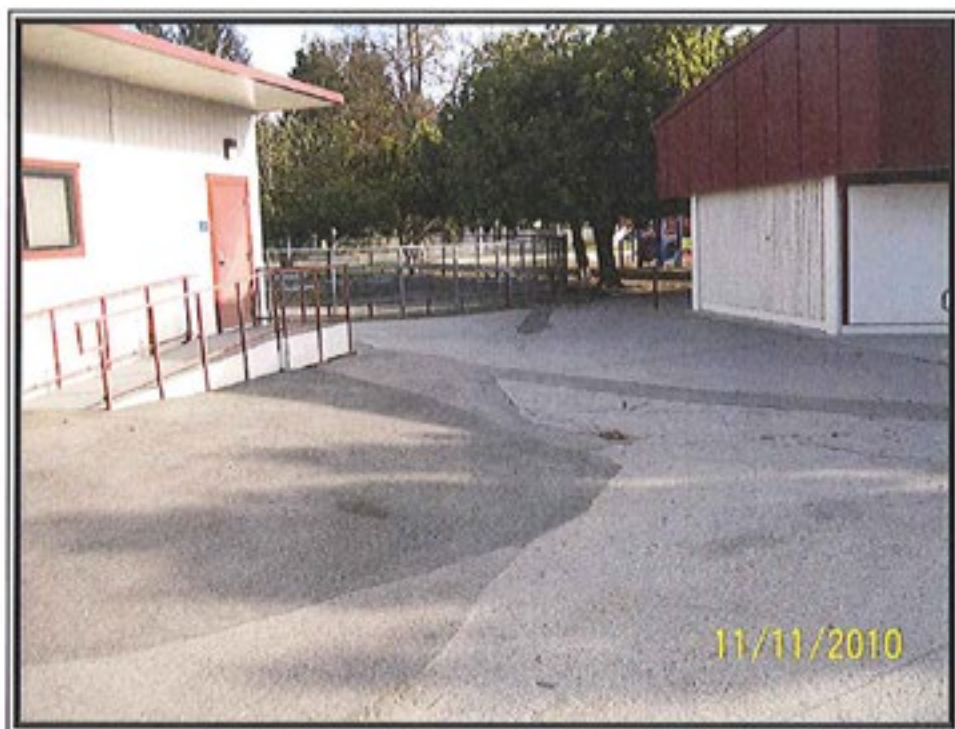
CHERRYWOOD SCHOOL - AREA H

School Name: Cherrywood School **Area (sf):** 8,994
Area Notation: H **Buses:** No
Surface Type: AC **Garbage Trucks:** No
Use: Pedestrian Areas
Defect Score: 23
Recommended Treatment: Crack Fill and Seal Coat
Year: 2011
Visual Description: Pavement exhibits slight raveling and trenching in one area of alligator cracking (5x5).
Miscellaneous: Slope = 1.4/ 8.1, Pavement drains to drop inlets located within the area.

Misc. AC Fill	Base Failure (%)	Alligator Cracking (%)	Crack Factor	Ravel
0	0%	0.0%	0.064	S
Crack Width		<1/8"

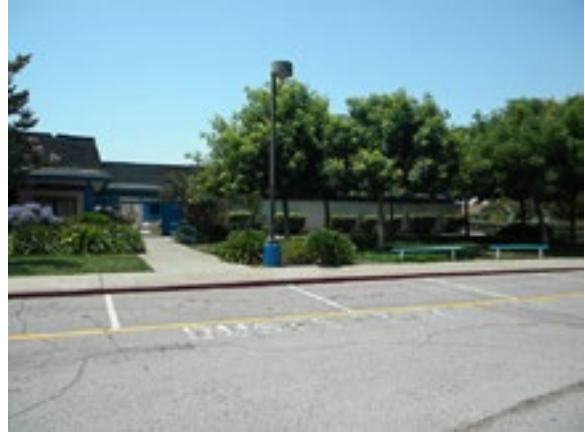
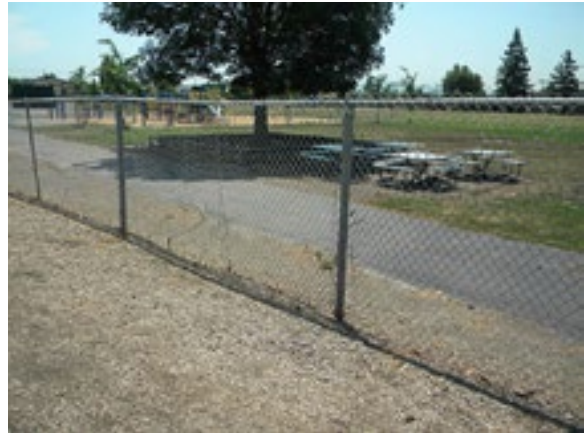
- While significant portions of this site have a perimeter fence in place, the site is largely open in the front and along the Warmwood Lane side; in addition, there are existing access openings in the fence that need lockable gates added.
- The campus core is secured with 4 double-door style gates. These gates are in poor condition, and are not compliant with current accessibility requirements.
- Exterior lighting is insufficient.
- The current administration space is located adjacent to the entries to the main school building, with no direct access control.
- Existing doors often have windows in them, and not all doors have modern security hardware.
- This site has a several windows below head height.

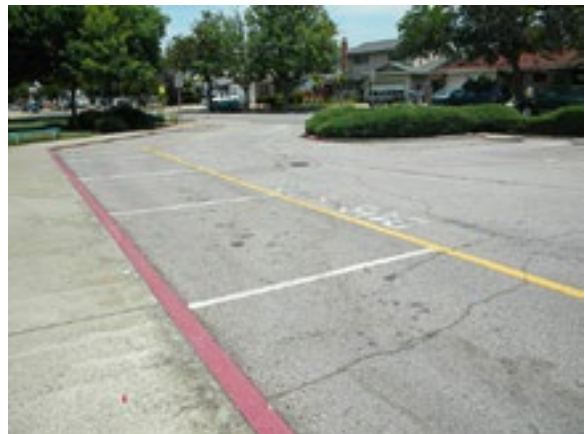
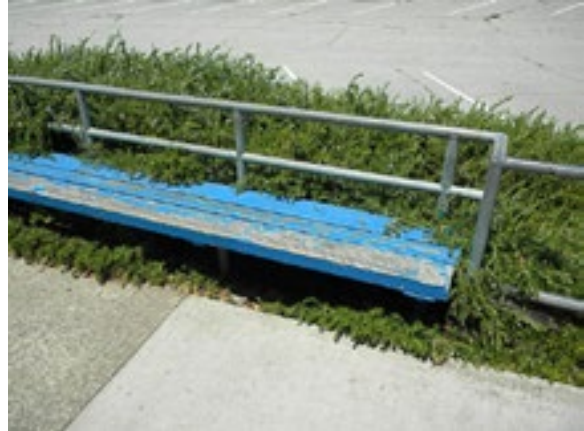
Parking lot and Drop-Off / Pick-Up:

- Circulation through the parking lot during pick-up and drop-off is inadequate, and creates problems with traffic congestion.
- Pick-up / Drop-off location sees considerable congestion during peak times, and does not allow traffic to flow through.
- The proximity of the driveways to an intersection controlled by a stop sign adds to this congestion.

tion as pedestrians and cars navigate the area.

- The circulation problems cause parents to park along the street, further adding to congestion. The streets are narrow, residential streets that already see many residents parking along the curb, further narrowing the street.

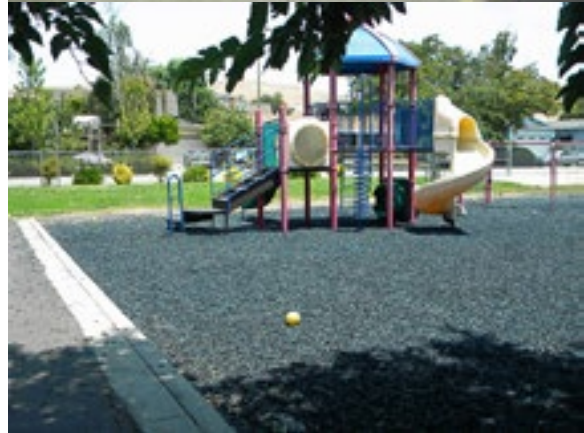
- The existing asphaltic concrete play surfaces appear to be in reasonably good condition, although some repair work is needed.
- The existing sports fields have issues with ground squirrels and gophers. Some parts of the grass fields are bare and/or more weeds than grass.
- Existing play structures appear in good condition; however, the existing shredded rubber in the play structure boxes is depleted and in need of replacement.
- The existing swing set takes up a significant amount of play box space for very few students.
- Access to the play area is limited due to a significant elevation change.

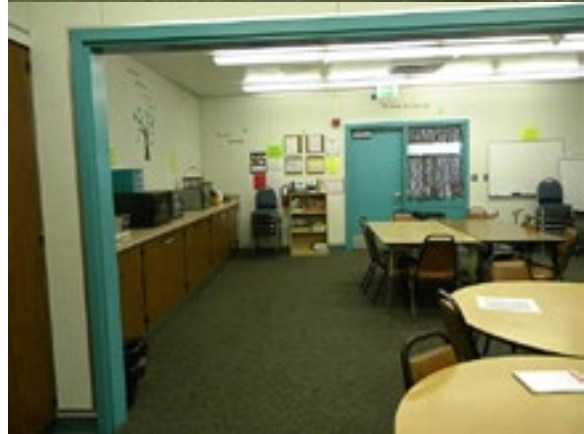
Library:

- Existing library appears to be in good condition.
- Insufficient storage for curriculum and library books.
- Librarian desk is not accessible.

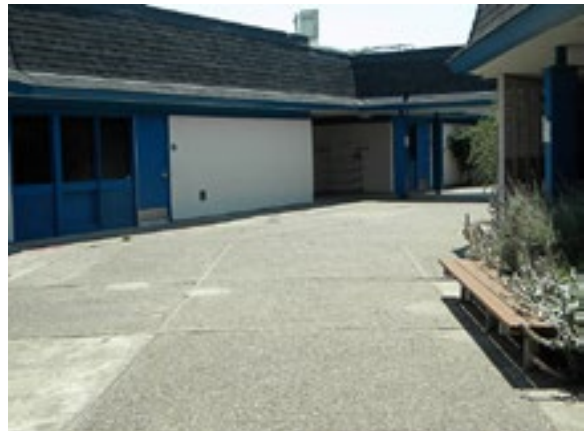
- There is currently no covered walkway to any of the detached structures.
- Existing door thresholds are too high for current accessibility standards.
- Occasional areas of concrete or asphalt paving that have heaved or cracked cause accessibility issues.

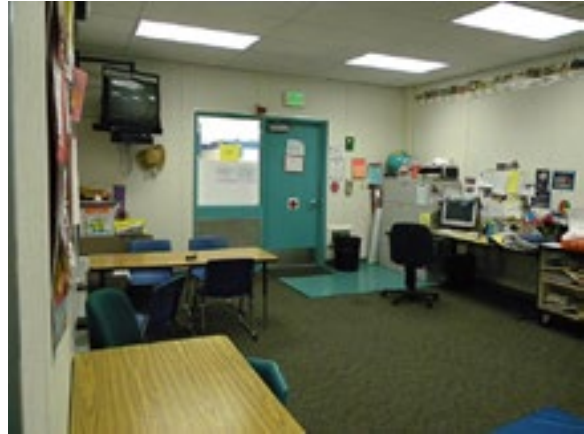
Specialty Classrooms:

- The Speech Therapy Classroom is too small for the program requirements.
- The site currently has no dedicated Science Lab.
- The existing Media Center / Computer Lab space lacks the proper infrastructure for power and data distribution.

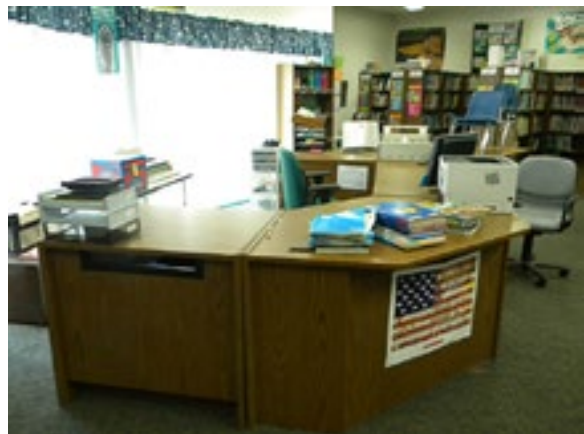
- The staff work area is too small for the current staff to effectively work in.
- Existing finishes are worn and dated.
