Berryessa Union School District Facilities Needs and Assessment Study

Prepared For
Berryessa Union School District

In April of 2013, Berryessa Union School District requested that Sugimura Finney Architects prepare a District-wide survey to assess the current status of the District's facilities, and to help guide upcoming decisions related to facility utilization and improvement.

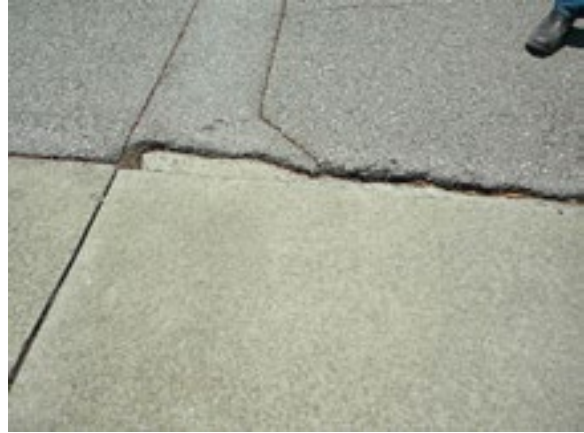
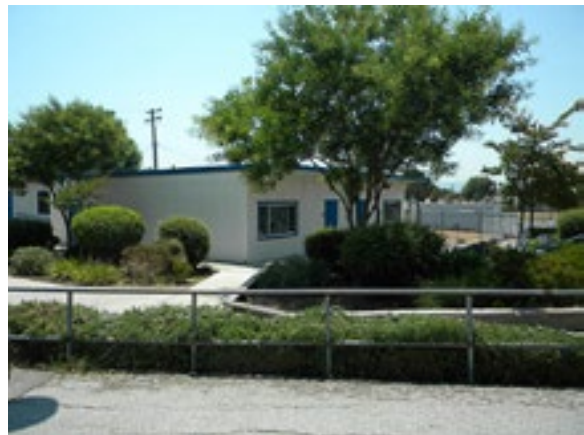
- Building D: This building is a single story wood structure with a single level roof joist system supported on bearing walls. This building's lateral force resisting system consists of a plywood sheathed roof acting as a horizontal wood diaphragm spanning between vertical plywood shear walls. Seismic loads are resisted in both orthogonal directions by way of the wood shear walls located on the ex-

terior of the building structure. Our review of the building is that the building is comprised of shear walls in each direction that can handle the lateral load of the structure if the shear walls are in good condition.

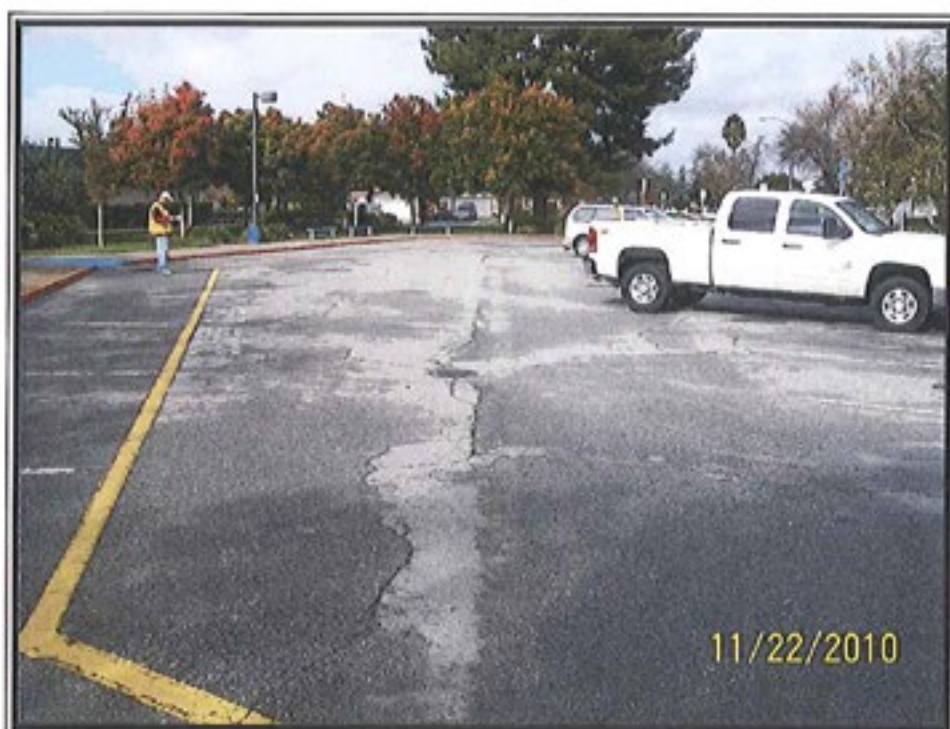
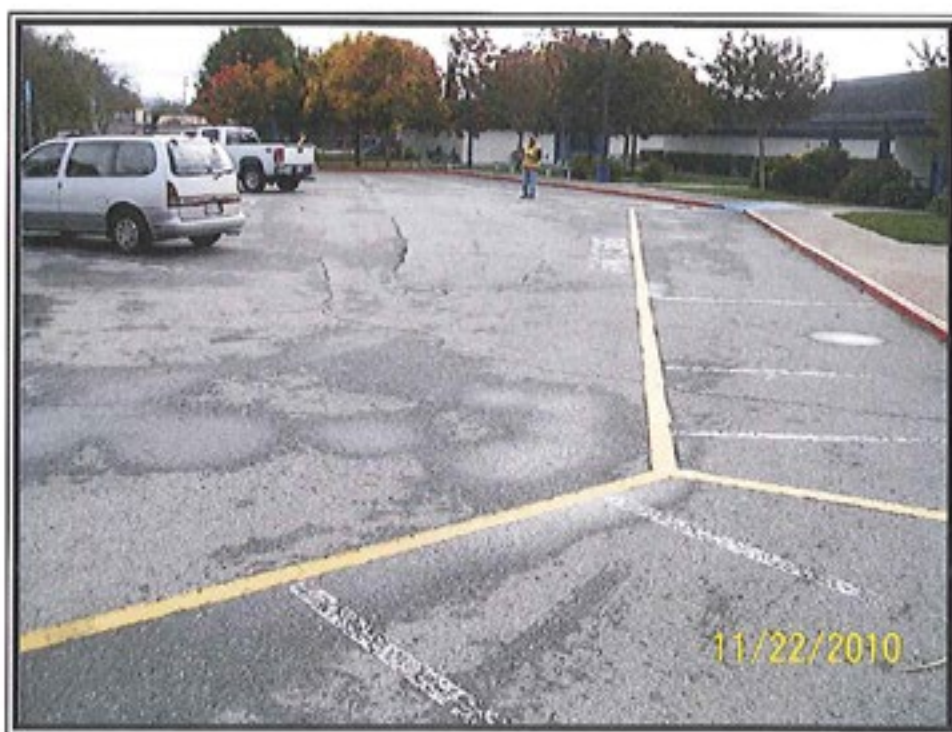
LANEVIEW SCHOOL - AREA A

Defect Score: 54

Visual Description: Pavement exhibits moderate to severe raveling with moderate shrinkage cracking.

Misc. AC Fill	Base Failure (%)	Alligator Cracking (%)	Crack Factor	Ravel
0	0%	0.0%	0.152	M
Crack Width		1/8 - 1/4"

Recommended Treatment: Crack Fill and Seal Coat

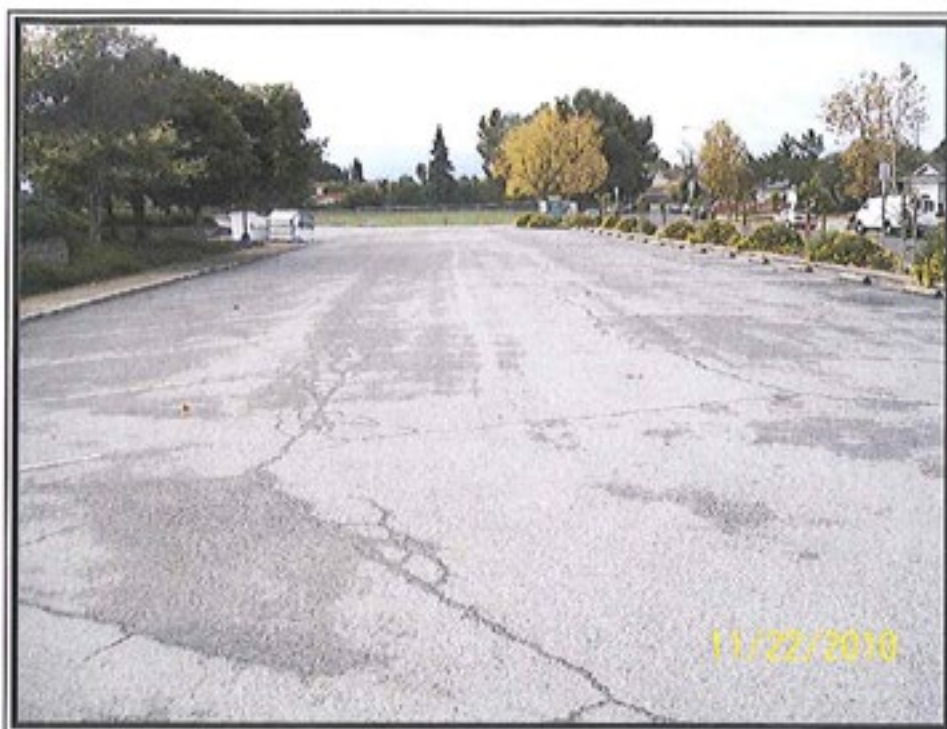
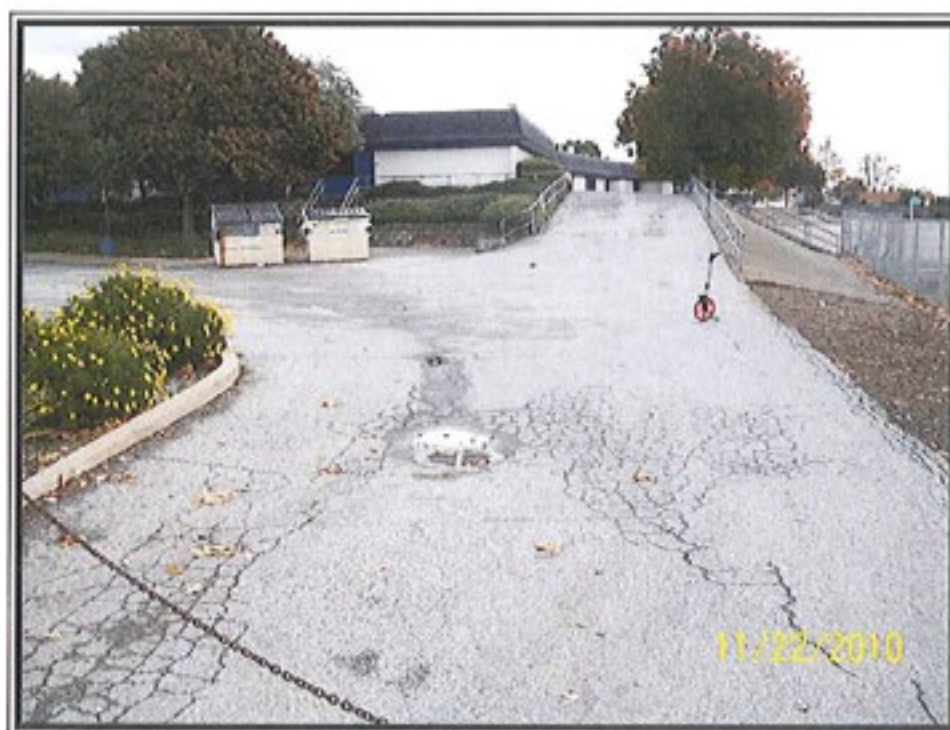
LANEVIEW SCHOOL - AREA B

Defect Score: 74

Visual Description: Pavement exhibits moderate to severe raveling with moderate shrinkage cracking.

Misc. AC Fill	Base Failure (%)	Alligator Cracking (%)	Crack Factor	Ravel
0	0%	2.0%	0.176	M
Crack Width		1/8 - 1/4"

Recommended Treatment: Dig out/ Crack Fill/ Seal Coat

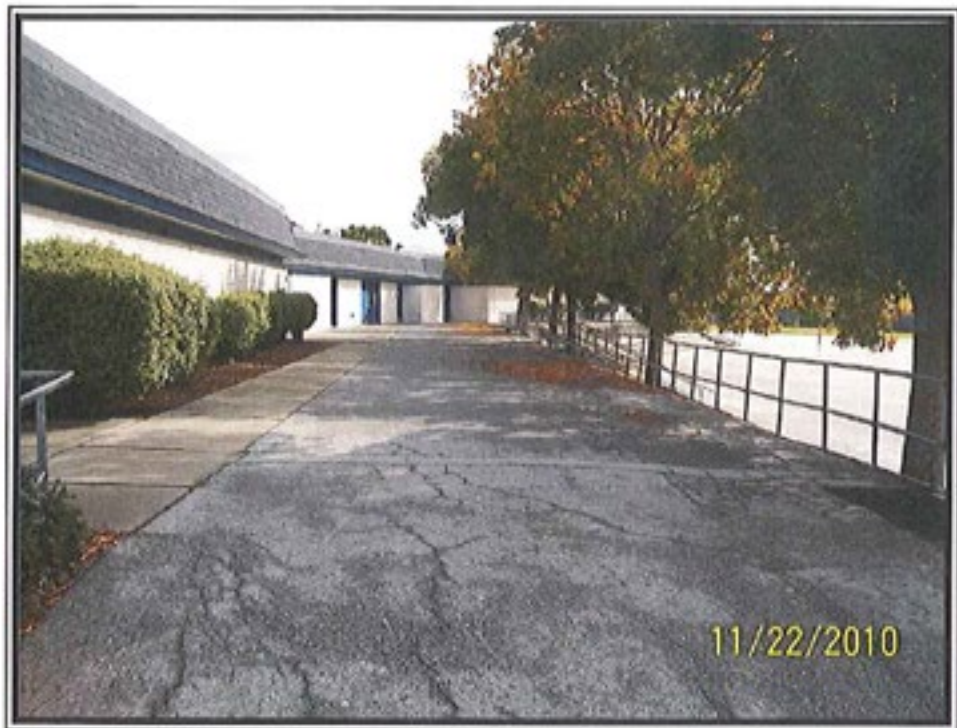
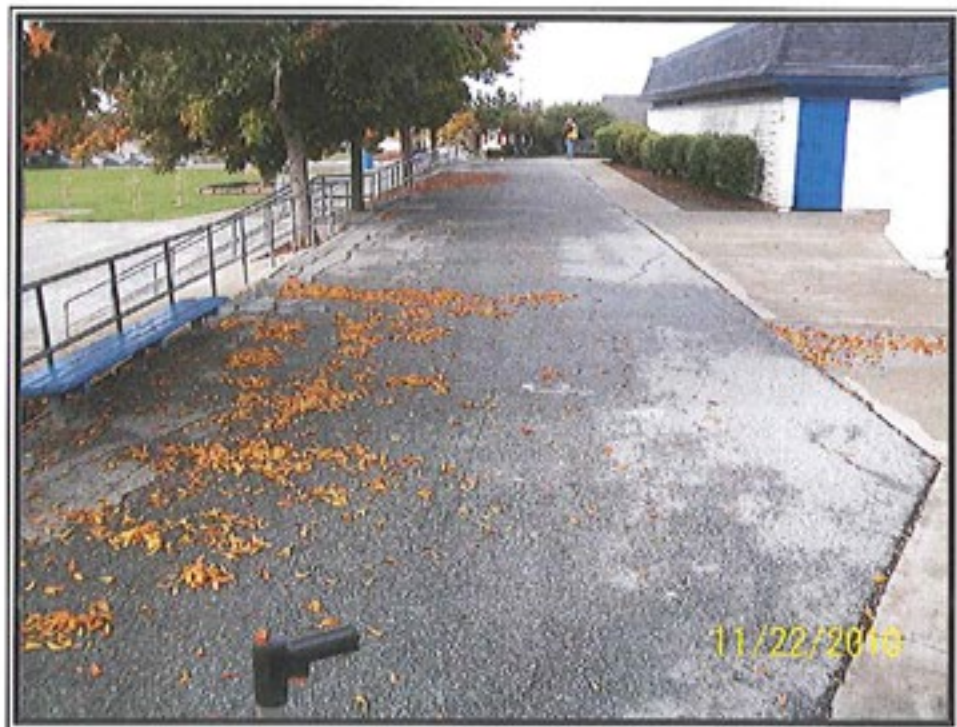
LANEVIEW SCHOOL - AREA C

School Name:	Laneview School	Area (sf):	2,898
Area Notation:	C	Buses:	No
Surface Type:	AC	Garbage Trucks:	No
Use:	Pedestrian Areas		
Defect Score:	86		
Recommended Treatment:	Dig out/ Crack Fill/ Seal Coat		
Year:	2011		
Visual Description:	Pavement exhibits several areas of alligator cracking and base failure due to vehicle access.		
Miscellaneous:	Slope = 10.1/ 1.5/ 2.4, Pavement drains to adjacent pavement area and planter, some tree root damage as well.

Misc. AC Fill	Base Failure (%)	Alligator Cracking (%)	Crack Factor	Ravel
0	5%	2.0%	0.000	M
Crack Width		1/8 - 1/4"

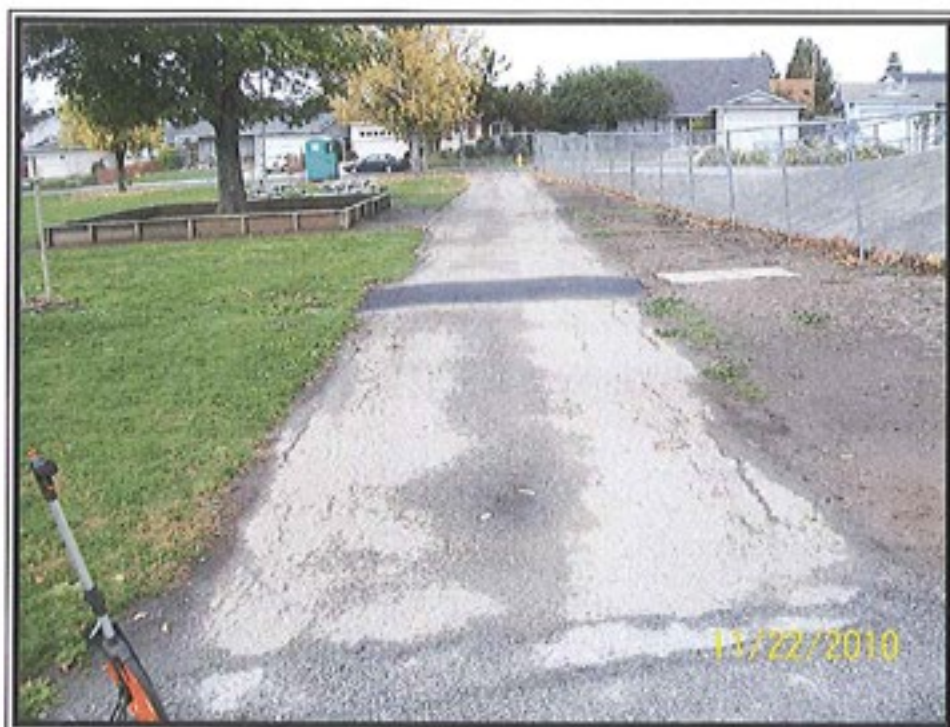
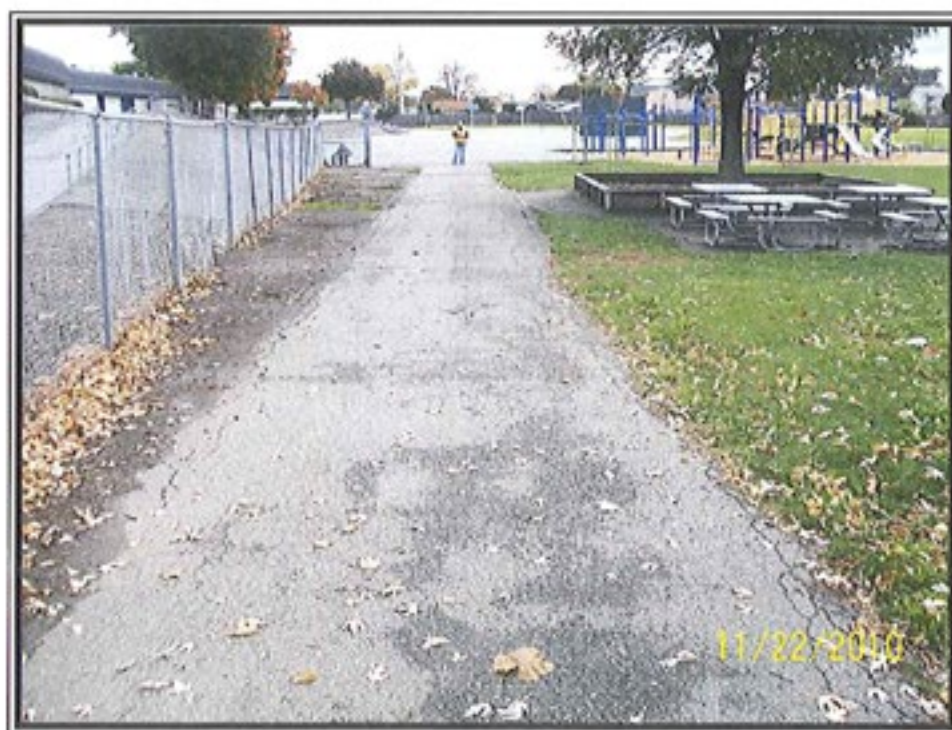
LANEVIEW SCHOOL - AREA D

School Name: Laneview School **Area (sf):** 1,550
Area Notation: D **Buses:** No
Surface Type: AC **Garbage Trucks:** No
Use: Roadways, Alleyways, Bus Turnouts, etc.
Defect Score: 170
Recommended Treatment: Remove & Replace
Year: 2011
Visual Description: Pavement exhibits severe raveling and expansion cracking.
Miscellaneous: Slope = 0.7/ 1.5, Pavement drains to adjacent lawn and planter.

Misc. AC Fill	Base Failure (%)	Alligator Cracking (%)	Crack Factor	Ravel
0	0%	0.0%	0.387	V
Crack Width		1/8 - 1/4"

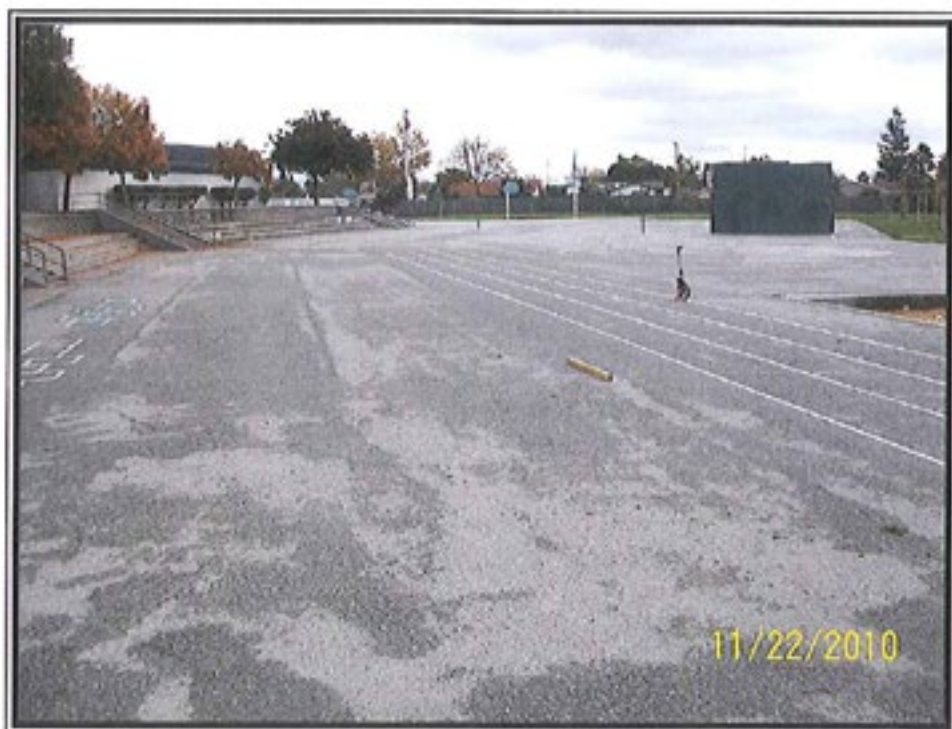
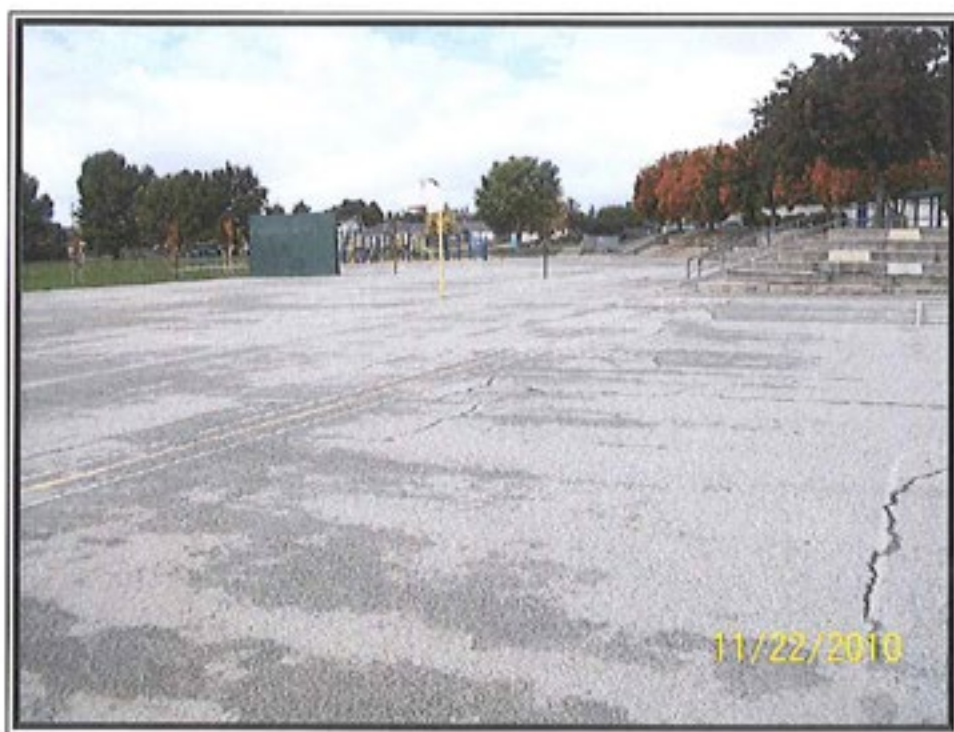
LANEVIEW SCHOOL - AREA E

School Name:	Laneview School	Area (sf):	35,740
Area Notation:	E	Buses:	No
Surface Type:	AC	Garbage Trucks:	No
Use:	Playground		
Defect Score:	58		
Recommended Treatment:	Crack Fill and Seal Coat		
Year:	2011		
Visual Description:	Pavement exhibits severe raveling and moderate shrinkage cracking.		
Miscellaneous:	Slope = 1.3/ 0.5/ 1.9, Pavement drains to adjacent lawn/ field.

Misc. AC Fill	Base Failure (%)	Alligator Cracking (%)	Crack Factor	Ravel
0	0%	0.0%	0.114	V
Crack Width		<1/8"

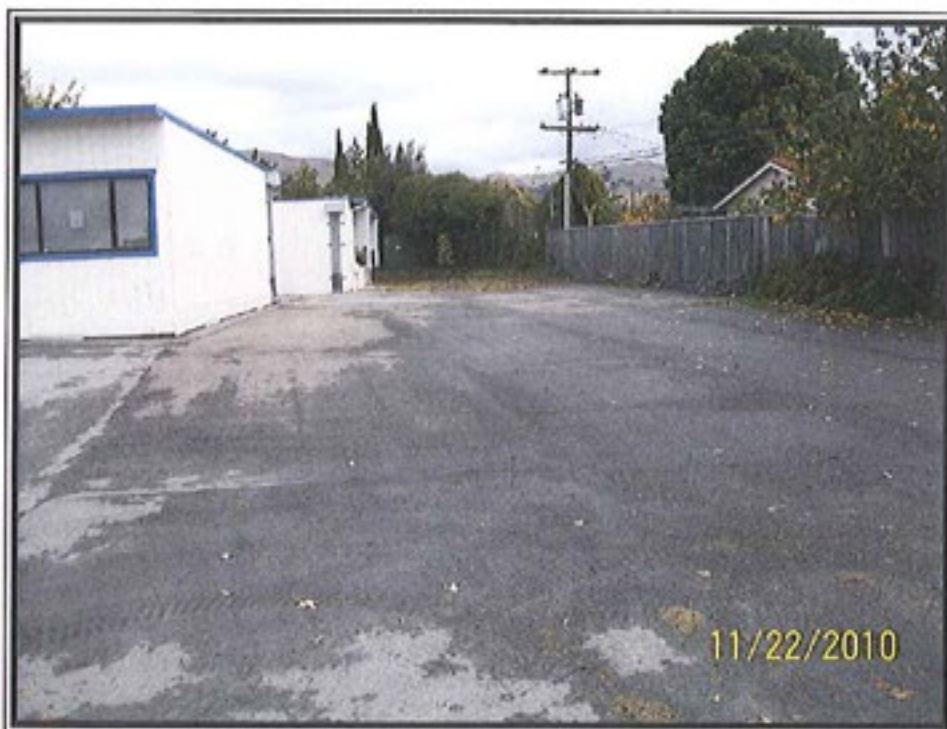
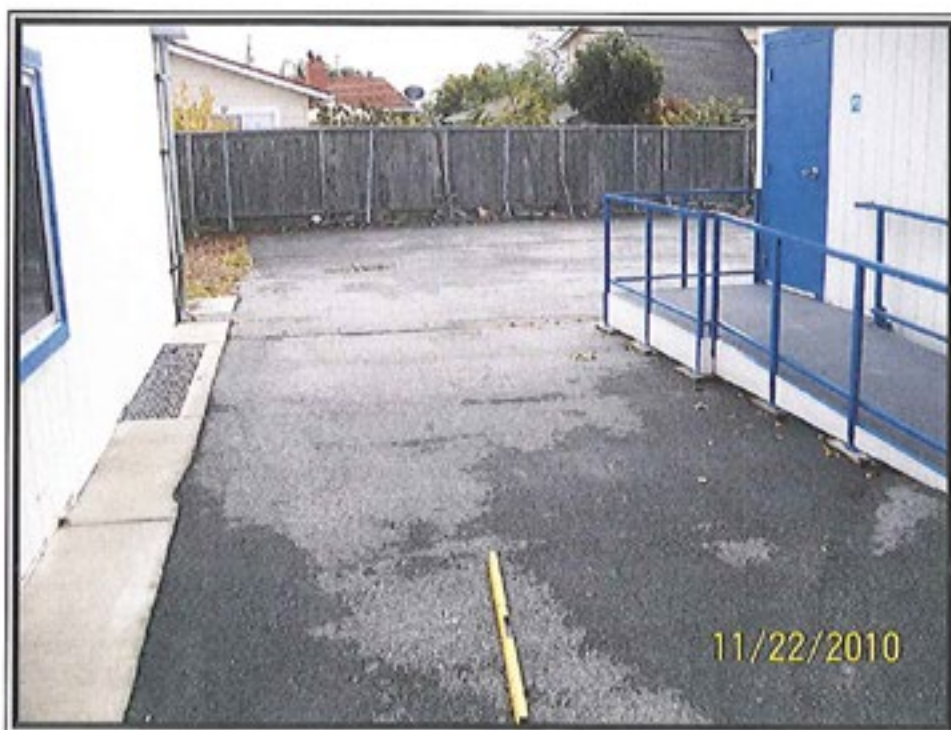
LANEVIEW SCHOOL - AREA F

Defect Score: 20

Misc. AC Fill	Base Failure (%)	Alligator Cracking (%)	Crack Factor	Ravel
0	0%	0.0%	0.000	M
Crack Width		0

Recommended Treatment: Crack Fill and Seal Coat

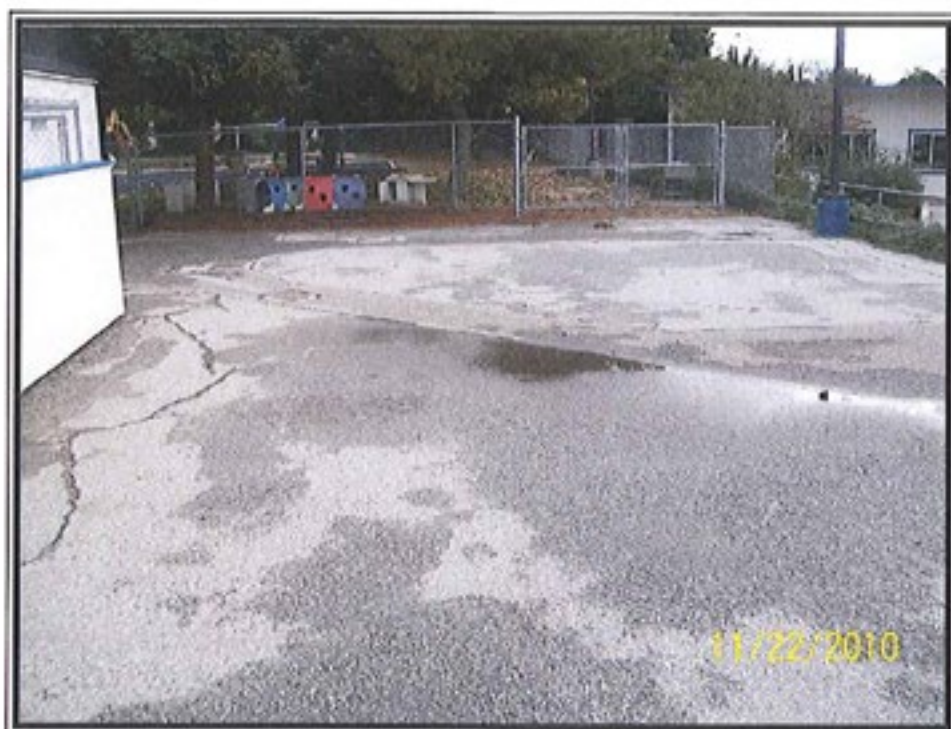
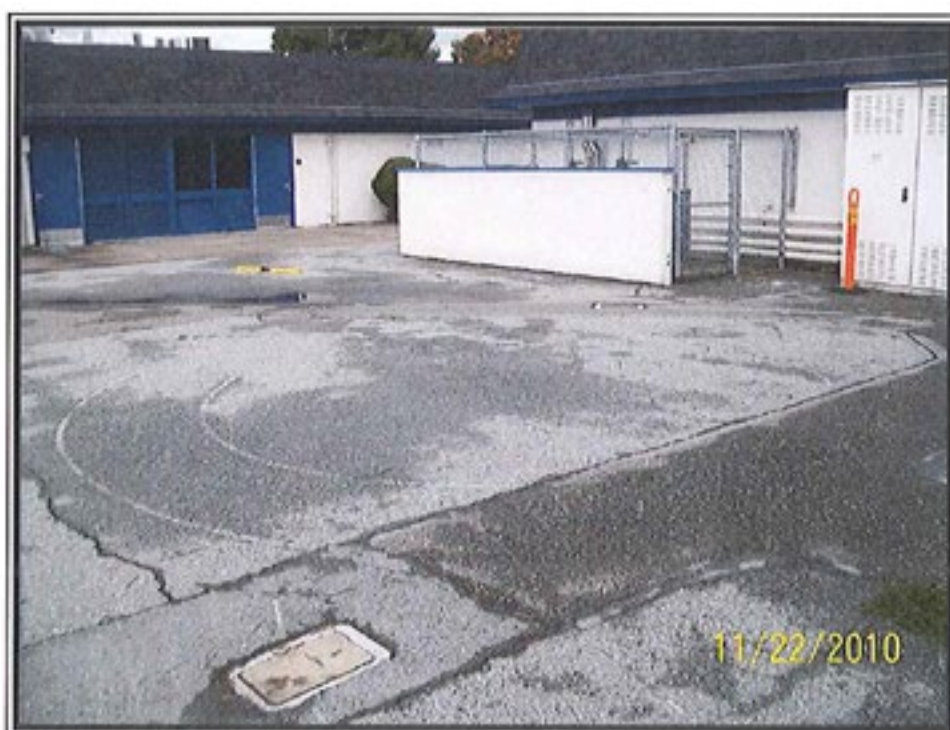
LANEVIEW SCHOOL - AREA G

School Name: Laneview School **Area (sf):** 2,173
Area Notation: G **Buses:** No
Surface Type: AC **Garbage Trucks:** No
Use: Pedestrian Areas
Defect Score: 40
Recommended Treatment: Crack Fill and Seal Coat
Year: 2011
Visual Description: Pavement exhibits severe raveling with a large area of utility patching, slight shrinkage cracking.
Miscellaneous: Slope = 1.5, Pavement drains to adjacent planter.

Misc. AC Fill	Base Failure (%)	Alligator Cracking (%)	Crack Factor	Ravel
0	0%	0.0%	0.039	V
		Crack Width	1/8 - 1/4"

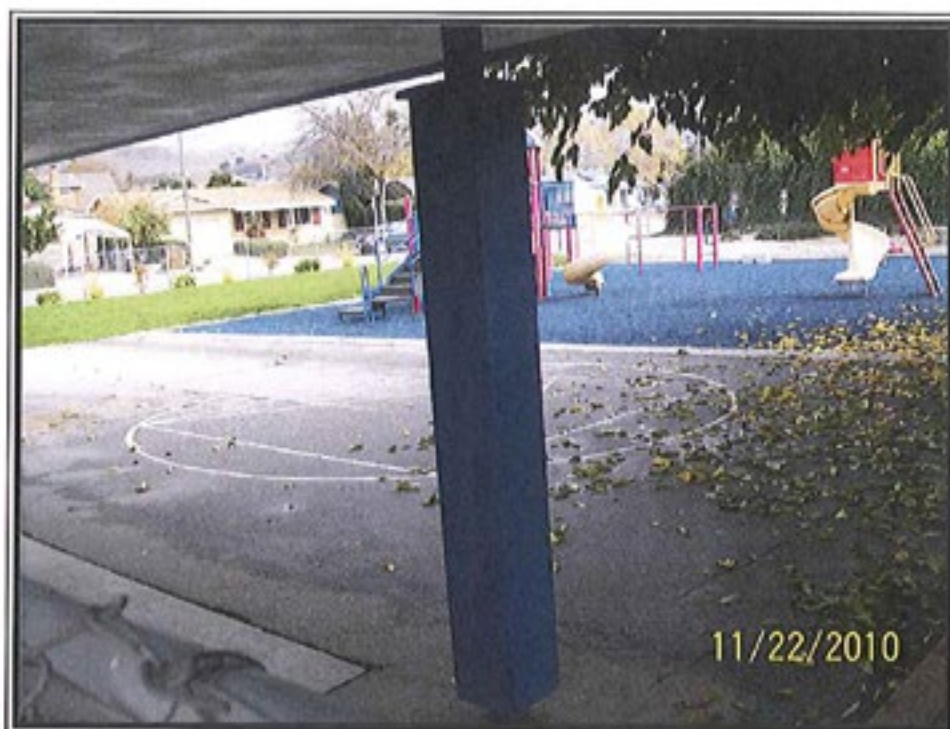
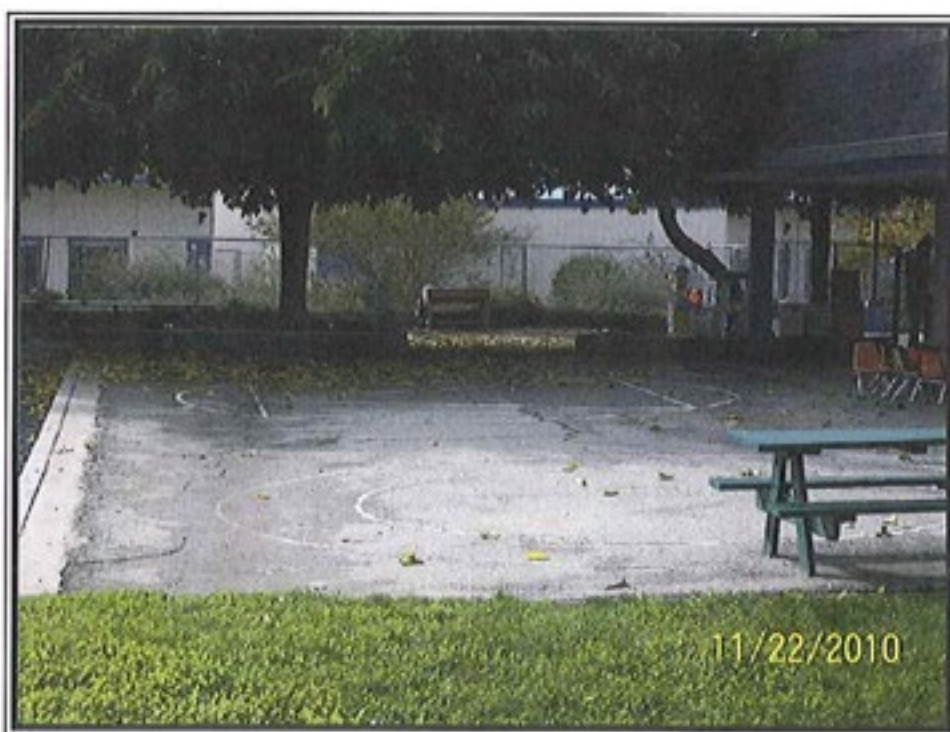
LANEVIEW SCHOOL - AREA H

School Name: Laneview School **Area (sf):** 1,684
Area Notation: H **Buses:** No
Surface Type: AC **Garbage Trucks:** No
Use: Playground
Defect Score: 41
Recommended Treatment: Crack Fill and Seal Coat
Year: 2011
Visual Description: Pavement exhibits moderate raveling with moderate shrinkage cracking.
Miscellaneous: Slope = 0.7/ 3.0, Pavement drains to AC swale which drains to planter.

Misc. AC Fill	Base Failure (%)	Alligator Cracking (%)	Crack Factor	Ravel
0	0%	0.0%	0.068	M
Crack Width		1/8 - 1/4"

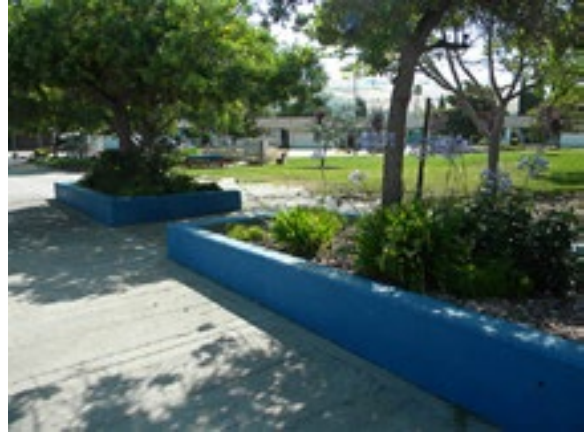
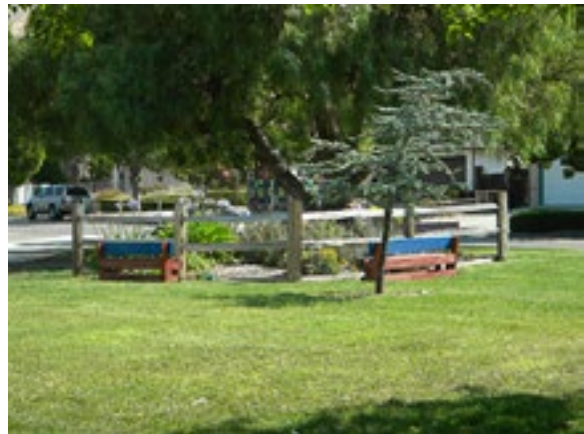
- While significant portions of this site have a perimeter fence in place, the site is largely open in the front; and because the site abuts a city park, there is an unfenced boundary at the rear of the site also.
- Building exterior lighting is insufficient.
- There is direct access without intervening obstacles from the main entry to interior building spaces.
- Existing doors often have windows in them, and not all doors have modern security hardware.
- Not all classrooms have doors that can be secured, due to original open plan of site.
- This site has a handful of windows below door height.

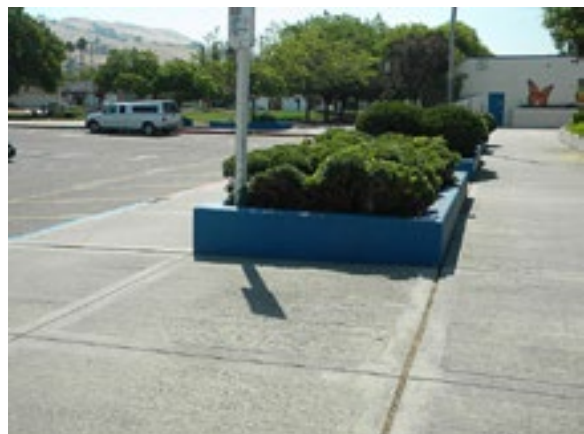
- Site often has three school busses in the parking lot at the same time for drop-off and pick-up.
- Circulation through the parking lot during pick-up and drop-off is narrow, and creates problems with traffic congestion.
- Pick-up / Drop-off location sees considerable congestion during peak times, and does not allow traffic to flow through.
- Existing accessible parking stalls are not accessible.

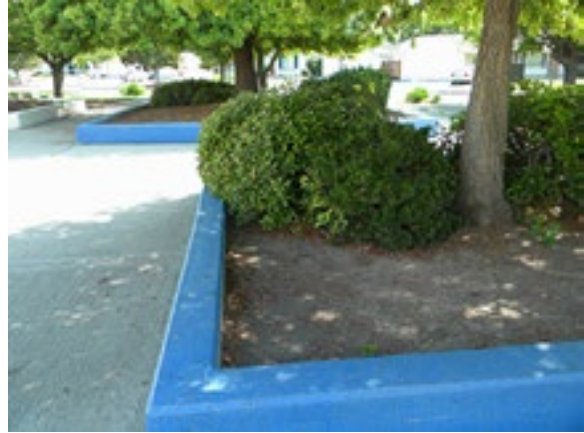
- The existing landscaping is dated, non-existent in some places, and overgrown in others. The bare areas face erosion issues, and the overgrown areas trap debris as well as providing a home to nuisance pests.
- The landscaping in the sloped planters adjacent to the building is causing moisture intrusion problems, as well as creating a security issue by assisting students in accessing the roof of the building.

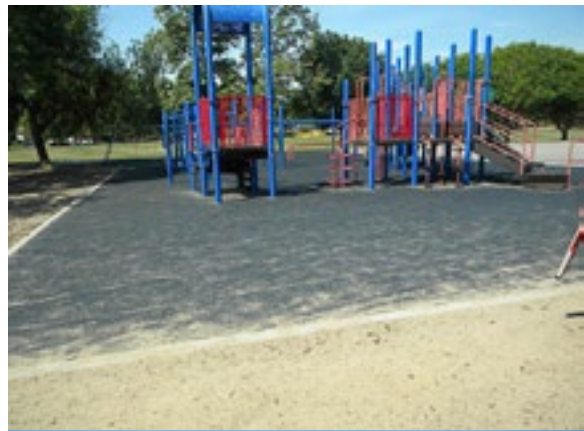
- The existing asphaltic concrete play surfaces appears to be in moderately good condition, some repair work is needed.
- The existing sports fields have issues with ground squirrels and gophers. Some parts of the grass fields are bare and/or more weeds than grass.
- Existing play structures appear in good condition; however, the existing shredded rubber in the play structure boxes is depleted and in need of replacement.

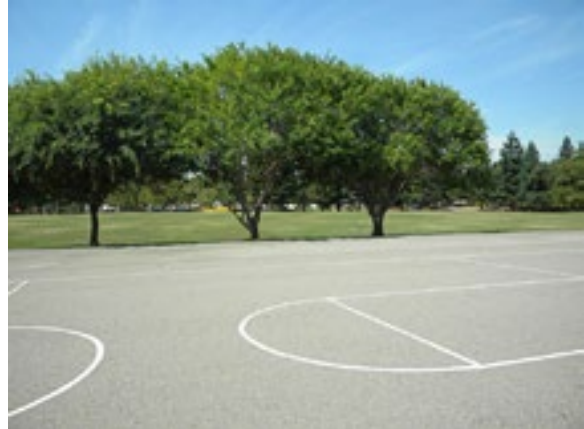
- Current outdoor eating area is the grassy amphitheater area, which has no little seating and no covered area.

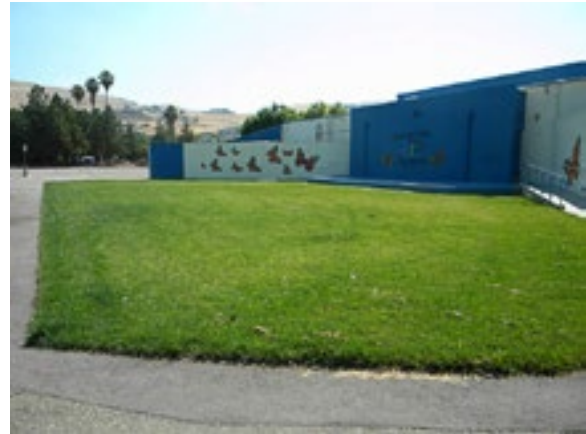
- Building entry visibility is acceptable, but could be improved.

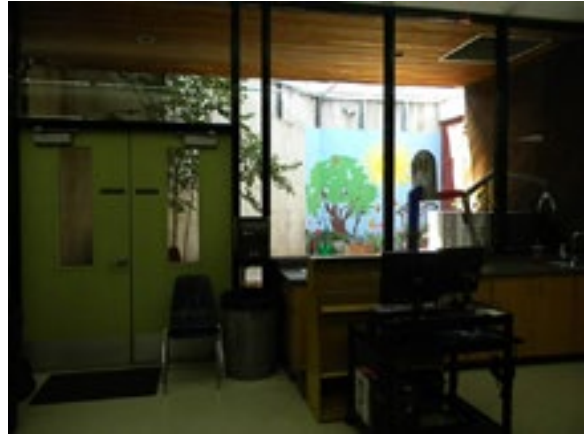
- Classrooms are generally in good condition, although many of the finishes are faded and/or dirty.
- Many classrooms do not have doors, due to original school design's open plan. Partition walls have been added over the years, but doors were never added. This causes noise to easily travel between adjacent classrooms, and also presents a security risk.
- Some classrooms have a CRT television mounted in a location that does not comply with current accessibility requirements.

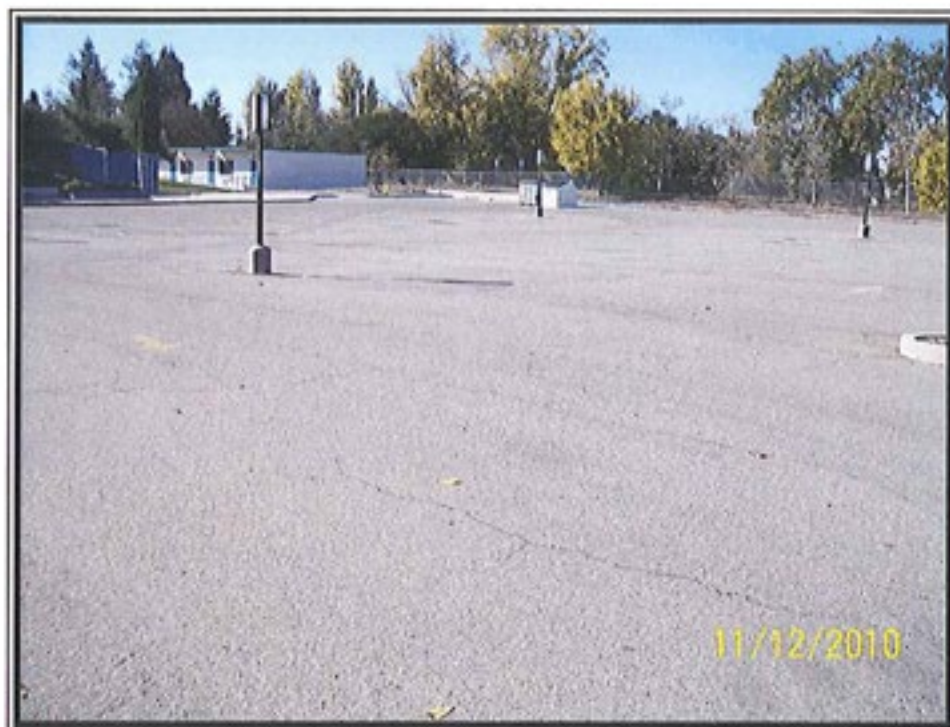
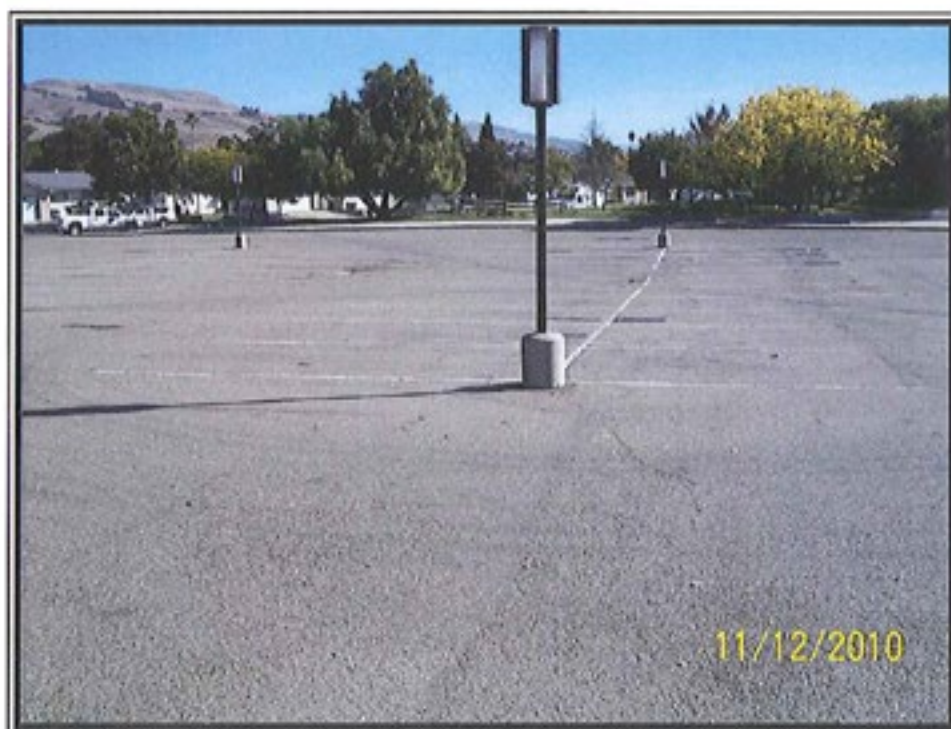
MAJESTIC WAY SCHOOL - AREA A

Defect Score: 74

Visual Description: Pavement exhibits moderate to severe raveling and doesn't appear to have ever been seal coated, sub-surface moisture was observed.

Misc. AC Fill	Base Failure (%)	Alligator Cracking (%)	Crack Factor	Ravel
0	0%	1.0%	0.168	V
Crack Width		1/8 - 1/4"

Recommended Treatment: Dig out/ Crack Fill/ Seal Coat

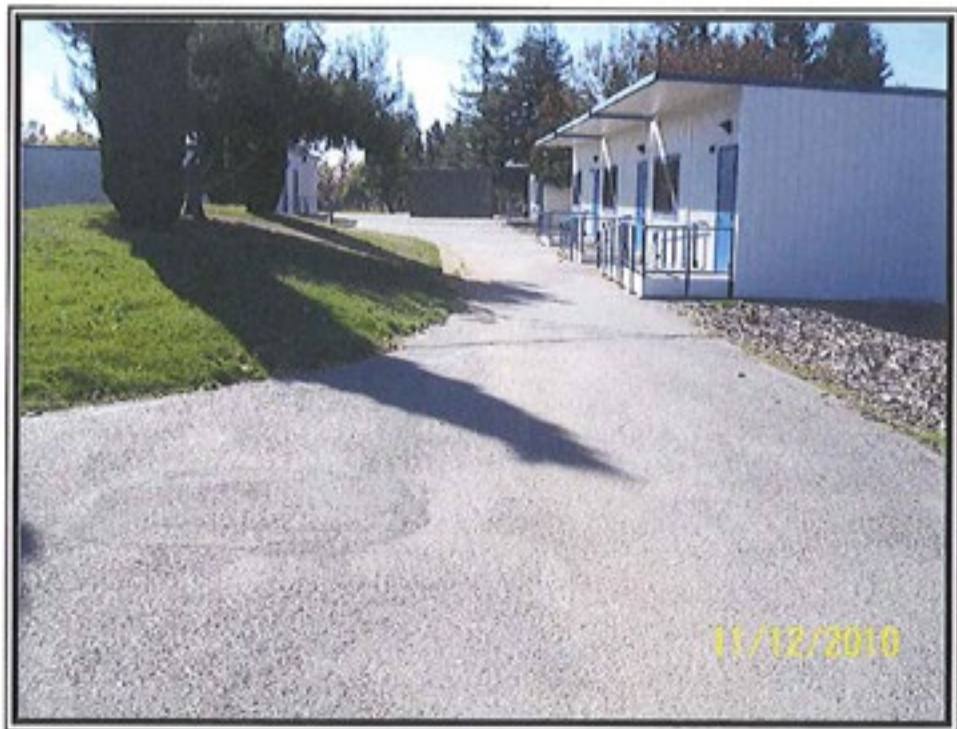
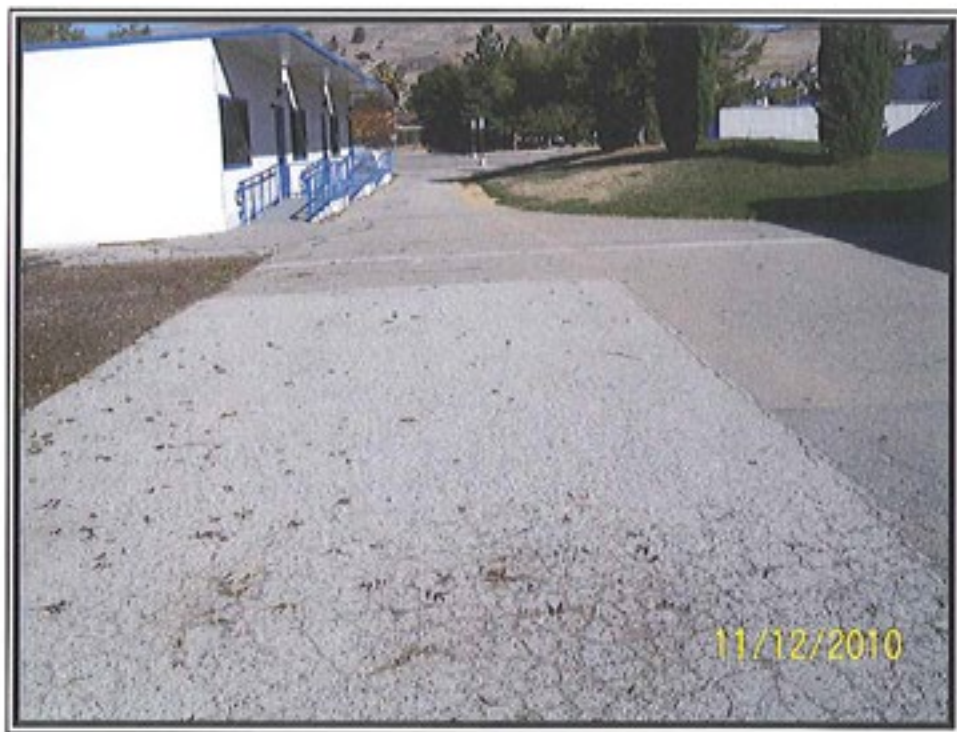
MAJESTIC WAY SCHOOL - AREA B

Defect Score: 18

Visual Description: Pavement exhibits slight raveling, settlement trenches, one area of alligator cracking (20x20).

Miscellaneous: Slope = 1.2/ 1.0/ 2.5, Pavement drains to lawn area and standing water was observed.

Recommended Treatment: Double application Emulsion Seal Coat

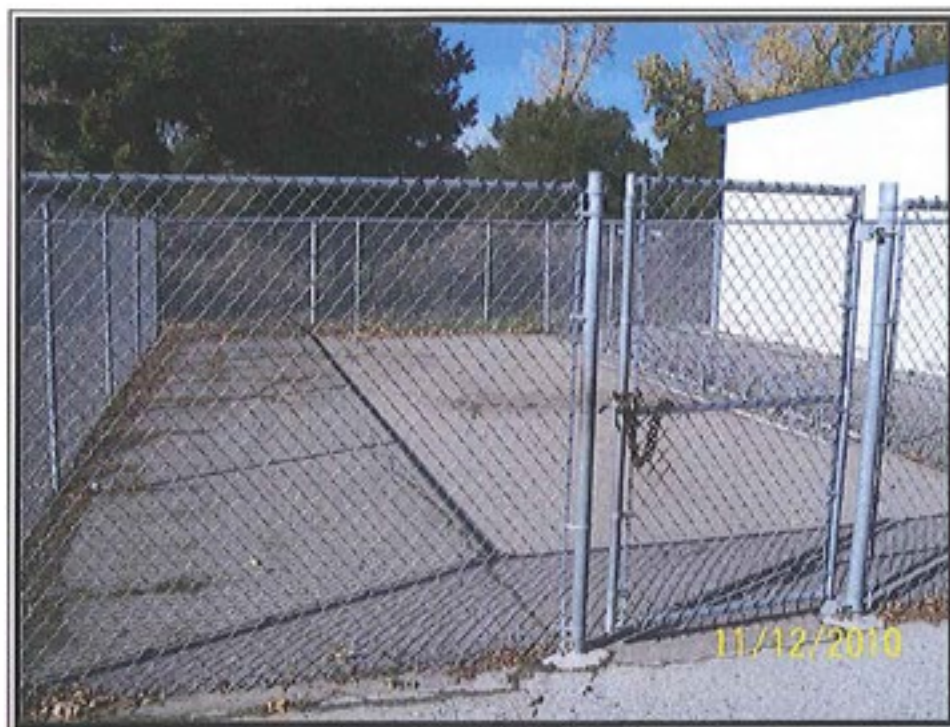
MAJESTIC WAY SCHOOL - AREA C

School Name: Majestic Way School **Area (sf):** 800
Area Notation: C **Buses:** No
Surface Type: AC **Garbage Trucks:** No
Use: Pedestrian Areas
Defect Score: 44
Recommended Treatment: Crack Fill and Seal Coat
Year: 2011
Visual Description: Pavement exhibits moderate raveling and moderate shrinkage cracking.
Miscellaneous: Slope = 1.5/ 2.3, Pavement drains to adjacent planter.

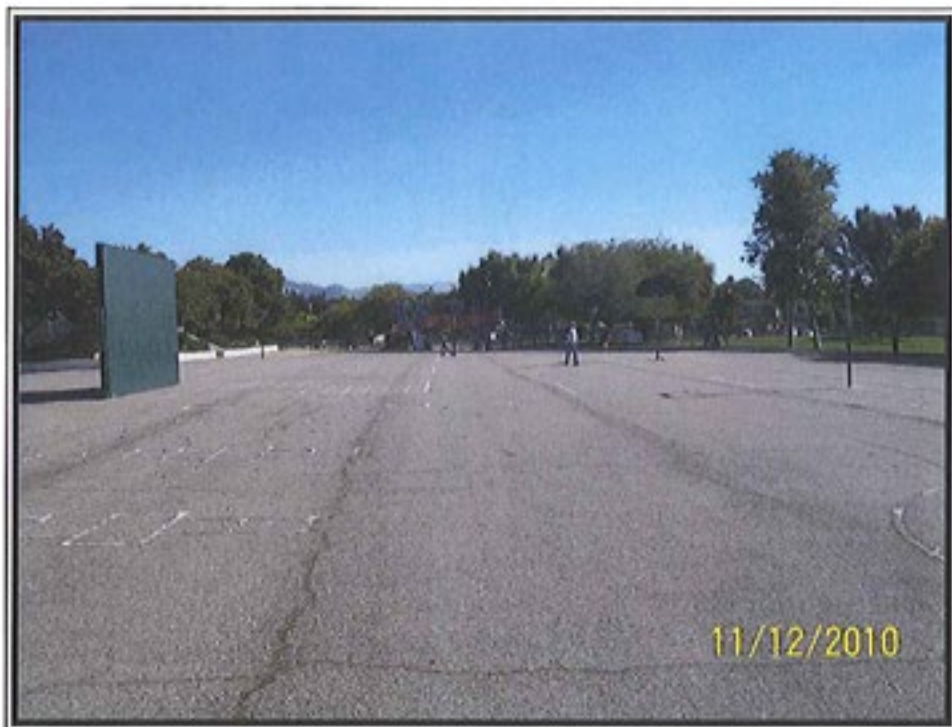
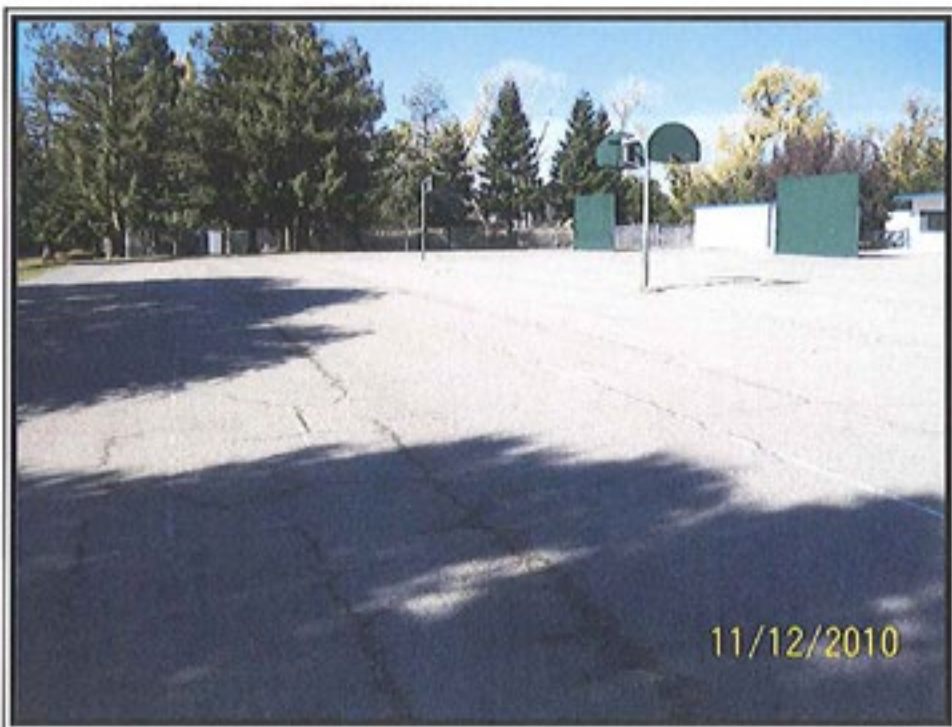
MAJESTIC WAY SCHOOL - AREA D

School Name: Majestic Way School **Area (sf):** 41,335
Area Notation: D **Buses:** No
Surface Type: AC **Garbage Trucks:** No
Use: Playground
Defect Score: 86
Recommended Treatment: Dig out/ Crack Fill/ Seal Coat
Year: 2011
Visual Description: Pavement exhibits sever raveling and moderate shrinkage cracking.
Miscellaneous: Slope = 1.1/ 4.2/ 2.3, Pavement drains to adjacent field and planters.

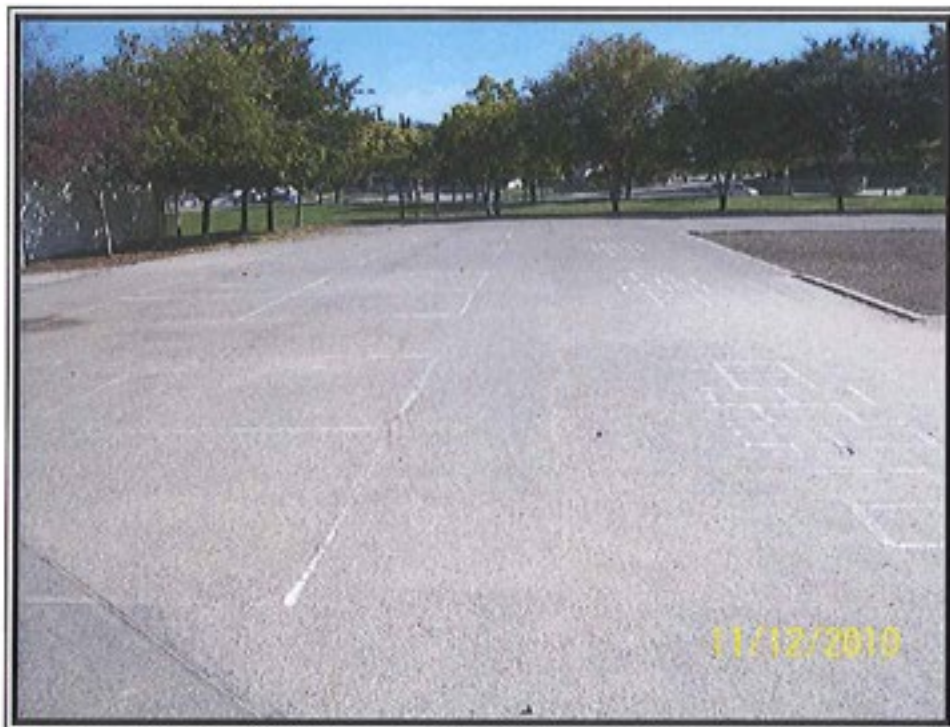
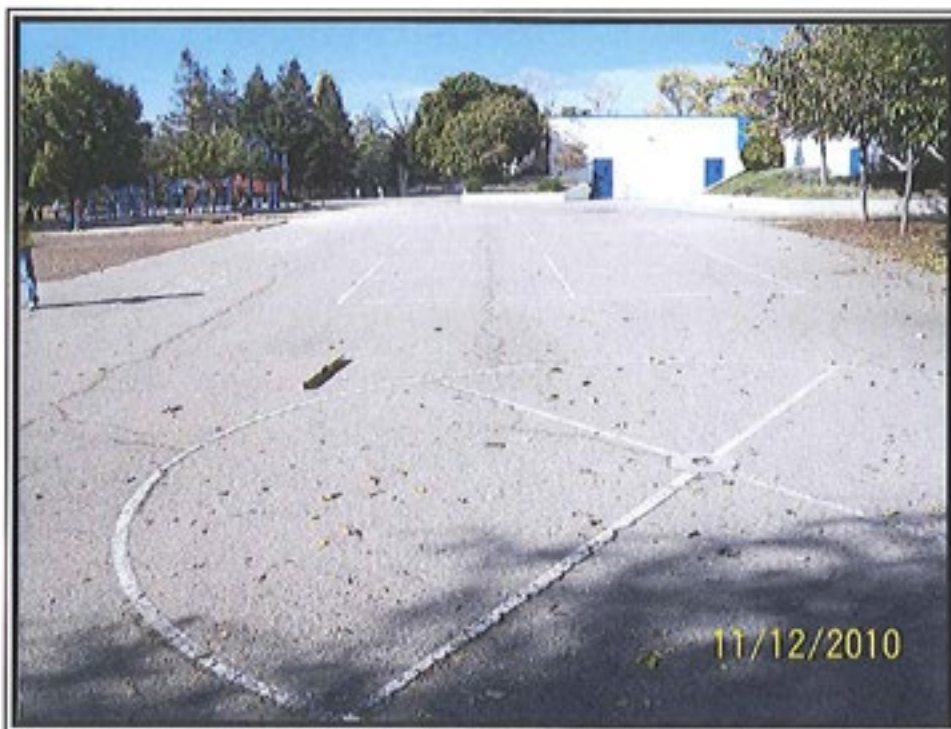
MAJESTIC WAY SCHOOL - AREA E

Defect Score: 60

Visual Description: Pavement adjacent to sidewalk is uplifted and has developed a trip hazard.

Recommended Treatment: Crack Fill and Seal Coat
