Berryessa Union School District Facilities Needs and Assessment Study

Prepared For
Berryessa Union School District

In April of 2013, Berryessa Union School District requested that Sugimura Finney Architects prepare a District-wide survey to assess the current status of the District's facilities, and to help guide upcoming decisions related to facility utilization and improvement.

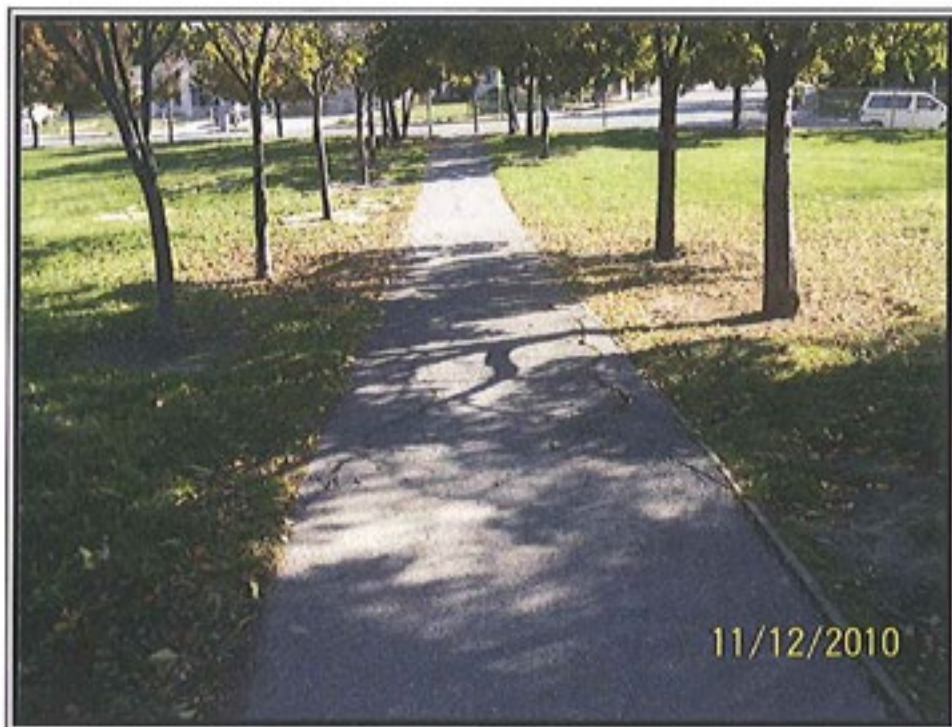
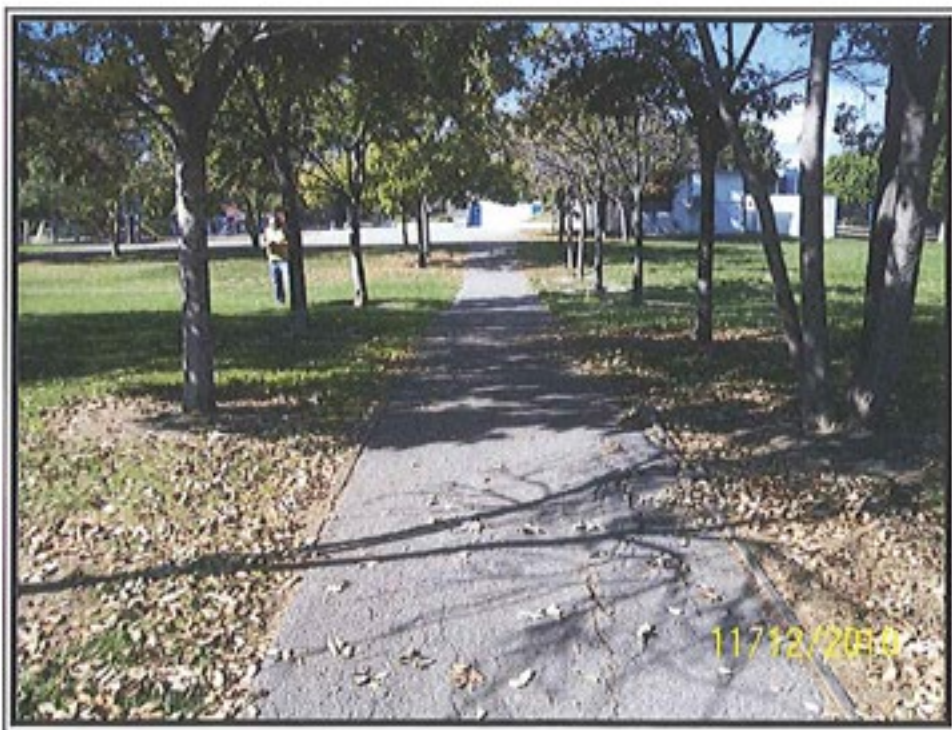
MAJESTIC WAY SCHOOL - AREA F

School Name: Majestic Way School **Area (sf):** 995
Area Notation: F **Buses:** No
Surface Type: AC **Garbage Trucks:** No
Use: Pedestrian Areas
Defect Score: 99
Recommended Treatment: Dig out/ Crack Fill/ Seal Coat
Year: 2011
Visual Description: Pavement exhibits moderate raveling, severe expansion cracking, and moderate tree root damage.
Miscellaneous: Slope = 5.2/ 0.5/ 2.5/ 7.7, Pavement drains to lawn area.

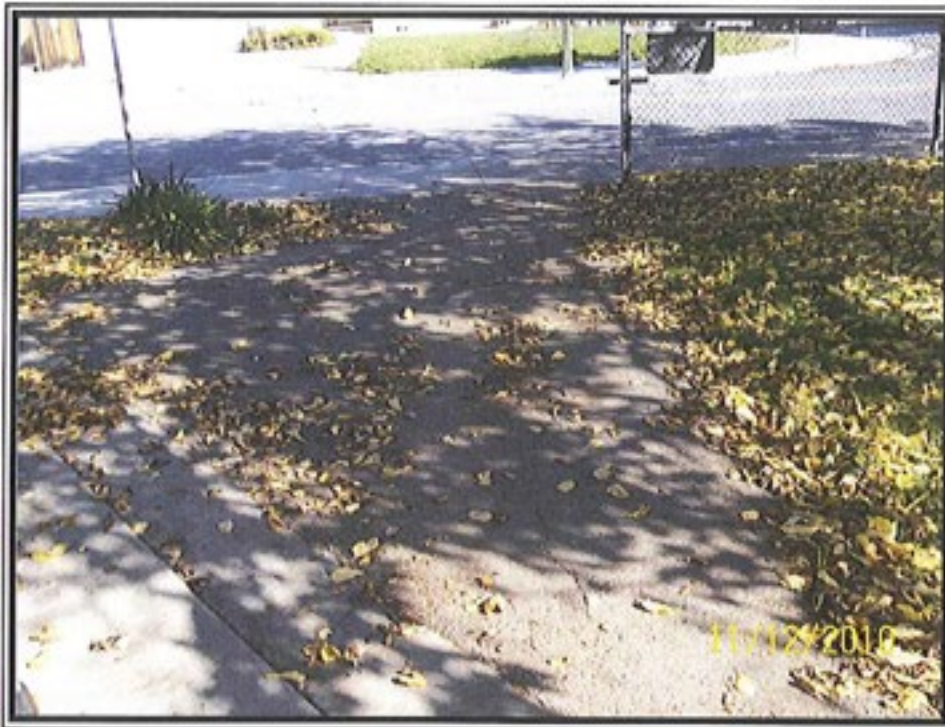
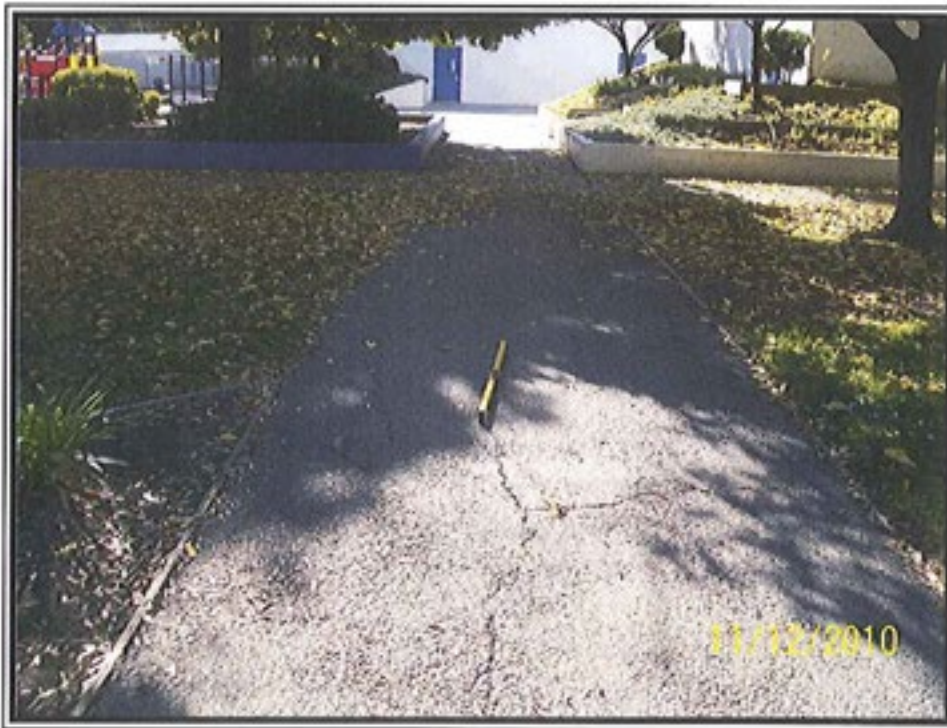
MAJESTIC WAY SCHOOL - AREA G

School Name: Majestic Way School **Area (sf):** 599
Area Notation: G **Buses:** No
Surface Type: AC **Garbage Trucks:** No
Use: Pedestrian Areas
Defect Score: 63
Recommended Treatment: Crack Fill and Seal Coat
Year: 2011
Visual Description: Pavement exhibits moderate raveling with slight shrinkage.
Miscellaneous: Slope = 1.9/ 0.9, Pavement drains to planter or lawn.

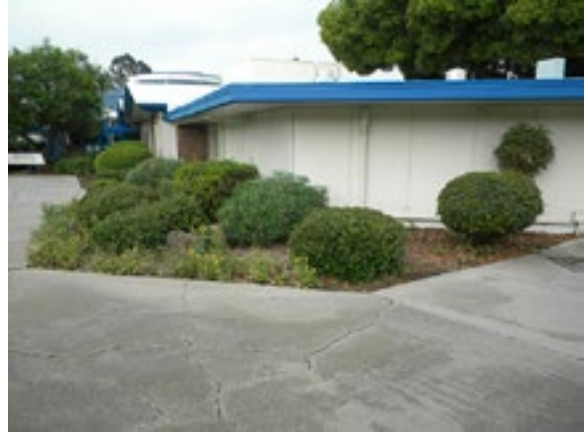
- While significant portions of this site have a perimeter fence in place, the site is largely open in the front.
- Building exterior lighting is insufficient.
- Existing doors often have windows in them, and not all doors have modern security hardware.
- This site has a handful of windows below door height.

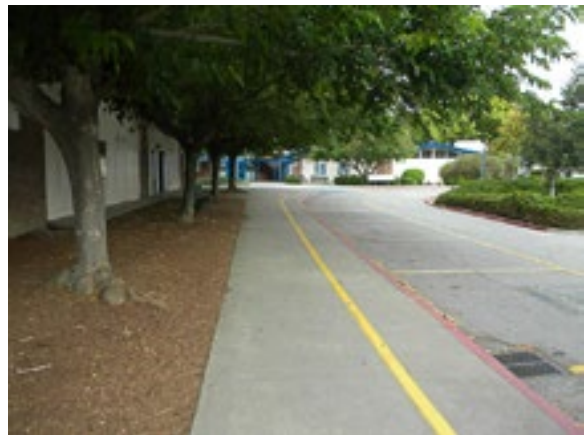
- Existing parking lot circulation is poor, both in the small parking lot in front of the school entry, and also in the adjacent larger parking lot.
- Because of the difficulty circulating through the parking lot at peak times, traffic backs up onto Grossmont Drive in front of the school.
- Pick-up / Drop-off location sees considerable congestion during peak times, and does not allow traffic to flow through.
- Existing accessible parking does not meet current requirements.

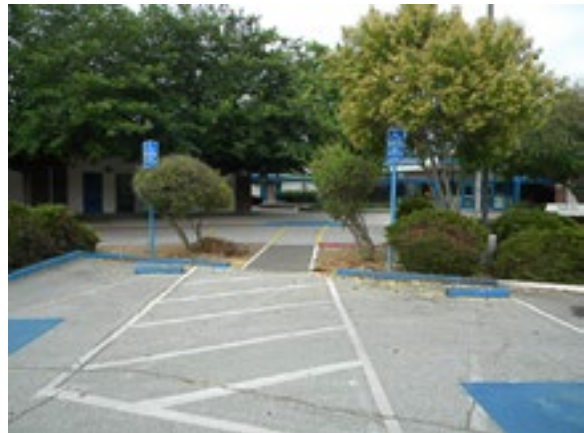
- The existing landscaping is generally in good condition, although some areas of original plantings have potential for trapping debris and creating places for nuisance pests to nest.

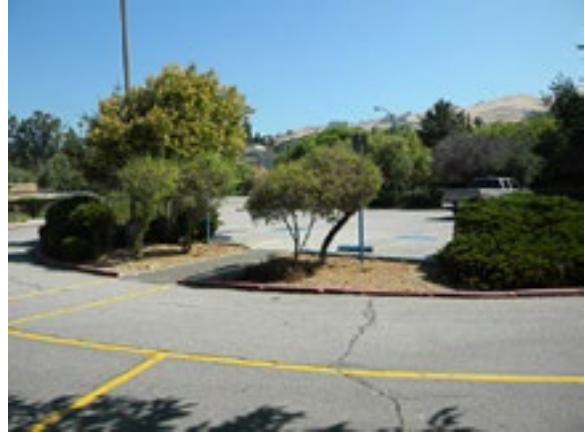
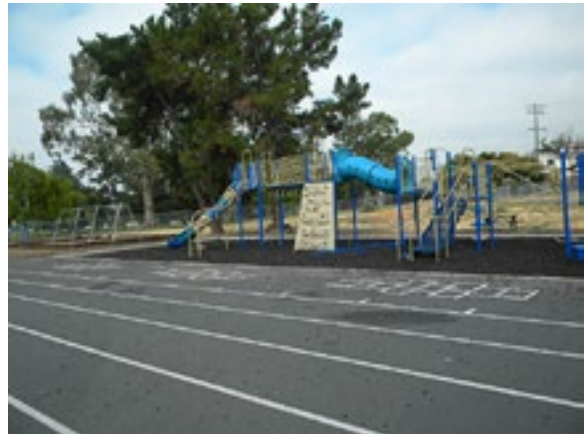
- The existing asphaltic concrete play surfaces appears to be in moderately good condition, some repair work is recommended.
- The existing sports fields have issues with ground squirrels and gophers. Some parts of the grass fields are bare and/or more weeds than grass.
- Existing play structures appear in good condition; however, the existing shredded rubber in the play structure boxes is depleted and in need of replacement.
- The existing swing set is past its anticipated lifespan, and takes up considerable space for the number of students it serves.

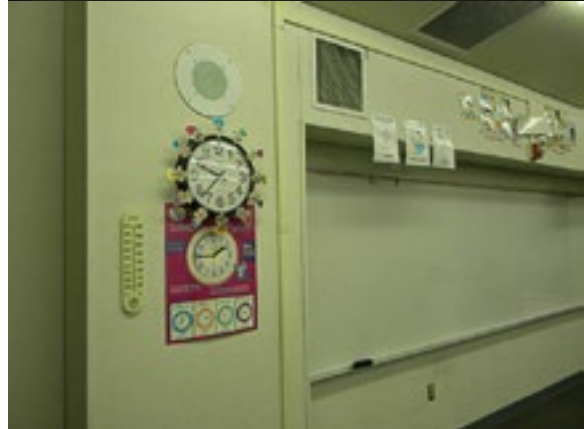
- Special Education classrooms are distributed around site due to lack of a centralized location.
- The site is currently utilizing the Multi-Purpose Room for the school Music Program.
- No dedicated media lab space.

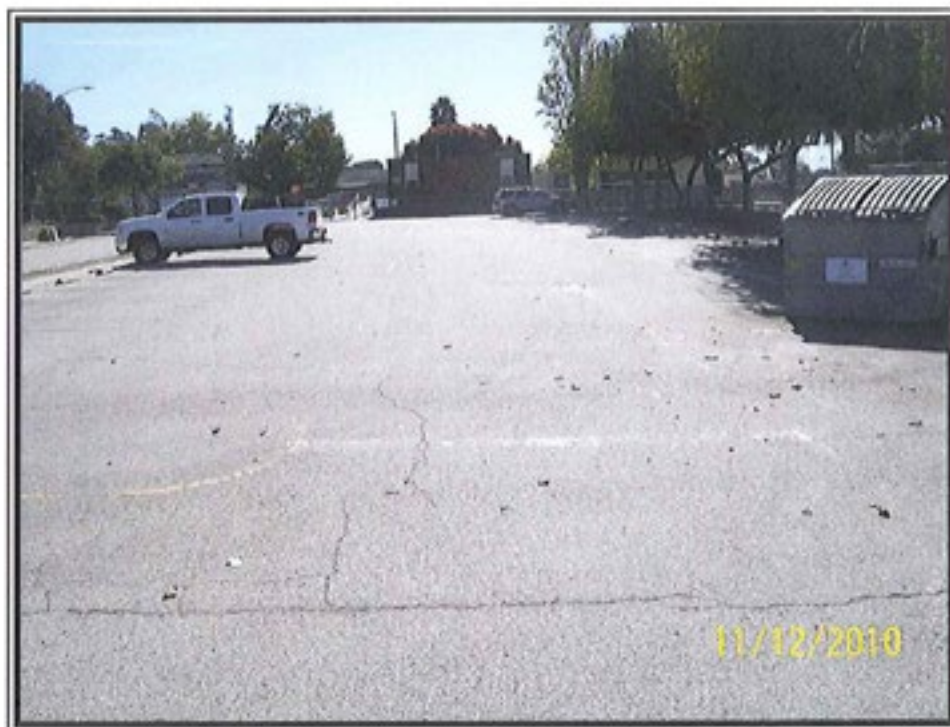
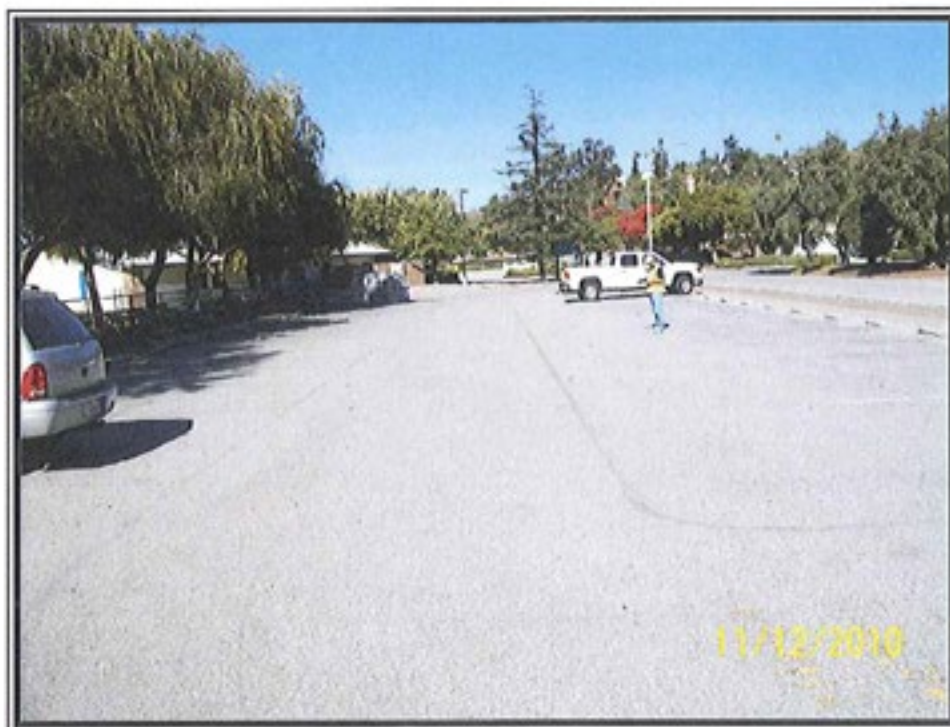
NOBLE SCHOOL - AREA A

School Name:	Noble School	Area (sf):	15,600
Area Notation:	A	Buses:	No
Surface Type:	AC	Garbage Trucks:	Yes
Use:	Parking Lots or Areas		
Defect Score:	37		
Recommended Treatment:	Dig out/ Crack Fill/ Seal Coat		
Year:	2011		
Visual Description:	Pavement exhibits moderate raveling and slight shrinkage cracking, three areas of alligator cracking (5x5) and (3x25)(10x15).		
Miscellaneous:	Slope = 3.6/ 2.5/ 0.2, Pavement drains to drop inlate located in pavement area, ADA - pavement slope 3.0, ramp does not meet ADA requirements, update signage, need dumpster pad.

Misc. AC Fill	Base Failure (%)	Alligator Cracking (%)	Crack Factor	Ravel
0	0%	0.0%	0.080	M
	Crack Width	1/8 - 1/4"

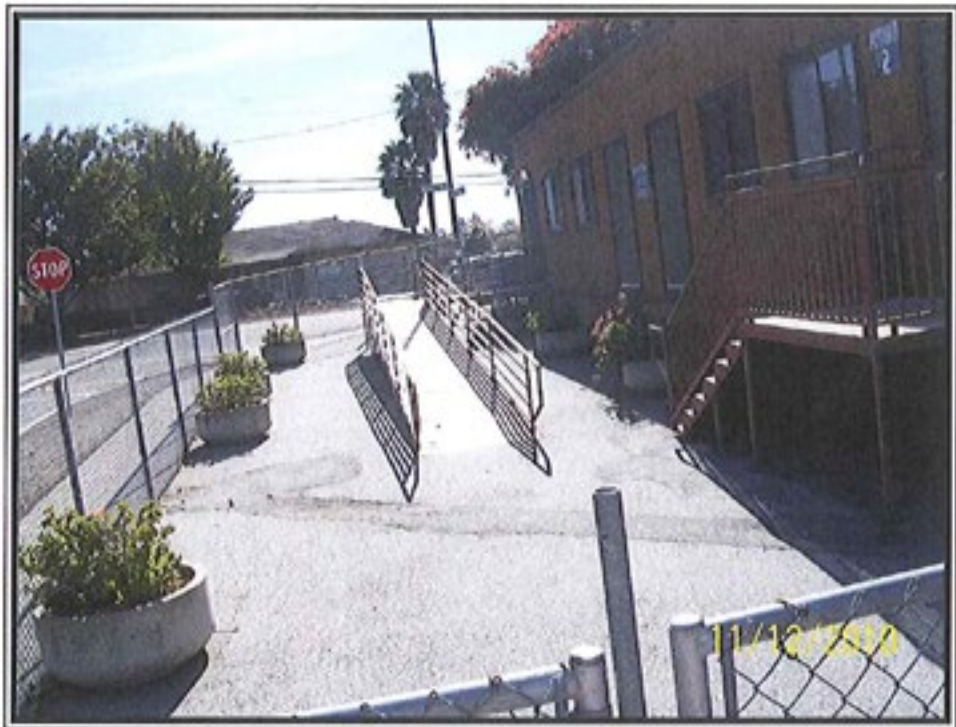
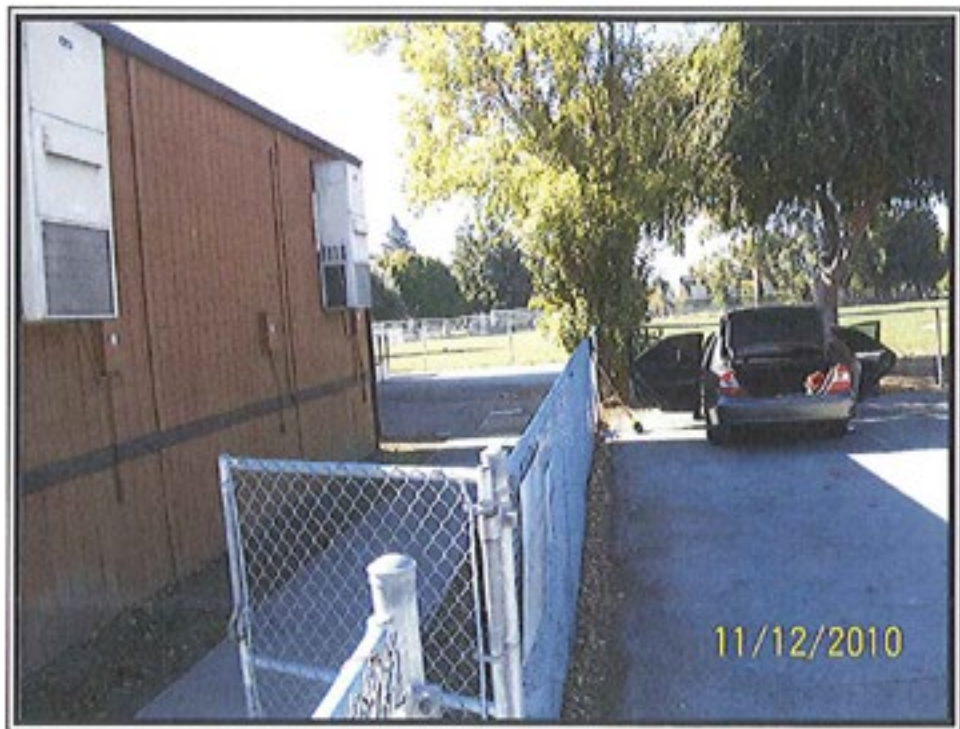
NOBLE SCHOOL - AREA B

School Name: Noble School **Area (sf):** 7,572
Area Notation: B **Buses:** No
Surface Type: AC **Garbage Trucks:** No
Use: Pedestrian Areas
Defect Score: 20
Recommended Treatment: Double application Emulsion Seal Coat
Year: 2011
Visual Description: Pavement exhibits moderate raveling and has never been sealed.
Miscellaneous: Slope = 0.5/ 4.5, Settled trench, pavement drains to adjacent lawn area.

Misc. AC Fill	Base Failure (%)	Alligator Cracking (%)	Crack Factor	Ravel
0	0%	0.0%	0.000	M
		Crack Width	0

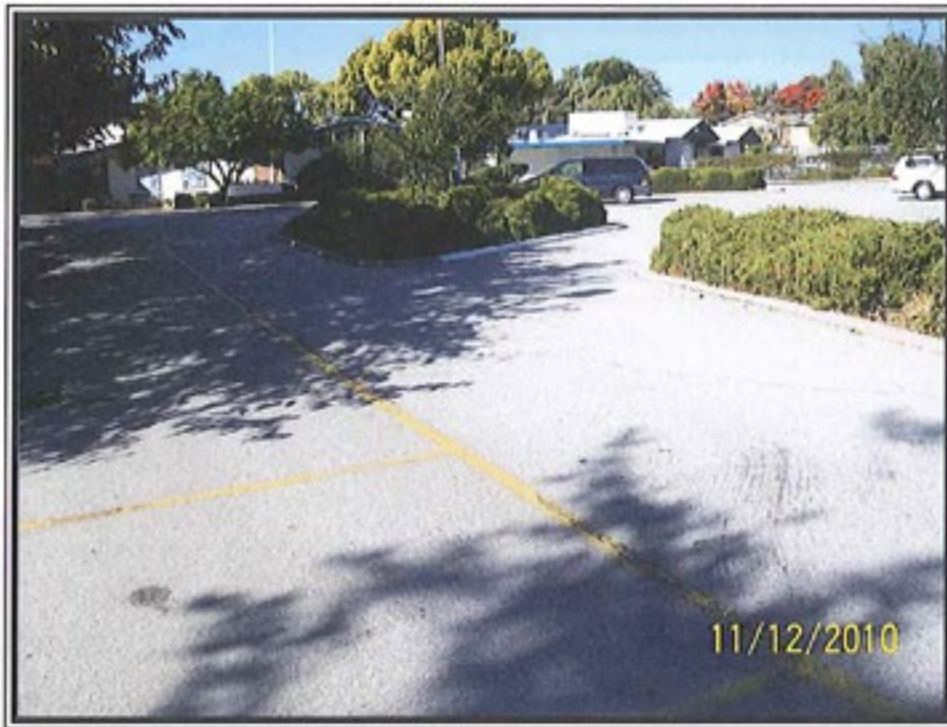
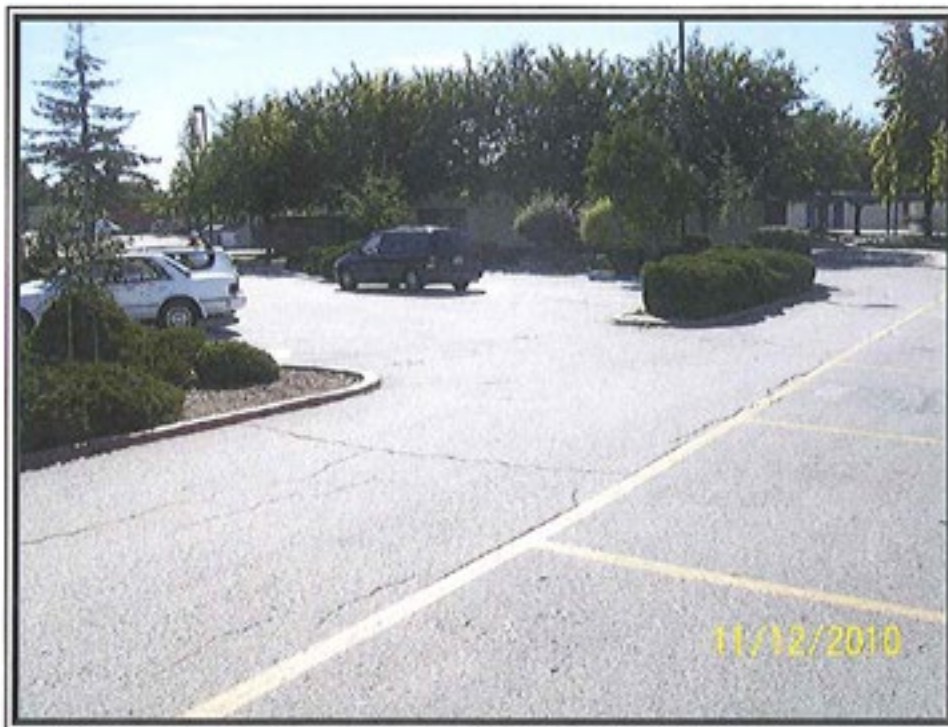
NOBLE SCHOOL - AREA C

School Name:	Noble School	Area (sf):	10,220
Area Notation:	C	Buses:	Yes
Surface Type:	AC	Garbage Trucks:	No
Use:	Parking Lots or Areas		
Defect Score:	49		
Recommended Treatment:	Crack Fill and Seal Coat		
Year:	2011		
Visual Description:	Pavement exhibits moderate raveling with moderate shrinkage cracking, previous maintenance was an overlay leaving a 3-4 inch curb height		
Miscellaneous:	Slope = 2.5/ 3.0/ 0.6, ADA - need to update signage, pavement slope is 0.6.

Misc. AC Fill	Base Failure (%)	Alligator Cracking (%)	Crack Factor	Ravel
0	0%	0.0%	0.133	M
Crack Width		1/8 - 1/4"

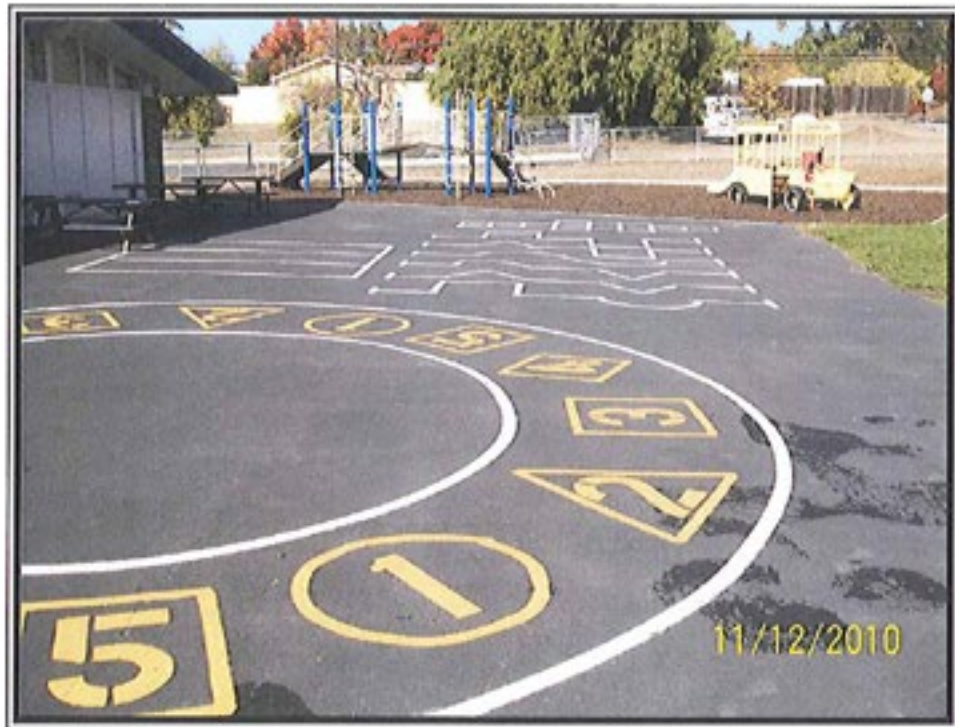
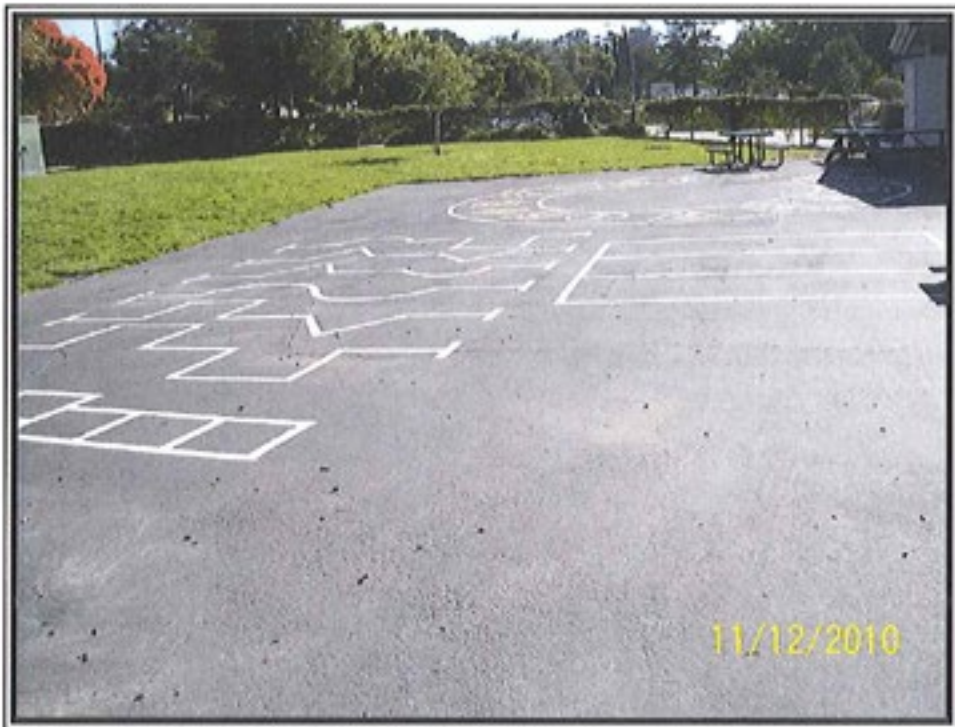
NOBLE SCHOOL - AREA D

School Name: Noble School **Area (sf):** 3,615
Area Notation: D **Buses:** No
Surface Type: AC **Garbage Trucks:** No
Use: Playground
Defect Score: 63
Recommended Treatment: Crack Fill and Seal Coat
Year: 2015
Visual Description: Pavement was recently seal coated, in good condition.
Miscellaneous: Slope = 0.5/ 2.3, Pavement drains to drop inlet in lawn area.

Misc. AC Fill	Base Failure (%)	Alligator Cracking (%)	Crack Factor	Ravel
0	0%	1.0%	0.152	S
Crack Width		1/8 - 1/4"

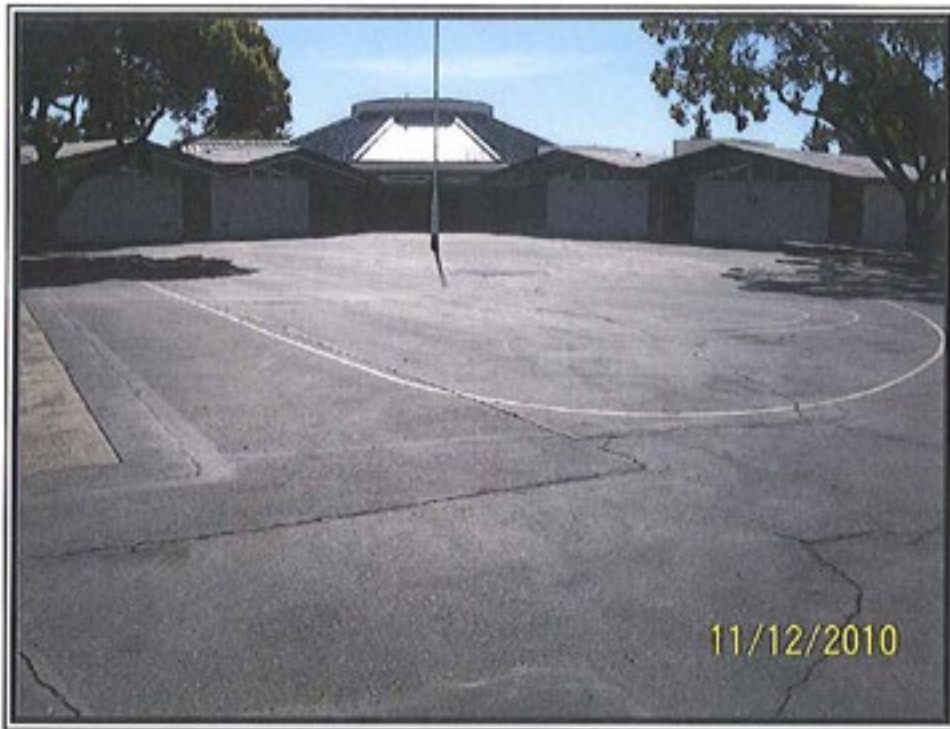
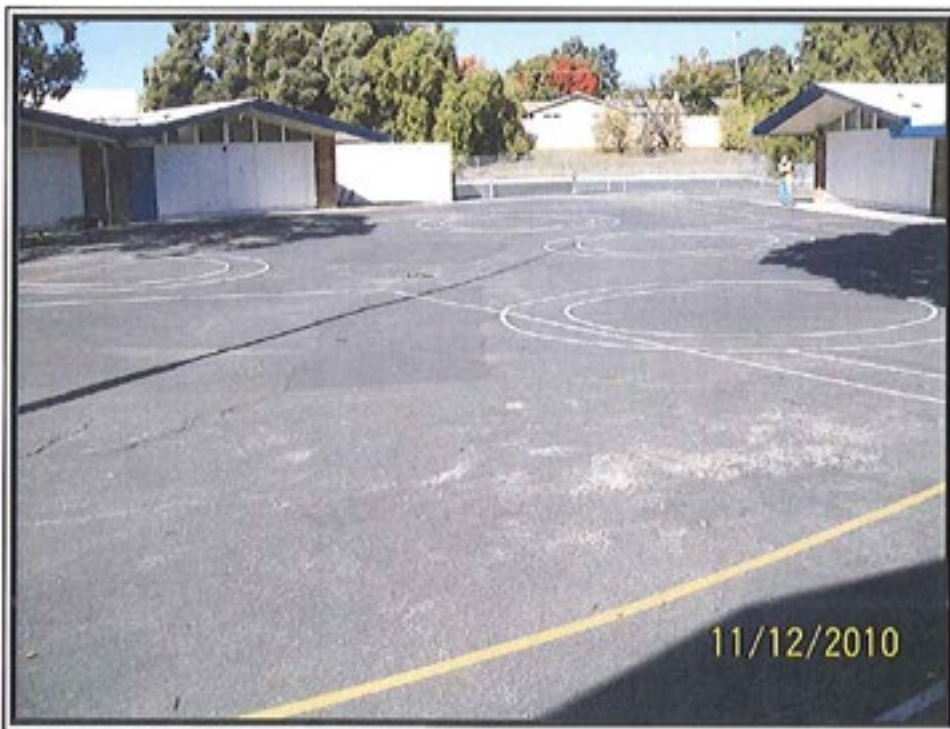
NOBLE SCHOOL - AREA E

School Name:	Noble School	Area (sf):	10,590
Area Notation:	E	Buses:	No
Surface Type:	AC	Garbage Trucks:	No
Use:	Playground		
Defect Score:	60		
Recommended Treatment:	Crack Fill and Seal Coat		
Year:	2013		
Visual Description:	Pavement exhibits slight raveling and moderate shrinkage cracking, previously sealed, in fair condition.		
Miscellaneous:	Slope = 0.5/ 3.3/ 5.3, Pavement drains to drop inlet located within the pavement area.

Misc. AC Fill	Base Failure (%)	Alligator Cracking (%)	Crack Factor	Ravel
0	0%	0.0%	0.173	S
Crack Width		1/8 - 1/4"

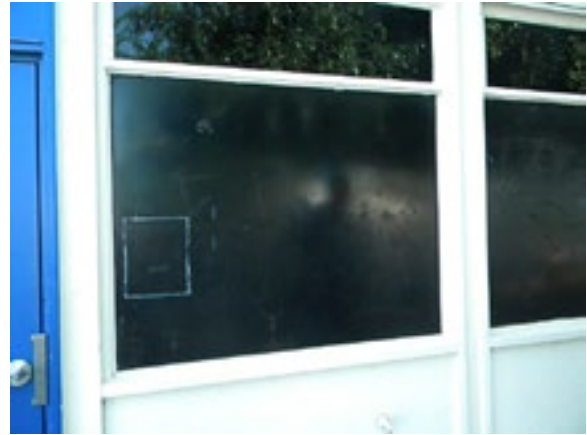
- While significant portions of this site have a perimeter fence in place, the site is largely open in the front.
- The site is also open in the back, where it abuts a city park.
- Building exterior lighting is insufficient.
- Existing doors often have windows in them, and not all doors have modern security hardware.
- This site has a handful of windows below door height.

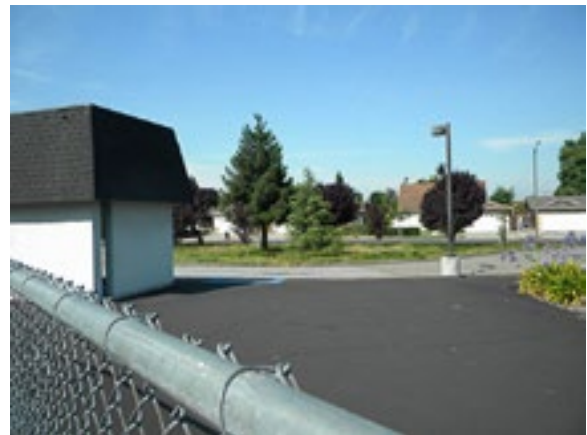
- Existing parking lot circulation is poor.
- Because of the difficulty circulating through the parking lot at peak times, traffic backs up onto Trimble Road in front of the school.
- Pick-up and drop-off area is insufficient.
- Insufficient parking for staff and guests.
- Existing accessible parking does not meet current requirements.

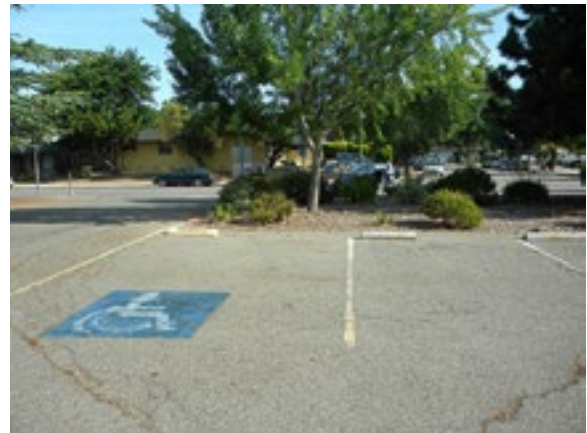
- The existing landscaping is generally in good condition, although some areas of original plantings have potential for trapping debris and creating

places for nuisance pests to nest.

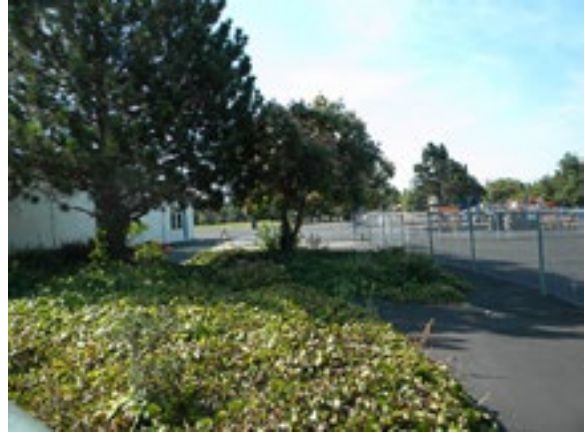
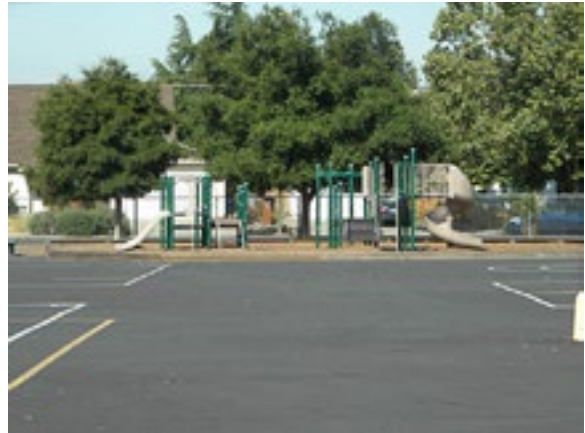
- The existing asphaltic concrete play surfaces appears to be in moderately good condition, some repair work is recommended.
- The existing sports fields have issues with ground squirrels and gophers. Some parts of the grass fields are bare and/or more weeds than grass.
- Existing play structures appear in good condition; however, the existing shredded rubber in the play structure boxes is depleted and in need of replacement.

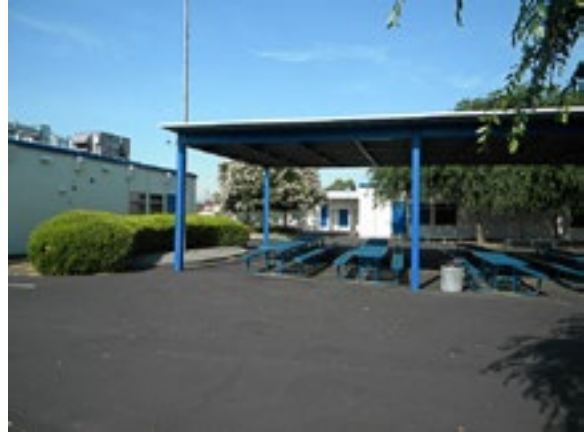
- Circulation occurs primarily outdoors, without covered walkways.
- Accessibility is generally good.
- Door thresholds are approximately 1" high in places.

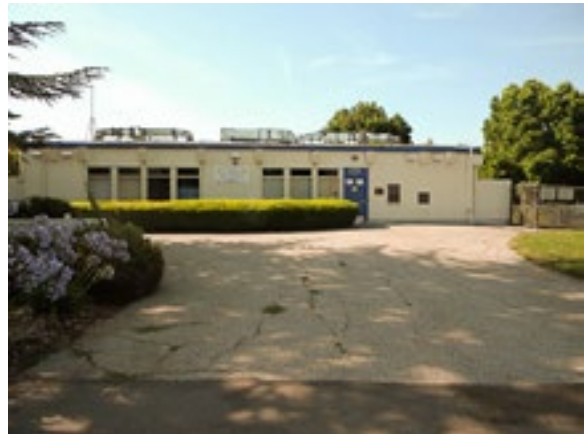
- Classrooms are generally in good condition, although many of the finishes are faded and/or dirty.
- Many of the existing windows are in poor condition.

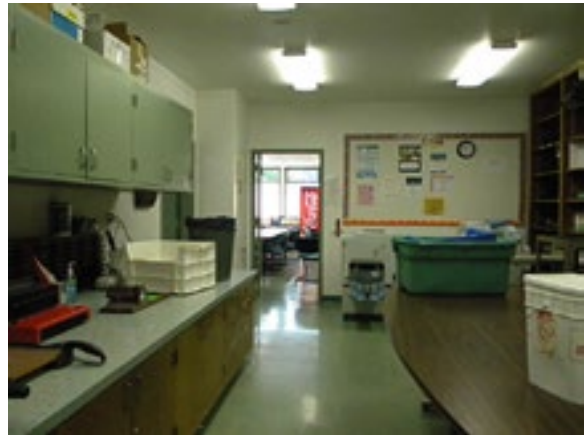
- Units 300, 400 & 500: This building's lateral force resisting system consists of a plywood sheathed roof acting as a horizontal wood diaphragm spanning between vertical plywood shear walls. Seismic loads are resisted in both orthogonal directions by way of the wood shear walls located on the exterior of the building structure. A preliminary review of the building is that the building is comprised of numerous shear walls that can adequately handle the lateral load if the walls are in good condition. During the review it was noted that not all shear walls included tie downs at each end of the wall.

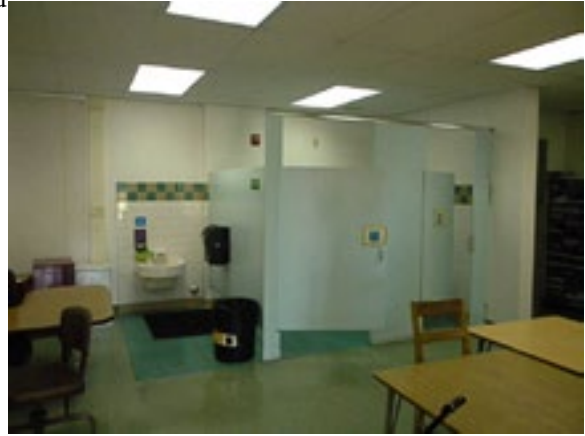
- Unit 600: This building's lateral force resisting system consists of a plywood sheathed roof acting as a horizontal wood diaphragm spanning between vertical plywood shear walls. Seismic loads are resisted on three sides by way of the wood shear walls located on the exterior of the building structure. A preliminary review of the building is that the building is comprised of numerous shearwalls that can adequately handle the lateral load if the walls are in good condition. During the review it was noted that not all shear walls included tie downs at each end of the wall.

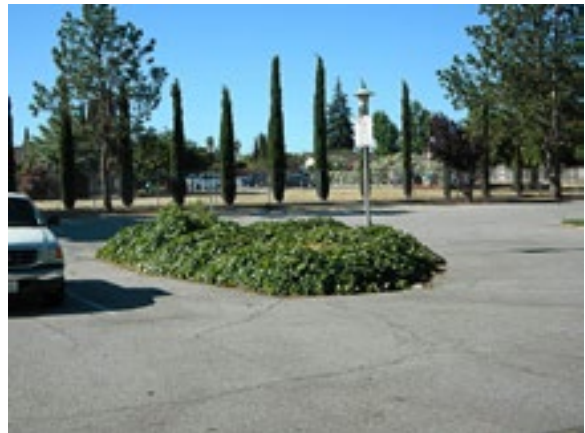
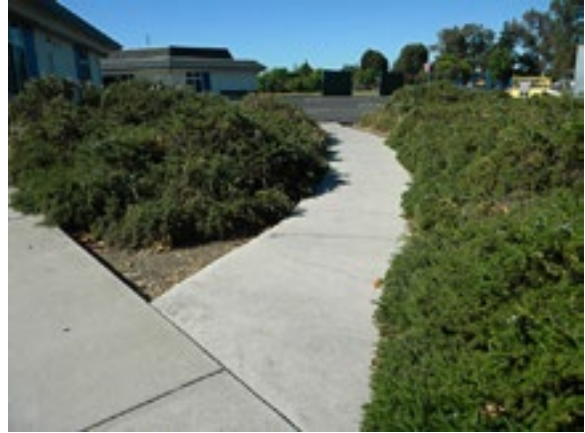
BROOKTREE SCHOOL - AREA G

BROOKTREE SCHOOL - AREA H

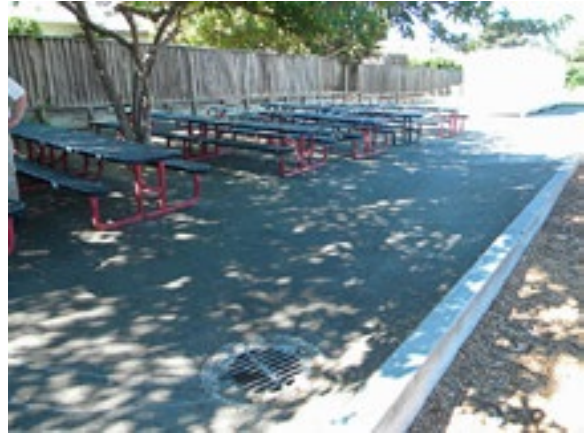
Brooktree Elementary School receives a subjective rating of 2.5.

Mechanical Systems Assessment Report

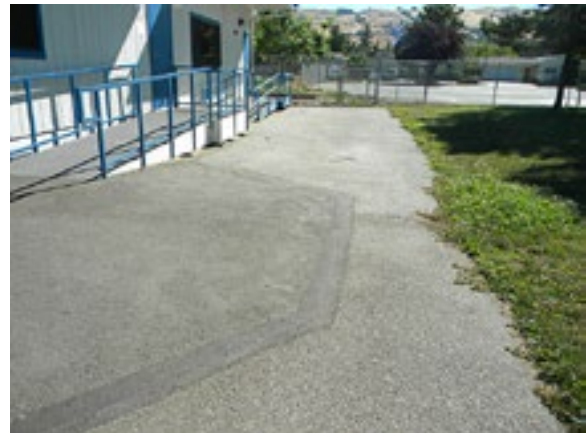
- a. An exterior covered eating area is desirable.
11. Roofing
 - a. No known issues.
12. Covered walkways
 - a. None currently. A covered path to the portables was requested.

- b. Potential for re-location of portables. (9/17/13)
 - c. Lunch room area is way too small for current needs. (9/17/13)
- 15. Curb Appeal
 - a. General landscaping improvements.
- 16. Portable classrooms/restrooms
 - a. Request made for additional restrooms at/near portables.
- 17. Storage
 - a. Request for additional storage around campus.
 - b. Small storage building requested. (9/17/13)
- 18. Drinking fountains
 - a. Request for additional drinking fountains at portables.
 - b. Replace existing drinking fountains. (9/17/13)
- 19. Signage
 - a. District plans to replace all existing wayfinding signage.
 - b. District plans to add marquee signage to each campus.

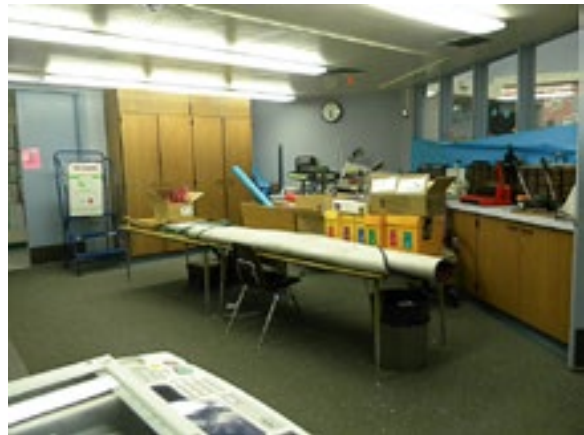
- f. Tackable Walls surfaces and all other interior finishes
 - a. Full-height, wall-to-wall tackable surfaces requested.
- g. Ceilings
 - a. No known issues.

- i. Classroom size/layout (21st Century Learning environment/classroom)
 - a. Meeting to be held on 23JUN2013 with District representatives to discuss this item.

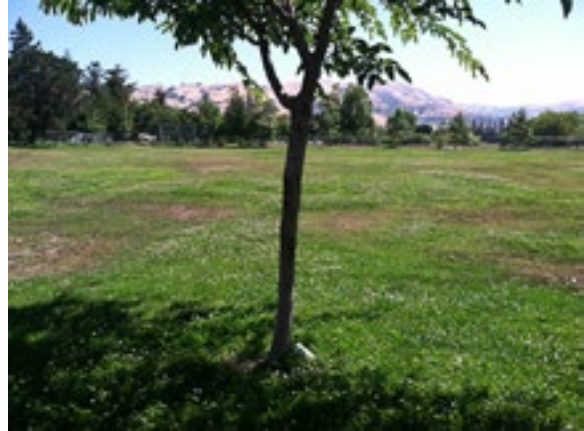
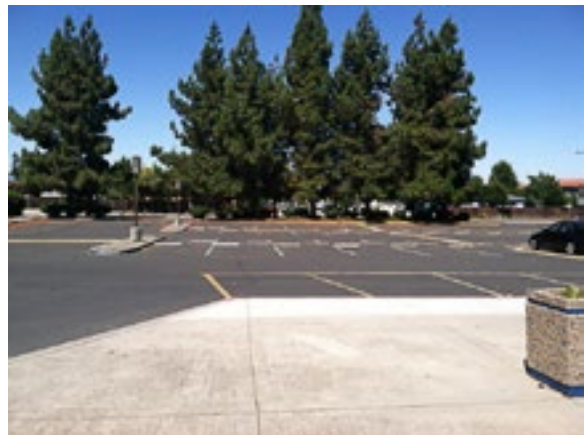
- While significant portions of this site have a perimeter fence in place, the site is largely open in the front; and because the site abuts a city park, there is an unfenced boundary at the rear of the site also.
- Building exterior lighting is insufficient.
- There is direct access without intervening obstacles from the main entry to interior building spaces.
- Existing doors often have windows in them, and not all doors have modern security hardware.
- Not all classrooms have doors that can be secured, due to original open plan of site.
- This site has a handful of windows below door height.

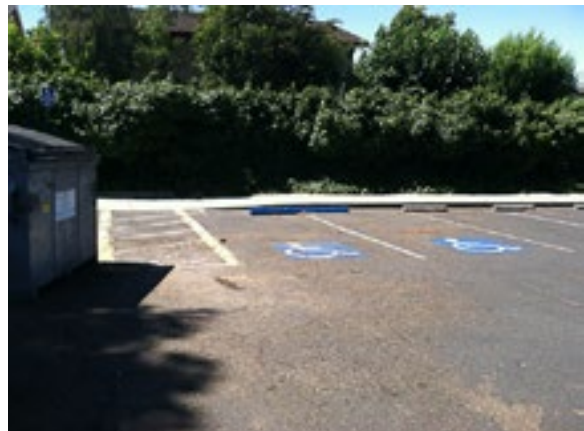
Parking lot and Drop-Off / Pick-Up:

- Site has no bus lane for drop-off or pick-up.
- Circulation through the parking lot during pick-up and drop-off is inadequate, and creates problems with traffic congestion.
- Pick-up / Drop-off location sees considerable congestion during peak times, and does not allow traffic to flow through.
- Existing accessible parking does not meet current requirements.

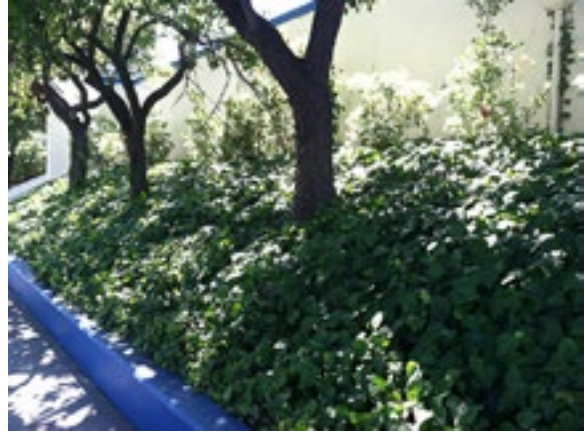
Landscaping:

- The existing landscaping is dated, non-existent in some places, and overgrown in others. The bare areas face erosion issues, and the overgrown areas trap debris as well as providing a home to nuisance pests.
- The landscaping in the sloped planters adjacent to the building is causing moisture intrusion problems, as well as creating a security issue by assisting students in accessing the roof of the building.

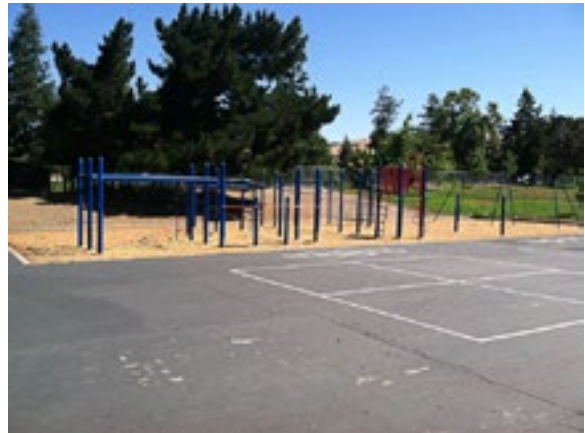
Play Surface / Fields / Play Structures:

- One of the two main asphalt play surfaces is in good condition. The other is in relatively poor condition.
- The existing sports fields have issues with ground squirrels and gophers. Some parts of the grass fields are bare and/or more weeds than grass.
- Existing play structures appear in good condition; however, the existing shredded rubber in the play structure boxes is depleted and in need of replacement.

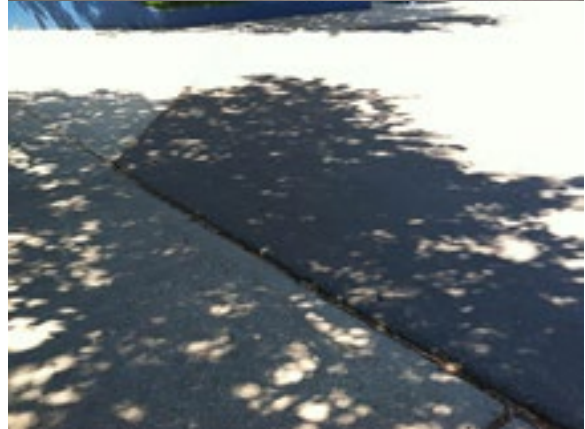
Outdoor eating area:

- Current outdoor eating area is the paved play area, which has little seating and no covered area.

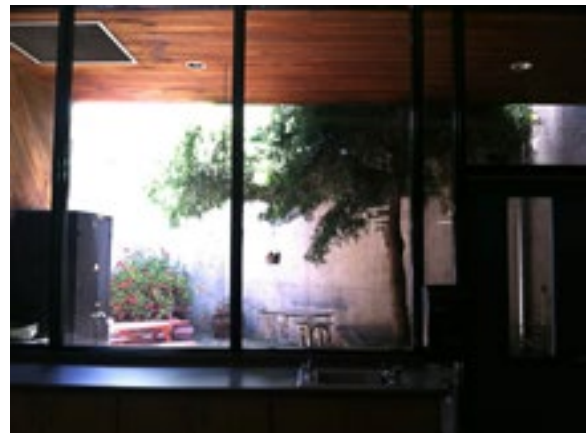
- Most finishes appear in need of replacement.
- Existing clerestory windows are in need of replacement.
- Existing sound system is inadequate for current needs.

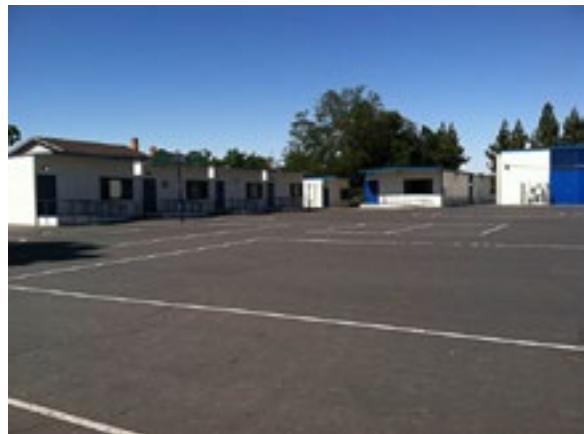
- A 1000A, 277/480V, 3-phase, 4-wire switchboard with a 300KVA utility pad mounted transformer located in the electrical service yard provides power to the campus. The switchboard was of original build and in fair condition. According to PG&E record, the current peak usage on the system is of 227 amps.

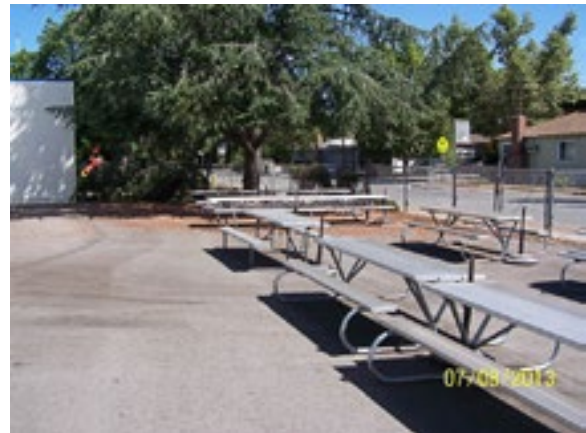
Brooktree Elementary School

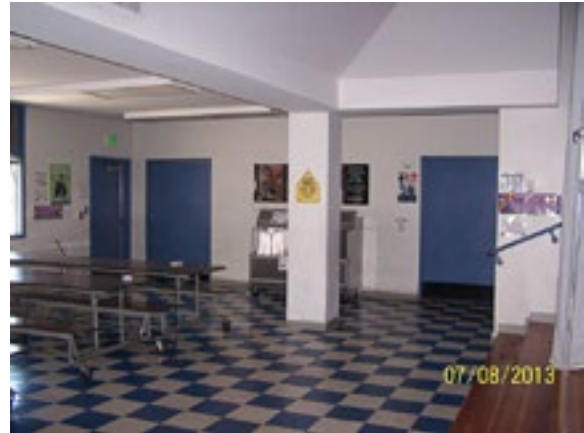
- MPR noted as being too small for full school assemblies. (9/24/13)
- Administration area functionality
 - Request was made to aggregate certain program spaces in the administration area that are currently remotely located. (RSP, Speech, Psych, etc.)

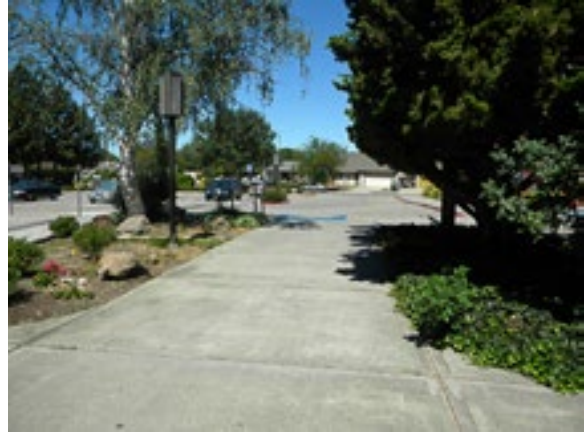
- This site is largely fenced in, although access from the front is still available. Some of the existing fence is less than 6'-0" high, and some openings in the fence exist.
- Building exterior lighting is insufficient.
- Existing doors often have windows in them.
- This site has numerous windows below door height.

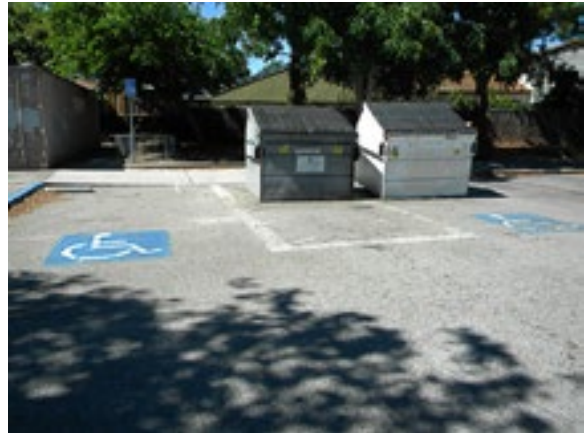
Parking lot and Drop-Off / Pick-Up:

- Circulation through the parking lot during pick-up and drop-off is inadequate, and creates problems with traffic congestion.
- Pick-up / Drop-off location sees considerable congestion during peak times, and does not allow traffic to flow through.
- Existing accessible parking does not meet current requirements.
- Parents and students using the remote private daycare facilities must walk a considerable distance from parking to classroom.
