Berryessa Union School District Facilities Needs and Assessment Study

Prepared For
Berryessa Union School District

In April of 2013, Berryessa Union School District requested that Sugimura Finney Architects prepare a District-wide survey to assess the current status of the District's facilities, and to help guide upcoming decisions related to facility utilization and improvement.

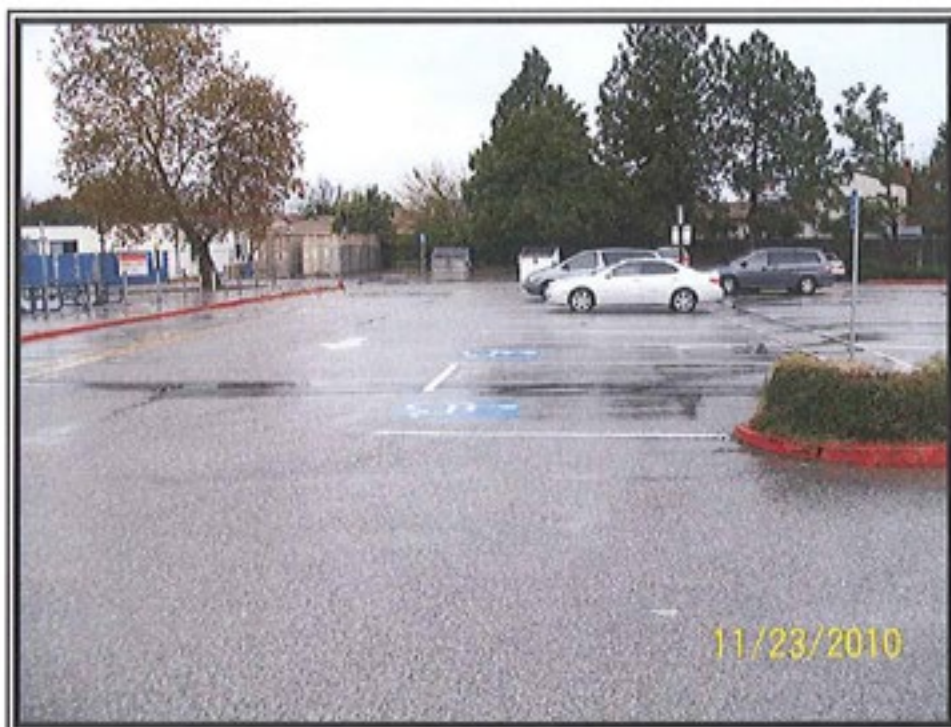
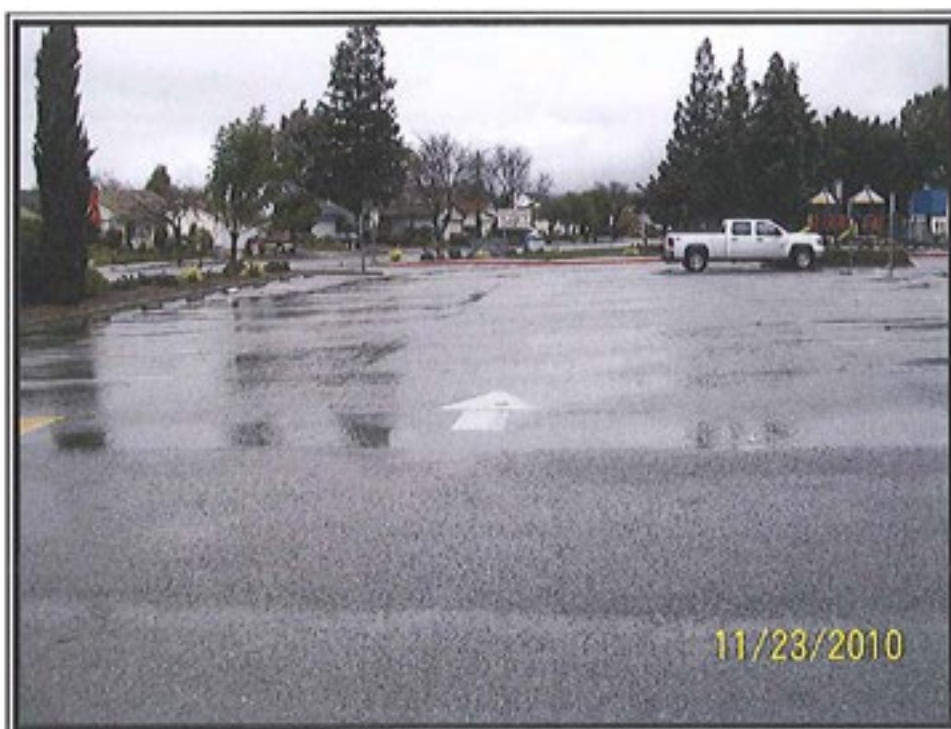
VINCI PARK SCHOOL - AREA A

School Name:	Vinci Park School	Area (sf):	25,252
Area Notation:	A	Buses:	Yes
Surface Type:	AC	Garbage Trucks:	Yes
Use:	Parking Lots or Areas		
Defect Score:	44		
Recommended Treatment:	Crack Fill and Seal Coat		
Year:	2011		
Visual Description:	Pavement exhibits severe raveling and slight shrinkage cracking, previously sealed, in poor condition.		
Miscellaneous:	Slope = 0.5/ 2.6/ 3.8, Pavement drains to drop inlets in pavement area, ADA - 1) slope exceeds 2%, no crosswalk to southwest 2) trash cans in stalls, cross slope of ramp exceeds 2%.

Misc. AC Fill	Base Failure (%)	Alligator Cracking (%)	Crack Factor	Ravel
1000	0%	1.0%	0.056	V
Crack Width		<1/8"

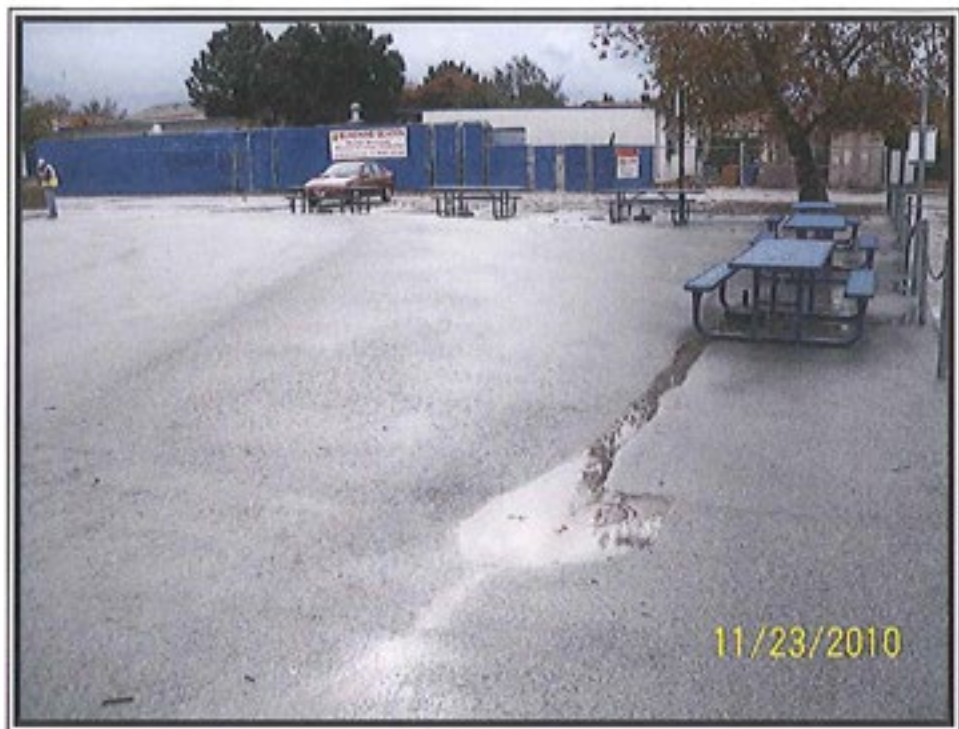
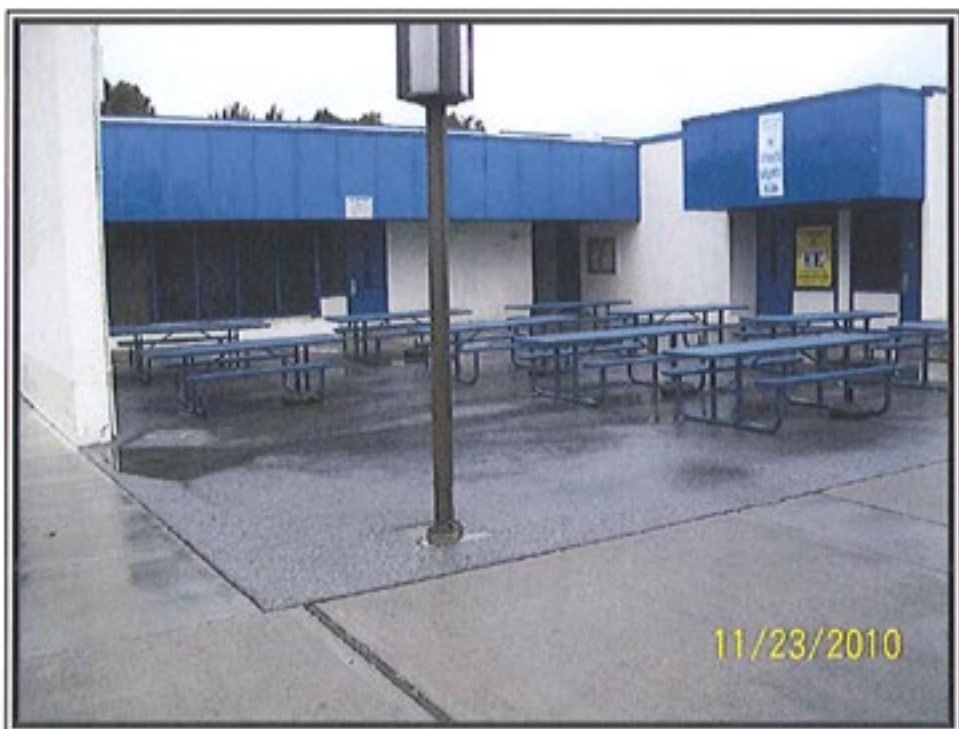
VINCI PARK SCHOOL - AREA B

School Name: Vinci Park School **Area (sf):** 6,604
Area Notation: B **Buses:** No
Surface Type: AC **Garbage Trucks:** No
Use: Pedestrian Areas
Defect Score: 20
Recommended Treatment: Double application Emulsion Seal Coat
Year: 2011

Visual Description: Pavement is in good condition, needs a seal coat.

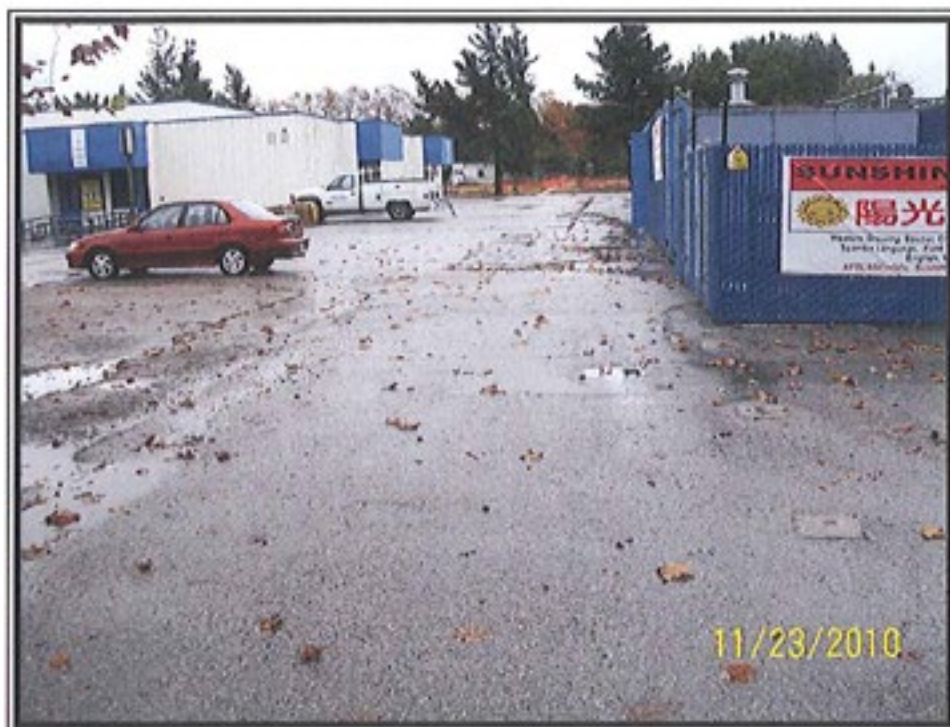
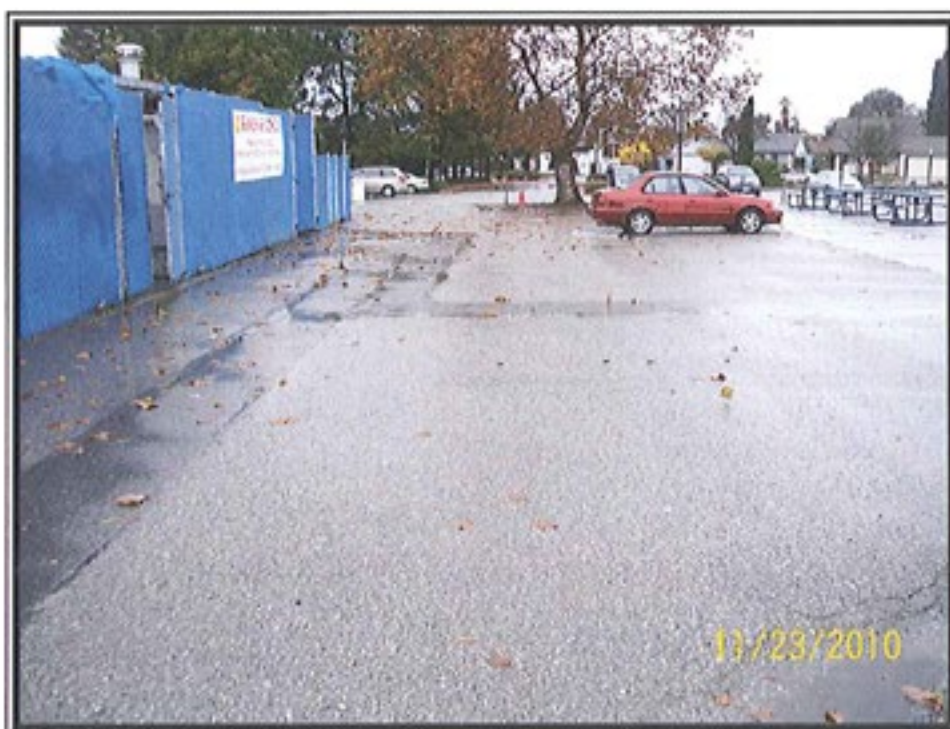
VINCI PARK SCHOOL - AREA C

Defect Score: 30

Recommended Treatment: Double application Emulsion Seal Coat

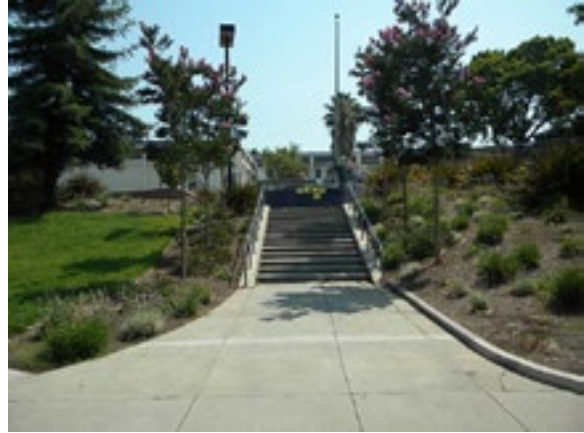
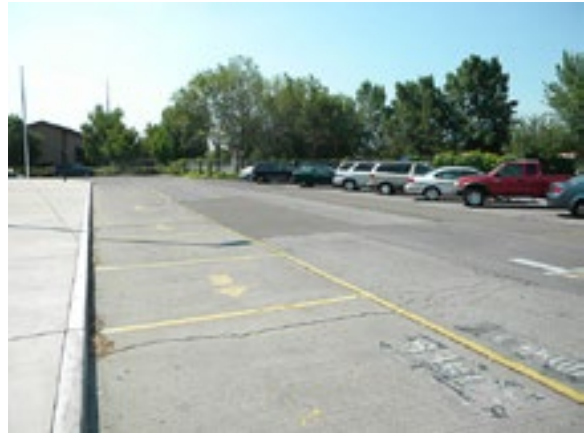
- While significant portions of this site have a perimeter fence in place, the site is largely open in the front and sides of the campus.
- Building exterior lighting is insufficient.
- Existing doors often have windows in them, and not all doors have modern security hardware.
- This site has several windows below door height.
- The location of the office makes access control difficult. Entrants to the campus must enter to the campus core to access the office space.

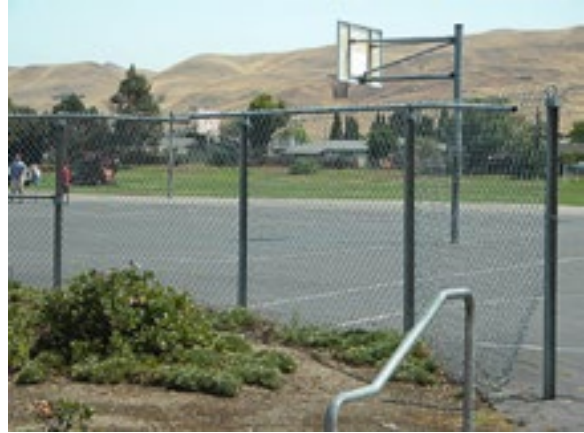
Landscaping:

- The existing landscaping is dated, non-existent in some places, and overgrown in others. The bare areas face erosion issues, and the overgrown areas trap debris as well as providing a home to nuisance pests.

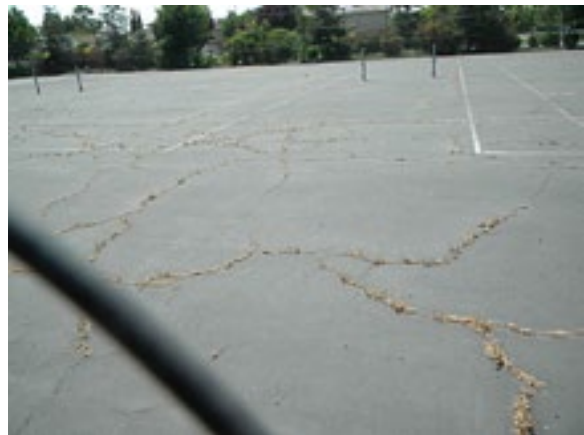
Play Surface / Fields / Play Structures:

- The existing asphaltic concrete play surfaces appear to be in fair condition, although some repair work is needed, particularly on the basketball and tennis play surfaces.
- The existing sports fields have issues with ground squirrels and gophers. Some parts of the grass fields are bare and/or more weeds than grass.

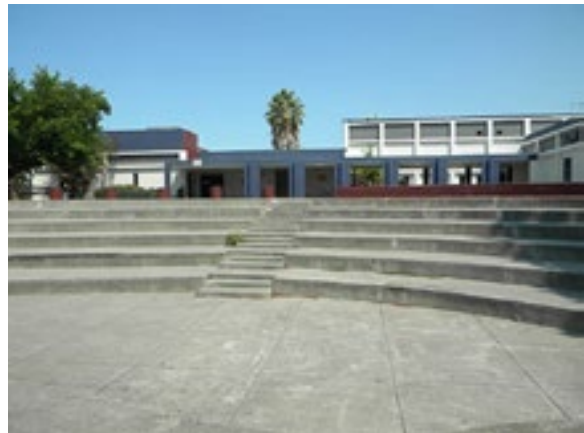
- Office entry visibility is poor from campus entry points.

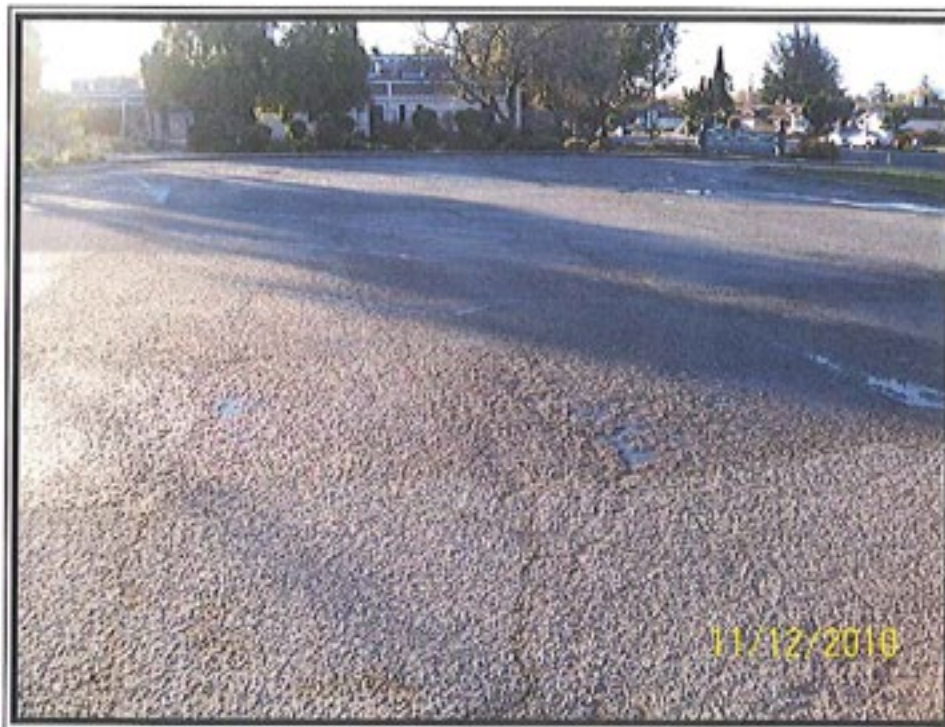
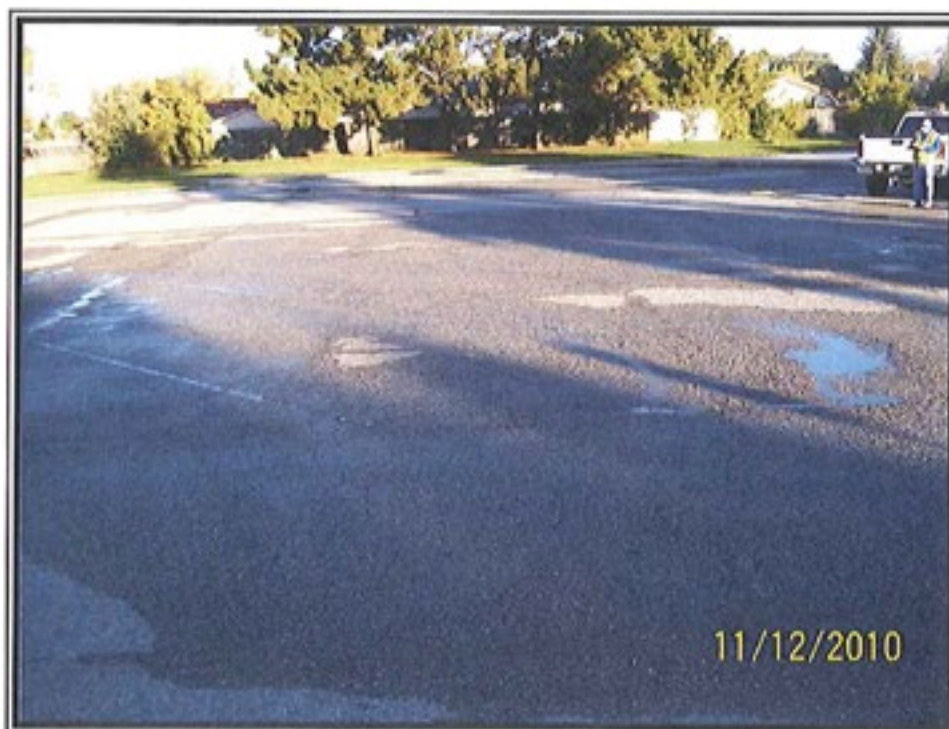
MORRILL MIDDLE SCHOOL - AREA A

School Name:	Morrill Middle School	Area (sf):	14,832
Area Notation:	A	Buses:	No
Surface Type:	AC	Garbage Trucks:	No
Use:	Parking Lots or Areas		
Defect Score:	74		
Recommended Treatment:	Reconstruct		
Year:	2011		
Visual Description:	Pavement exhibits severe raveling, previous slurry seal in poor condition.		
Miscellaneous:	Slope = 1.1/ 0.6/ 2.3, Pavement sheet flows to curb and gutter, then to drain inlet, ADA - new signage required.

Misc. AC Fill	Base Failure (%)	Alligator Cracking (%)	Crack Factor	Ravel
0	0%	1.0%	0.168	V
	Crack Width	1/8 - 1/4"

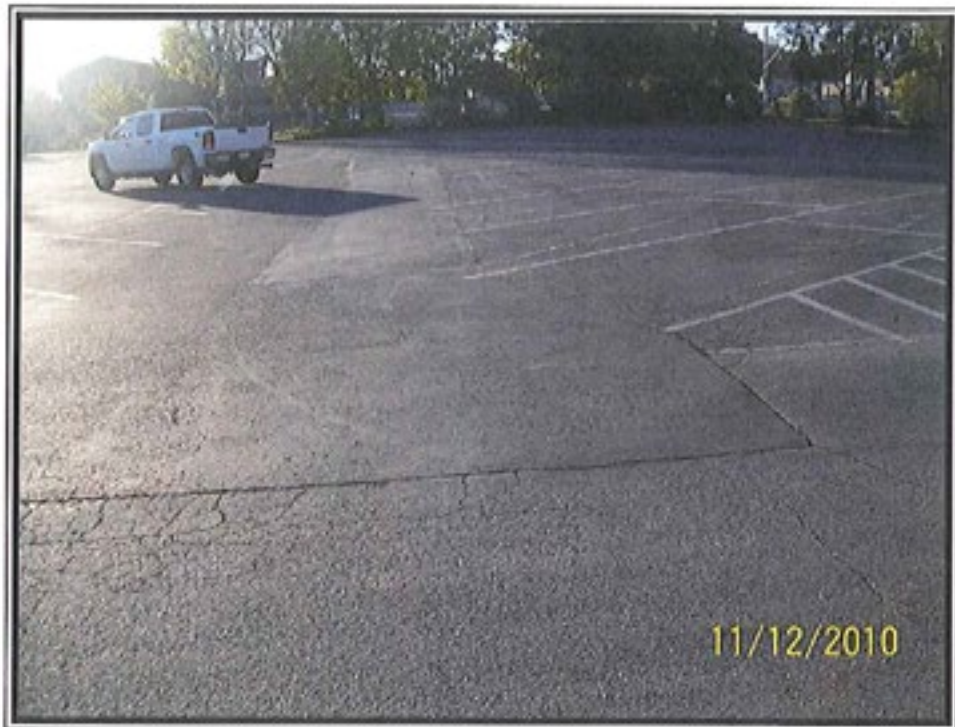
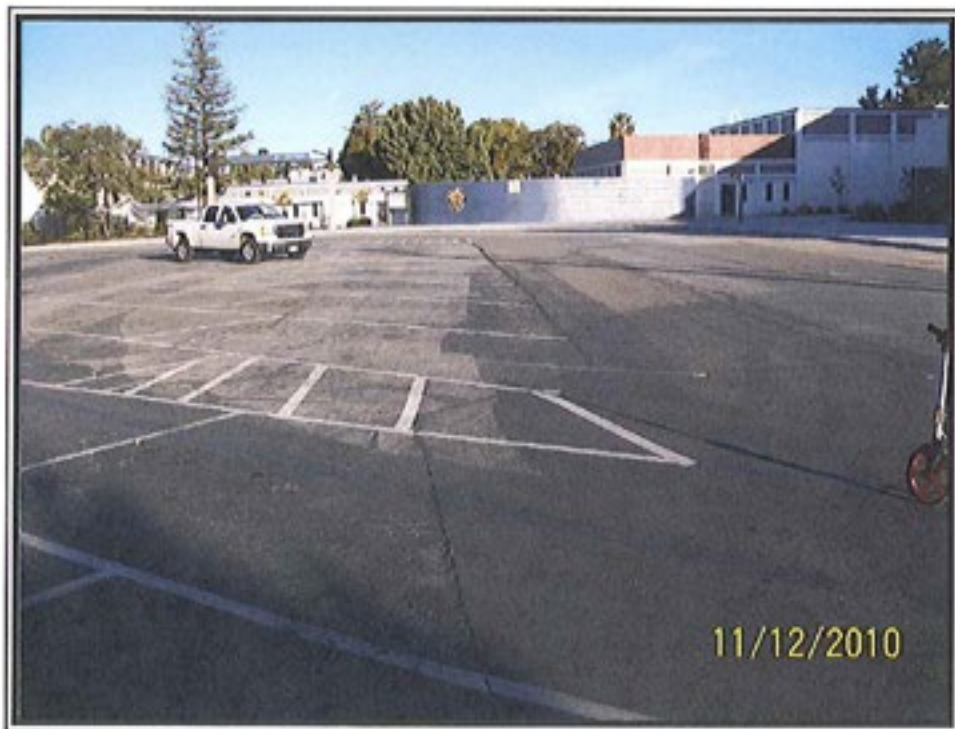
MORRILL MIDDLE SCHOOL - AREA B

Defect Score: 126

Visual Description: Pavement exhibits severe alligator cracking and numerous areas of previous patching.

Misc. AC Fill	Base Failure (%)	Alligator Cracking (%)	Crack Factor	Ravel
0	0%	10.0%	0.152	M
		Crack Width	1/8 - 1/4"

Recommended Treatment: Reconstruct

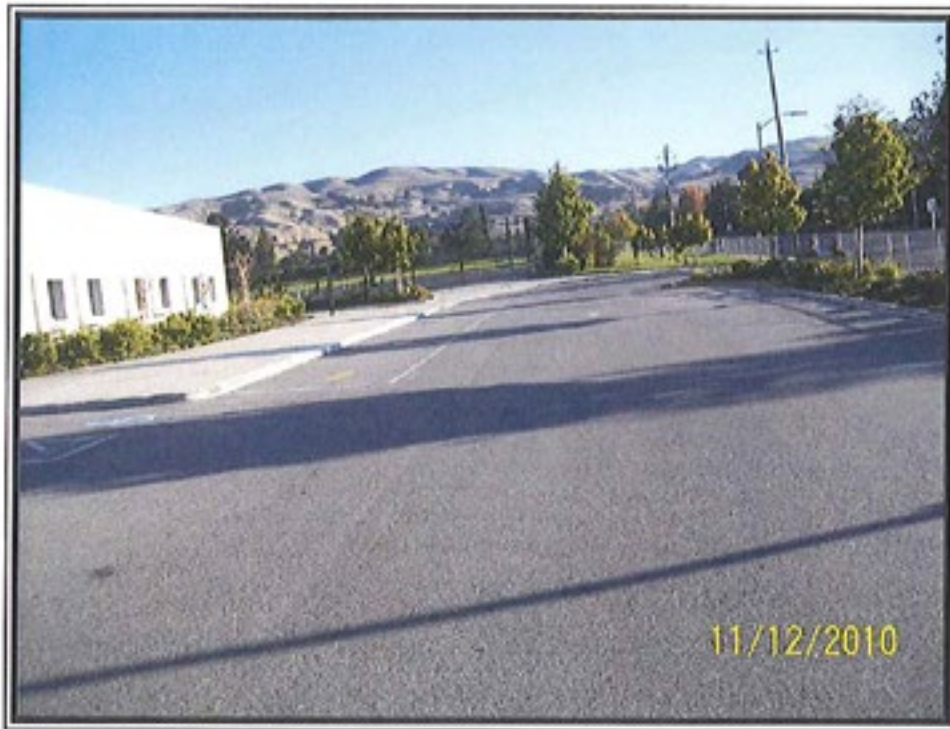
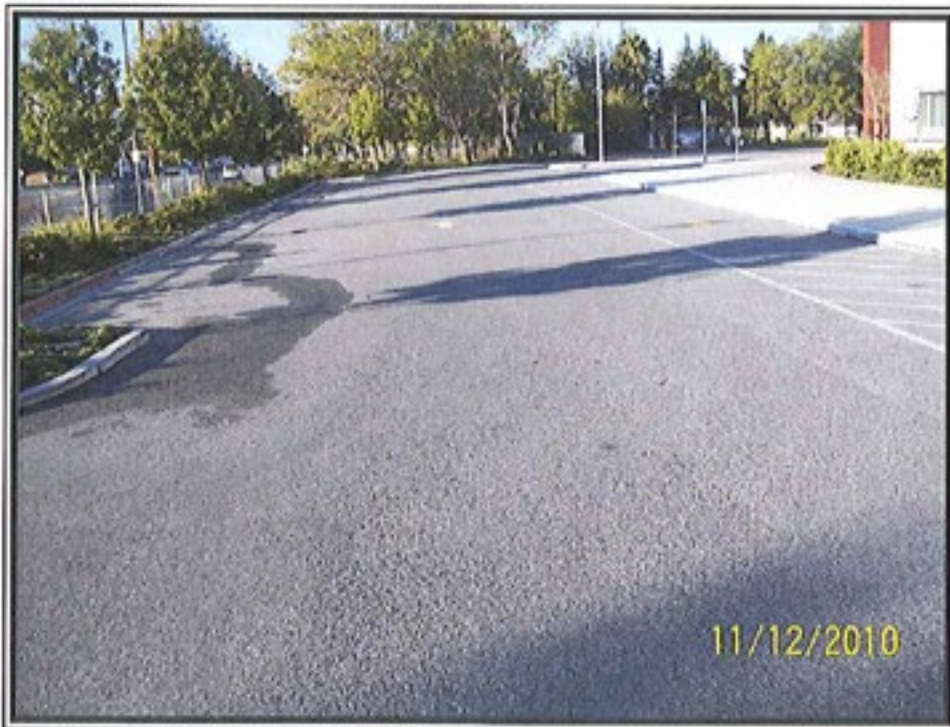
MORRILL MIDDLE SCHOOL - AREA C

School Name:	Morrill Middle School	Area (sf):	10,709
Area Notation:	C	Buses:	No
Surface Type:	AC	Garbage Trucks:	No
Use:	Parking Lots or Areas		
Defect Score:	9		
Recommended Treatment:	Double application Emulsion Seal Coat		
Year:	2011		
Visual Description:	Newer pavement area, never been sealed, slight raveling.		
Miscellaneous:	Slope = 0.9/ 2.2/ 2.9/ 1.7, Pavement flows to curb and gutter, then to drop inlet.

Misc. AC Fill	Base Failure (%)	Alligator Cracking (%)	Crack Factor	Ravel
0	0%	0.0%	0.000	S
	Crack Width	0

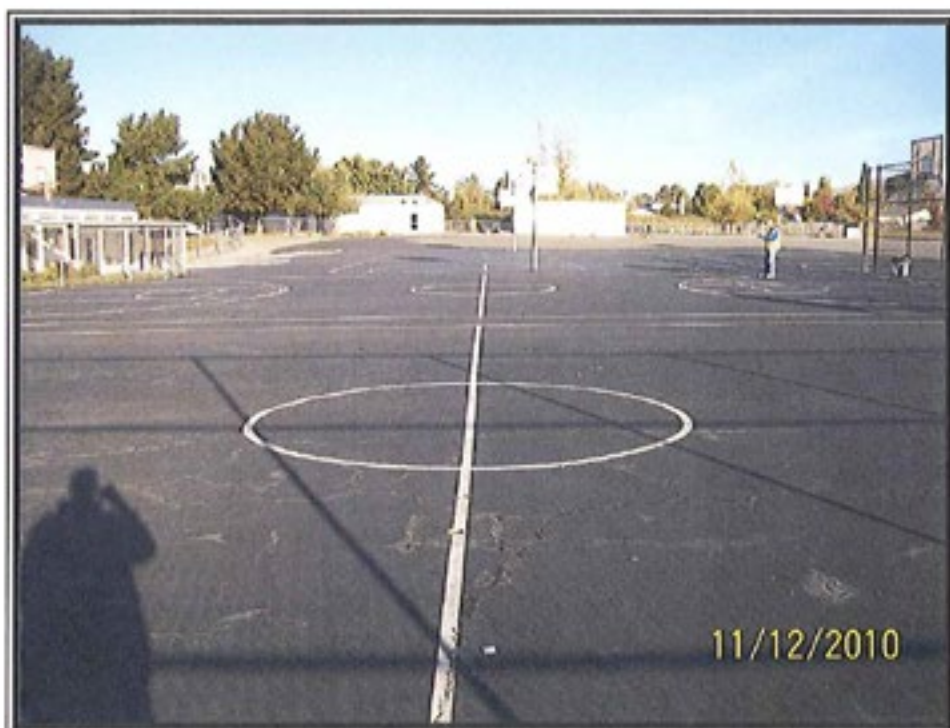
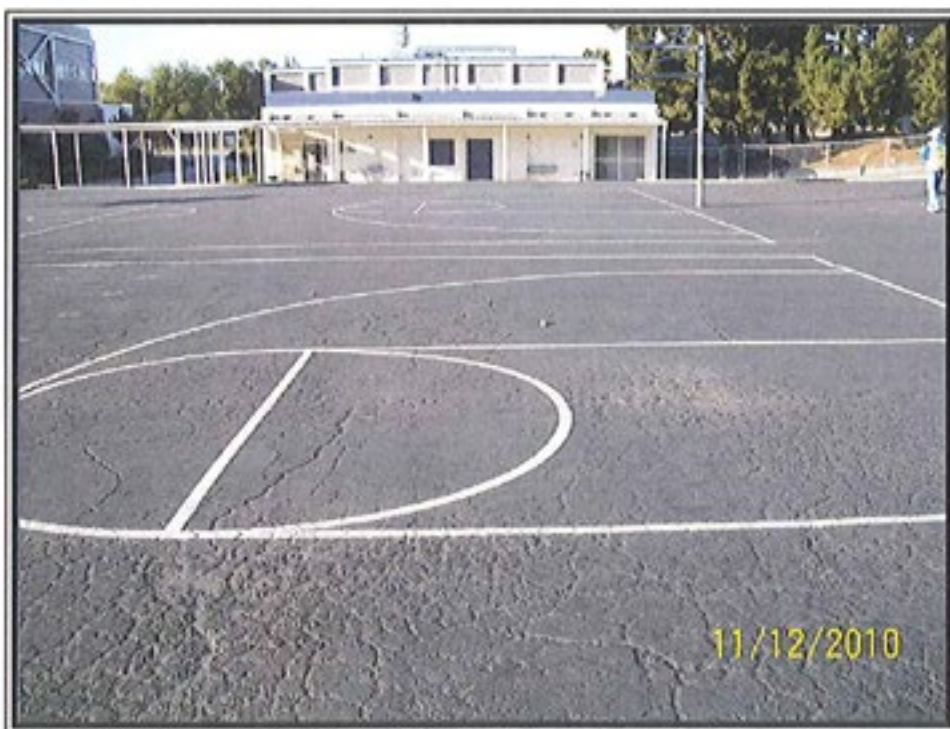
MORRILL MIDDLE SCHOOL - AREA E

School Name:	Morrill Middle School	Area (sf):	27,118
Area Notation:	E	Buses:	No
Surface Type:	AC	Garbage Trucks:	No
Use:	Playground		
Defect Score:	217		
Recommended Treatment:	Reconstruct		
Year:	2011		
Visual Description:	Pavement exhibits severe alligator cracking and block cracking, previously sealed, in good condition.		
Miscellaneous:	Slope = 1.7/ 2.6/ 2.2/ 12.3, Pavement sheet flows toward school, asphalt has been uplifted at adjacent sidewalks causing a trip hazard.

Misc. AC Fill	Base Failure (%)	Alligator Cracking (%)	Crack Factor	Ravel
0	0%	15.0%	0.260	S
	Crack Width	1/8 - 1/4"

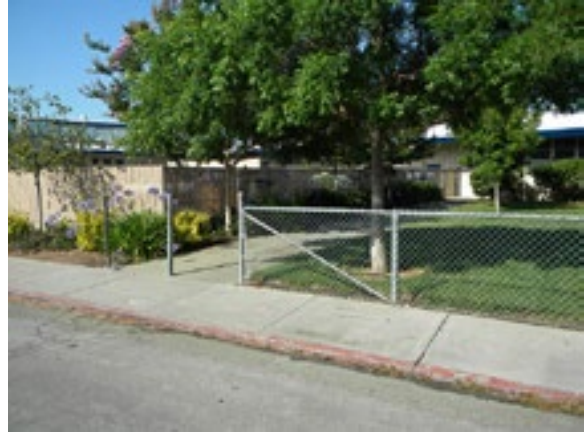
- While significant portions of this site have a perimeter fence in place, the site is largely open in the front and also is unsecured around approximately half the back side of the campus.
- Building exterior lighting is insufficient.
- Existing doors often have windows in them, and not all doors have modern security hardware.
- This site has many windows below door height.

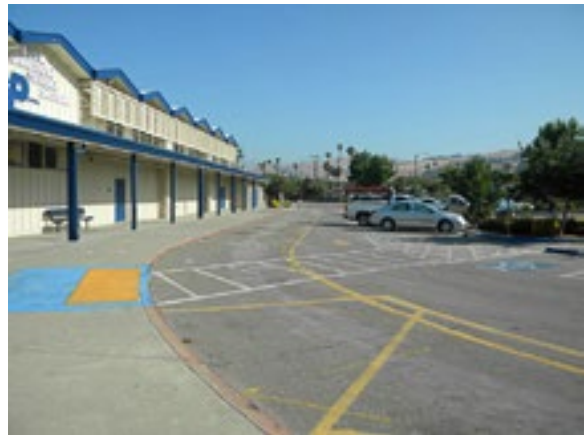
Parking lot and Drop-Off / Pick-Up:

- Parking lot is too small, with insufficient spaces for staff and visitors.
- Circulation through the parking lot during pick-up and drop-off is inadequate, and creates problems with traffic congestion.
- Pick-up / Drop-off location sees considerable congestion during peak times, and does not allow traffic to flow through.
- Existing accessible parking does not meet current requirements.

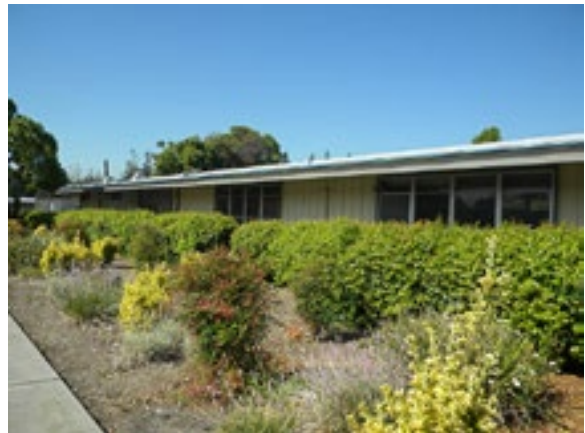
Landscaping:

- The existing landscaping is dated, non-existent in some places, and overgrown in others. The bare areas face erosion issues, and the overgrown areas

trap debris as well as providing a home to nuisance pests.

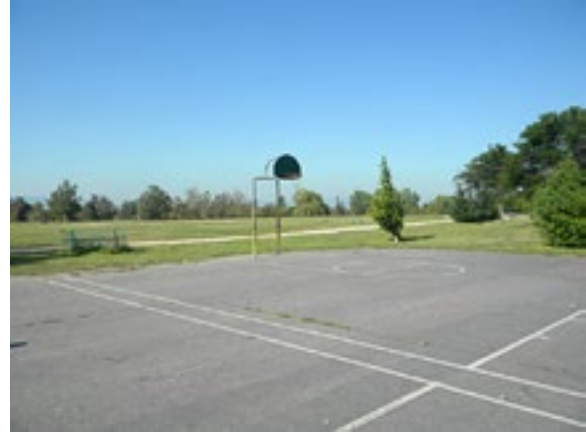
Play Surface / Fields / Play Structures:

- The existing asphaltic concrete play surfaces appears to be in reasonably good condition, although some repair work is needed.
- The existing sports fields and running track have issues with ground squirrels and gophers. Some parts of the grass fields are bare and/or more weeds than grass.
- Existing basketball standards are in poor condition.

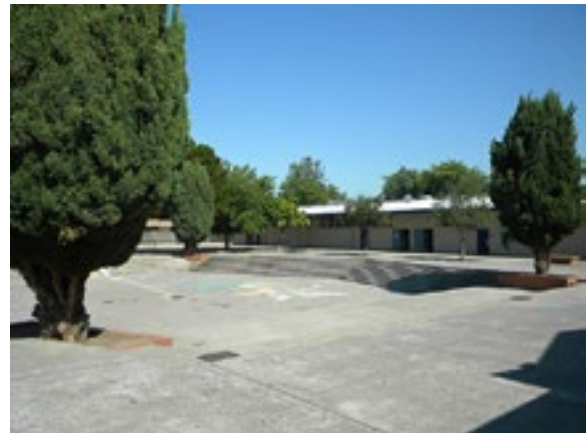
Entry Visibility:

- Main Office entry location is good; however, visibility is poor due to lack of distinguishing features. The office door looks very much like a standard classroom door.

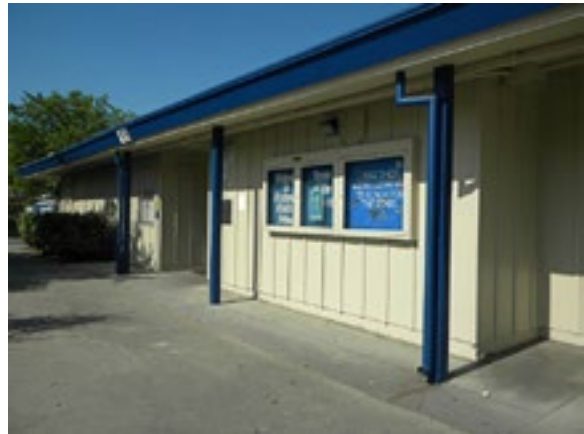
- Classrooms are generally in good condition, although many of the finishes are faded, worn, and/or dirty.
- Classrooms 26 - 31 are in an older modular building that is in poor condition.
- Many existing classrooms typically have a CRT television mounted in a location that does not comply with current accessibility requirements.

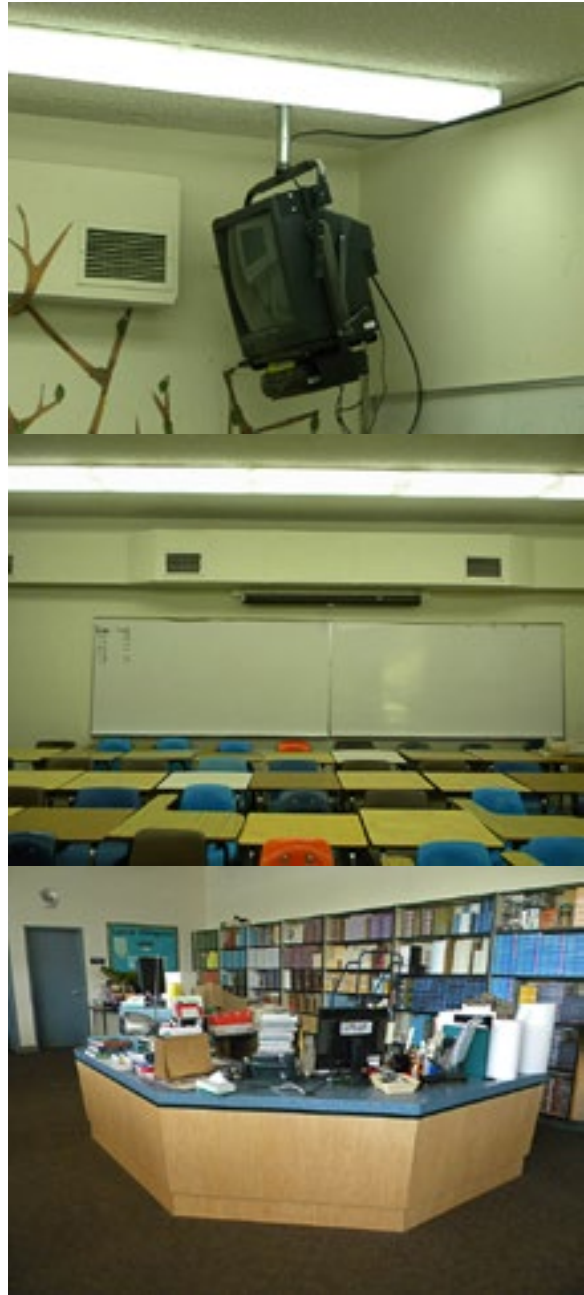
- The staff work area appears to be in good condition. The existing casework appears to

be aging, although still serviceable.

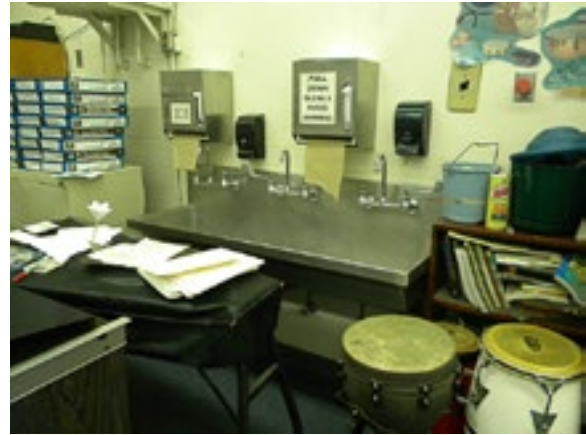
Storage and Custodial Spaces:

- Overall general storage capacity is acceptable.
- Custodial spaces are cluttered and in general show signs of wear and tear.

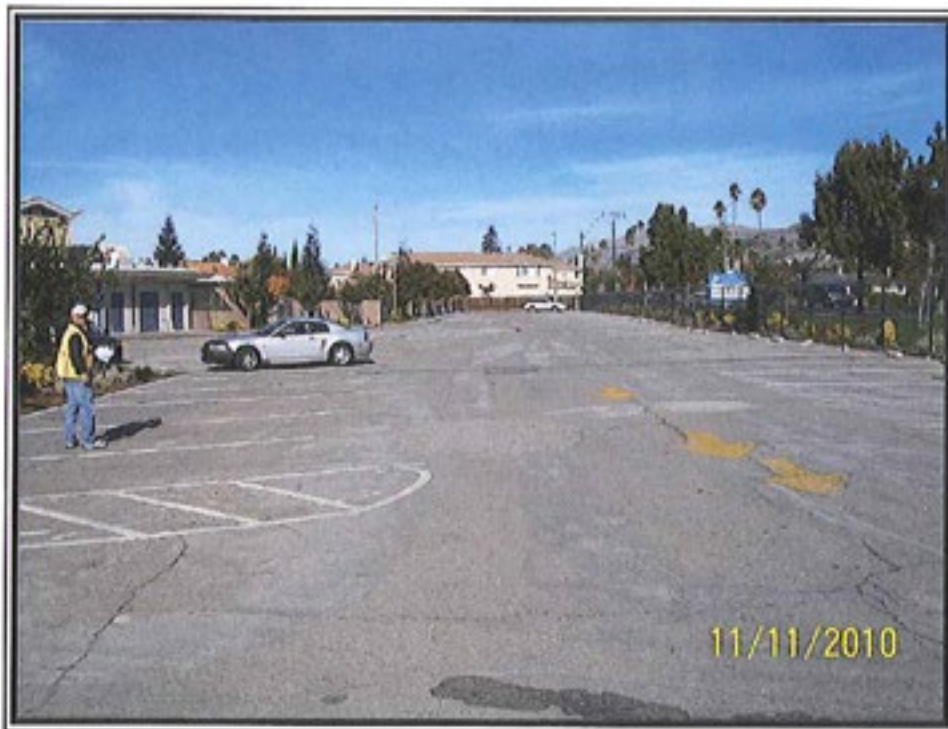
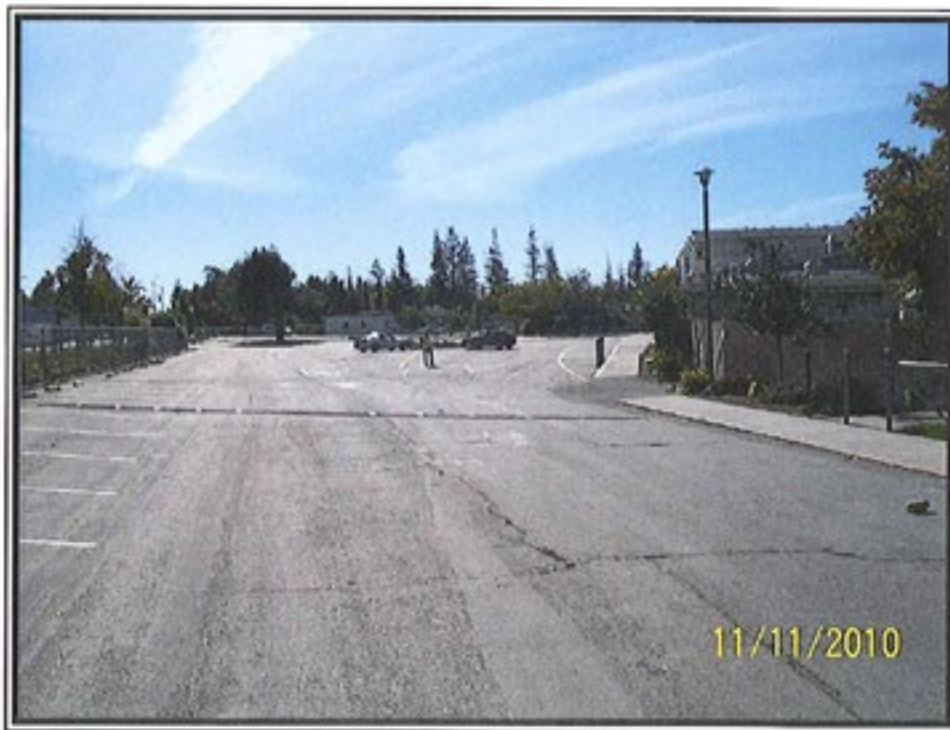
PIEDMONT MIDDLE SCHOOL - AREA A

School Name:	Piedmont Middle School	Area (sf):	29,355
Area Notation:	A	Buses:	Yes
Surface Type:	AC	Garbage Trucks:	No
Use:	Parking Lots or Areas		
Defect Score:	55		
Recommended Treatment:	Dig out/ Crack Fill/ Seal Coat		
Year:	2011		
Visual Description:	Pavement appears to have been overlaid, roof drains half blocked. Pavement exhibits moderate raveling, previously slurry almost gone.		
Miscellaneous:	Slope = 4.8/ 1.8/ 0.7, Pavement sheet flows to a low area at the north end and drains to a drop inlet behind a fenced area, ADA - needs AC fill and proper signage, bus unloading and HC stalls make drive path too small, need to adjust planter.

Misc. AC Fill	Base Failure (%)	Alligator Cracking (%)	Crack Factor	Ravel
600	0%	2.0%	0.085	M
	Crack Width	1/4 - 1/2"

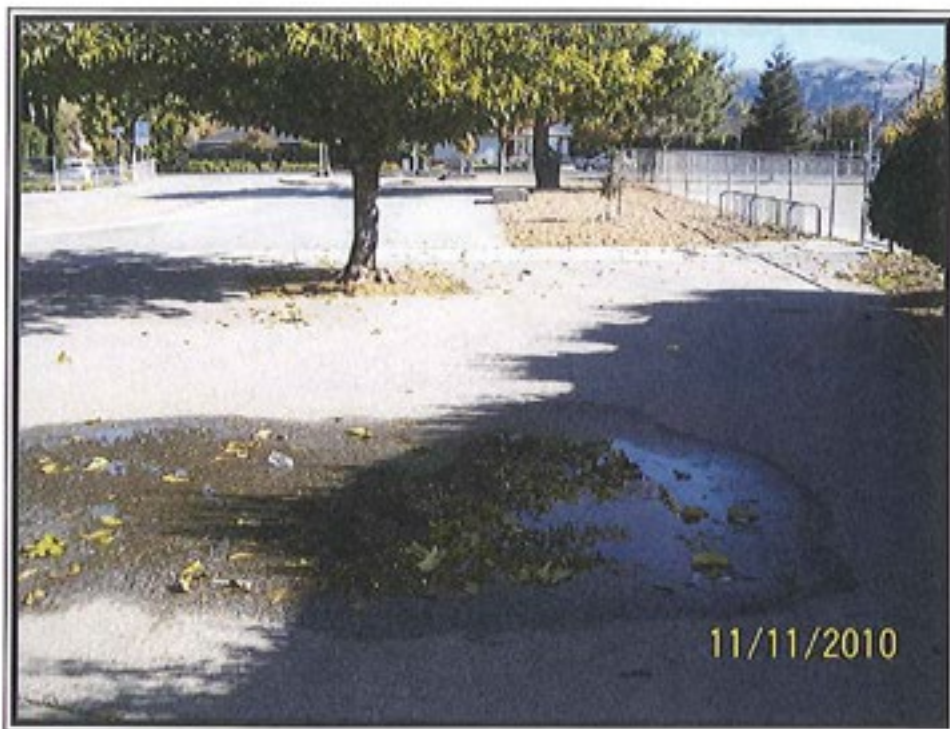
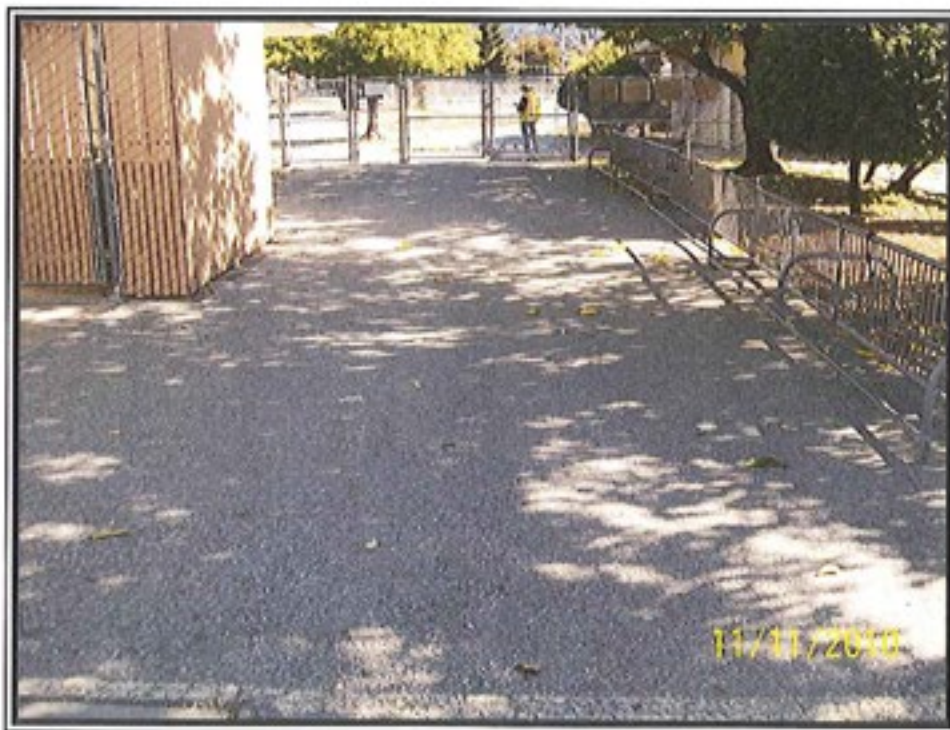
PIEDMONT MIDDLE SCHOOL - AREA B

Defect Score: 10

Recommended Treatment: Double application Emulsion Seal Coat

Visual Description: Pavement exhibits slight raveling and is in good condition with a couple of small areas with tree roots and one bird bath (8x12).

Miscellaneous: Slope = 0.9/ 2.7, AC at southwest is high, causing a trip/ fall hazard.

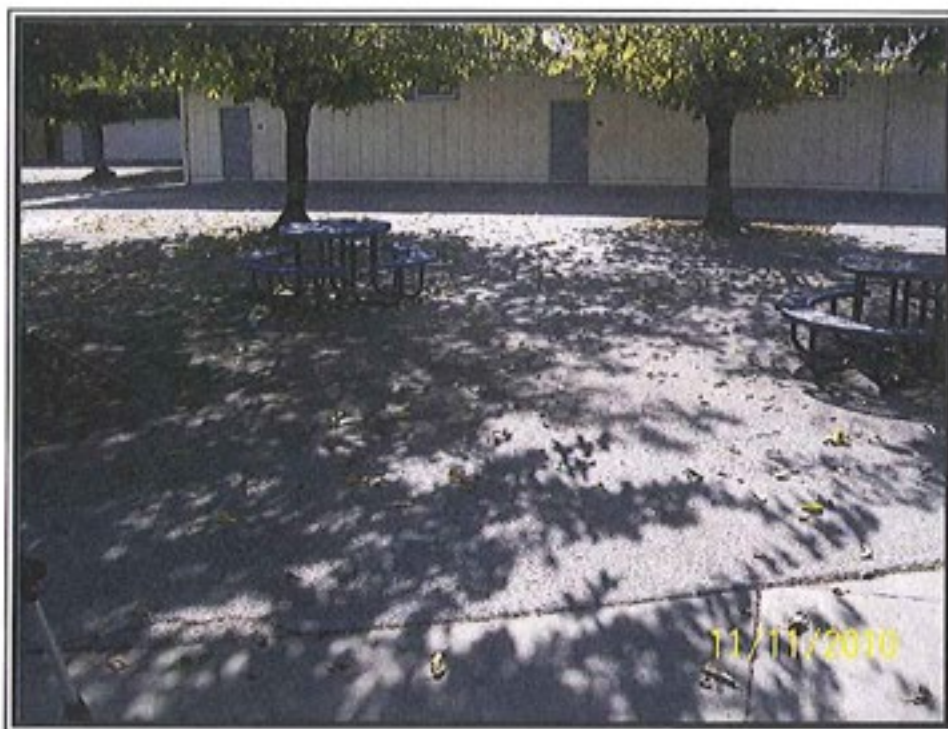
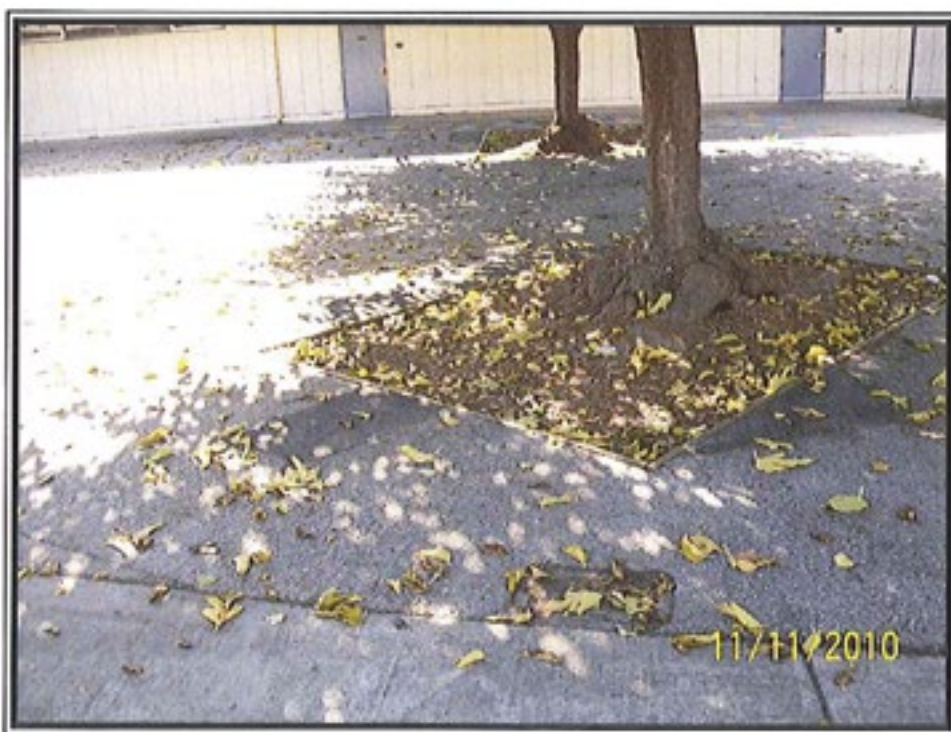
PIEDMONT MIDDLE SCHOOL - AREA C

School Name:	Piedmont Middle School	Area (sf):	5,334
Area Notation:	C	Buses:	No
Surface Type:	AC	Garbage Trucks:	No
Use:	Pedestrian Areas		
Defect Score:	74		
Recommended Treatment:	Remove & Replace		
Year:	2011		
Visual Description:	Pavement exhibits severe raveling and severe shrinkage cracking.		
Miscellaneous:	Slope= 1.1/ 3.8, Pavement drains to a 9" drop inlet that does not appear to drain, AC surrounding southwest is lifted, causing trip/ fall hazard, severe tree root damage.

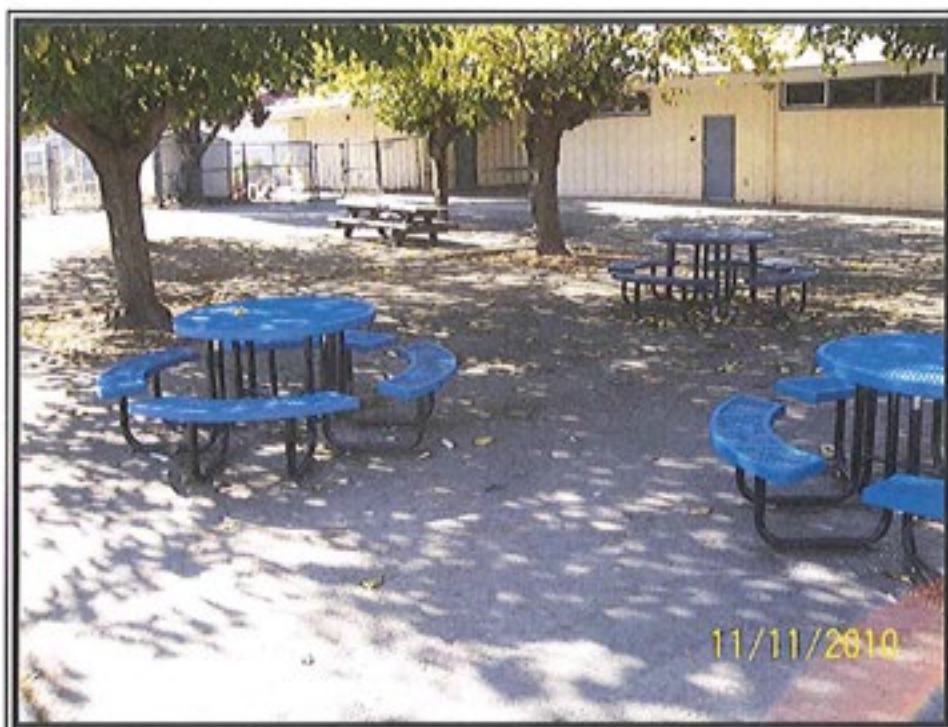
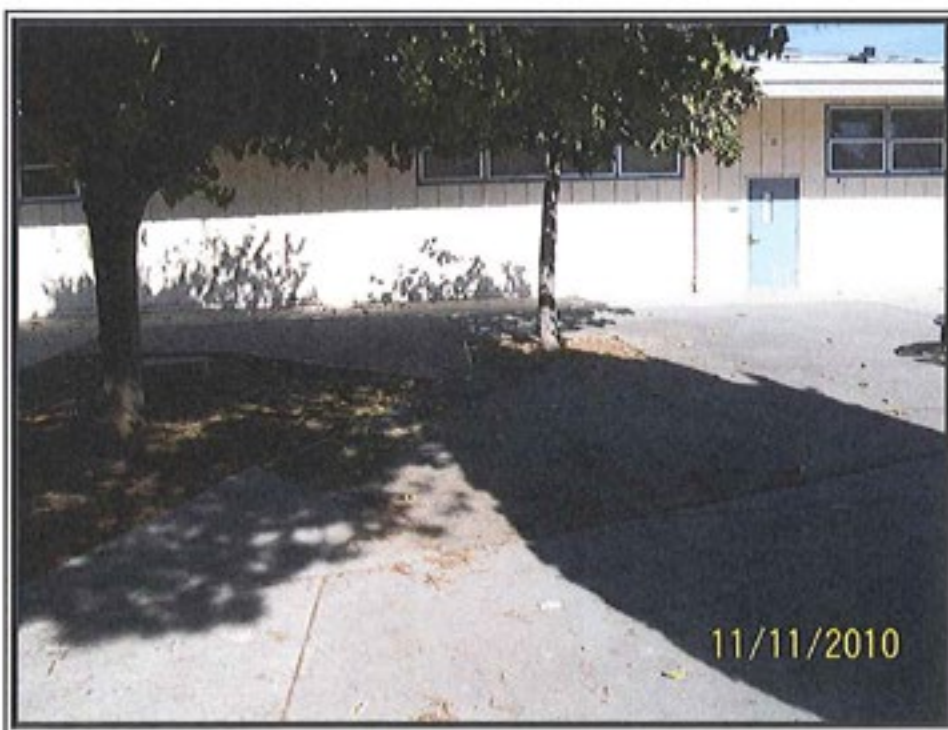
PIEDMONT MIDDLE SCHOOL - AREA D

School Name: Piedmont Middle School **Area (sf):** 6,432
Area Notation: D **Buses:** No
Surface Type: AC **Garbage Trucks:** No
Use: Pedestrian Areas
Defect Score: 23
Recommended Treatment: Crack Fill and Seal Coat
Year: 2011
Visual Description: Pavement exhibits moderate raveling and slight shrinkage cracking.
Miscellaneous: Slope = 1.5/ 5.7, Pavement drains to drop inlet and appears to be functioning properly.

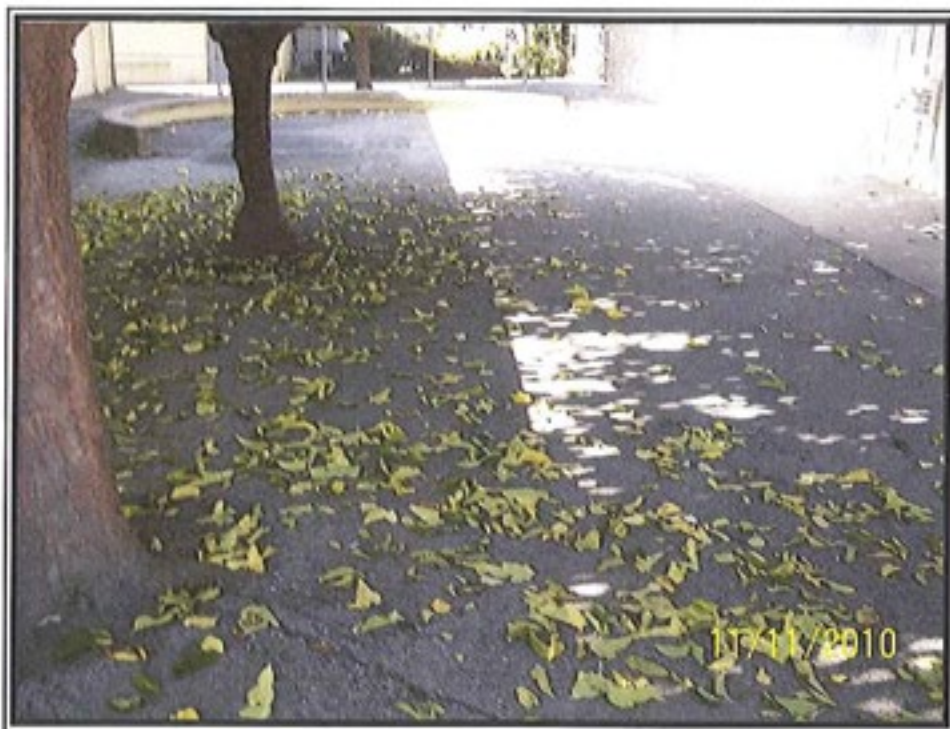
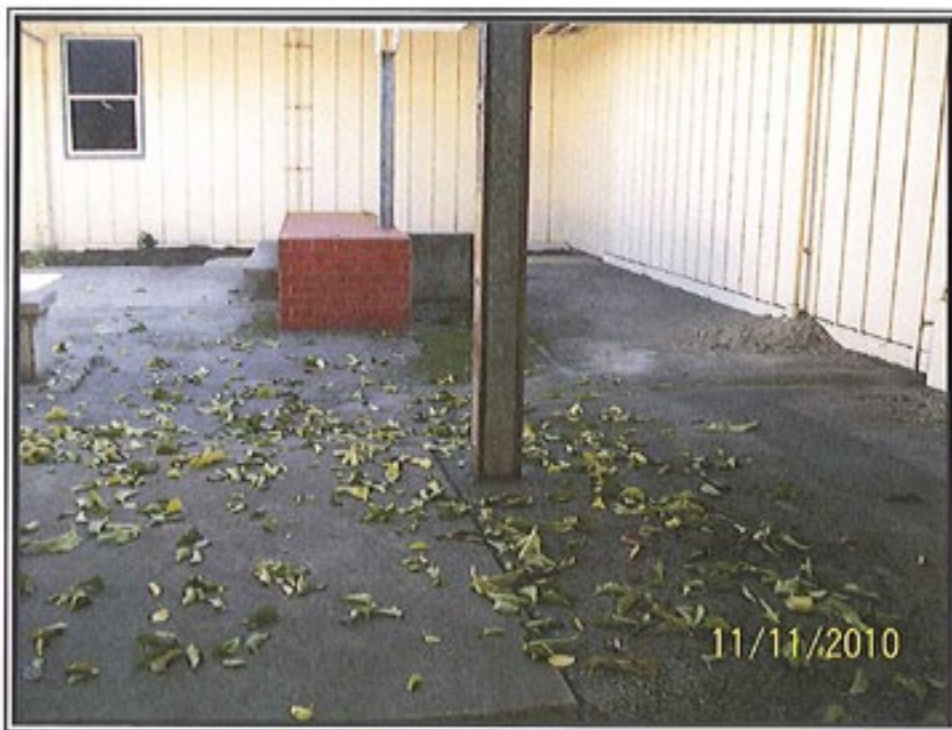
PIEDMONT MIDDLE SCHOOL - AREA E

School Name:	Piedmont Middle School	Area (sf):	3,583
Area Notation:	E	Buses:	No
Surface Type:	AC	Garbage Trucks:	No
Use:	Pedestrian Areas		
Defect Score:	33		
Recommended Treatment:	Dig out/ Crack Fill/ Seal Coat		
Year:	2011		
Visual Description:	Pavement exhibits severe raveling and slight shrinkage cracking.		
Miscellaneous:	Slope = 1.2/ 2.9, Pavement drains to drop inlet located within the area, severe tree root damage is evident.
