Berryessa Union School District Facilities Needs and Assessment Study

Prepared For
Berryessa Union School District

In April of 2013, Berryessa Union School District requested that Sugimura Finney Architects prepare a District-wide survey to assess the current status of the District's facilities, and to help guide upcoming decisions related to facility utilization and improvement.

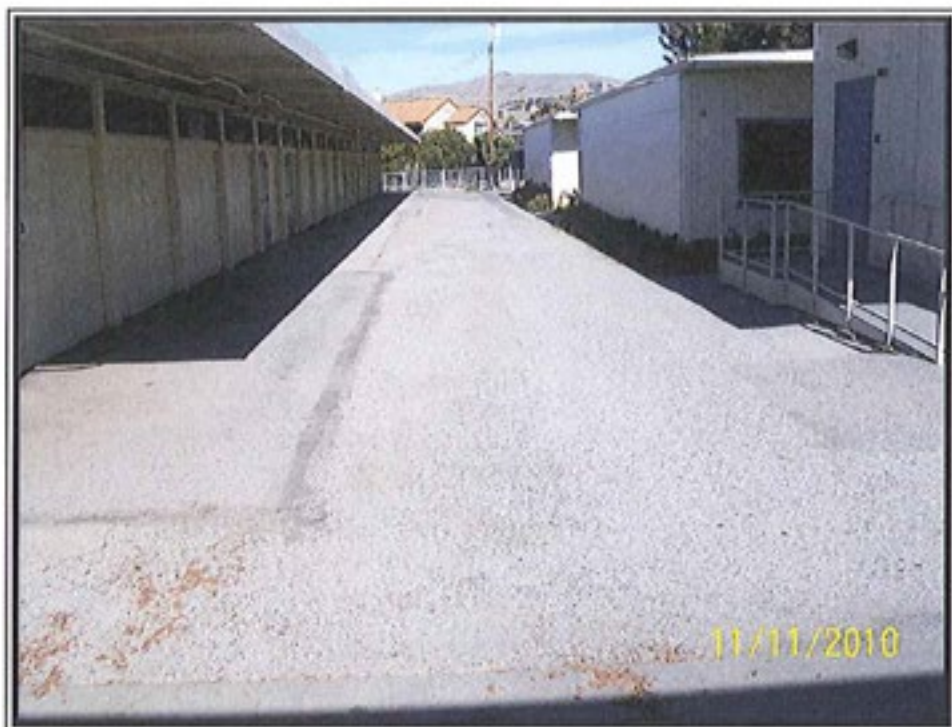
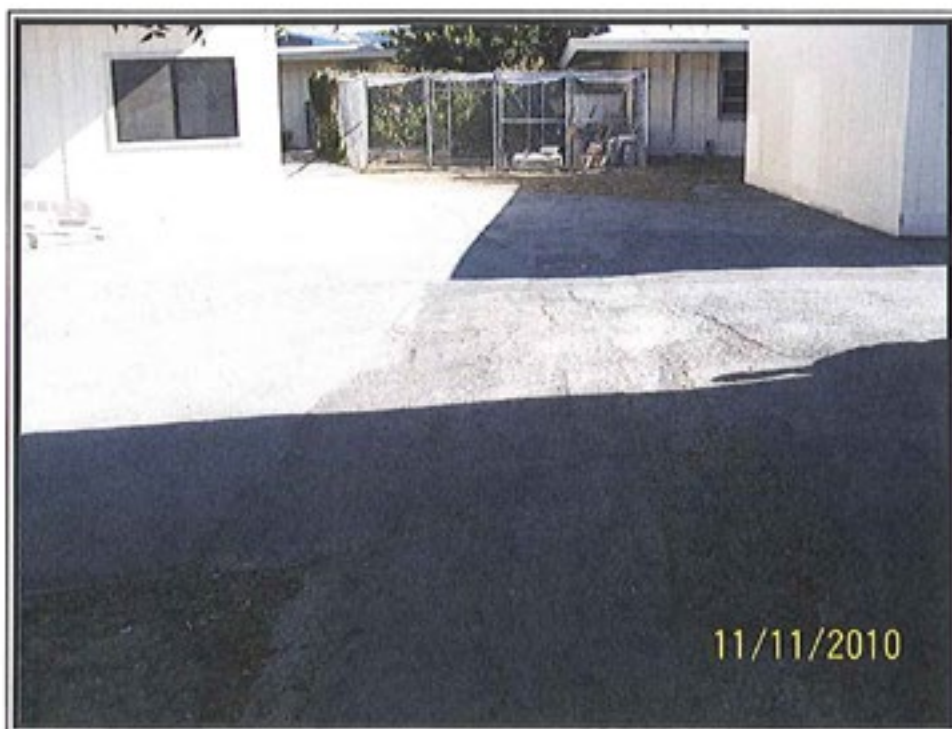
PIEDMONT MIDDLE SCHOOL - AREA F

School Name: Piedmont Middle School **Area (sf):** 8,481
Area Notation: F **Buses:** No
Surface Type: AC **Garbage Trucks:** No
Use: Pedestrian Areas
Defect Score: 39
Recommended Treatment: Dig out/ Crack Fill/ Seal Coat
Year: 2011
Visual Description: Pavement exhibits moderate to severe raveling, previously sealed.
Miscellaneous: Slope = 1.0/ 6.6 (11.2), Pavement flows to drop inlets located within the area.

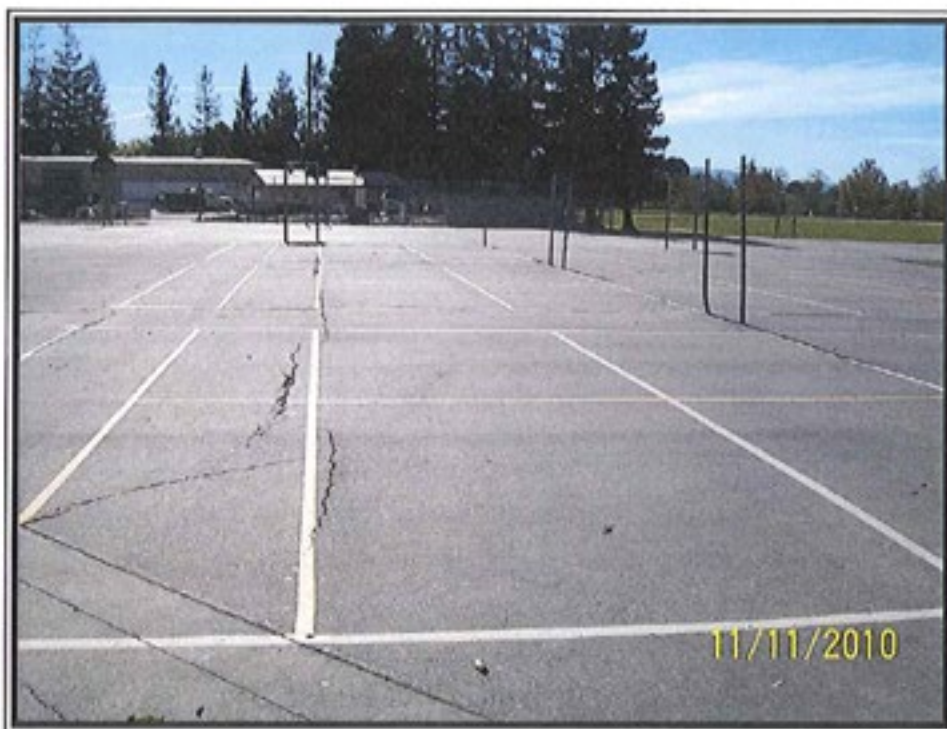
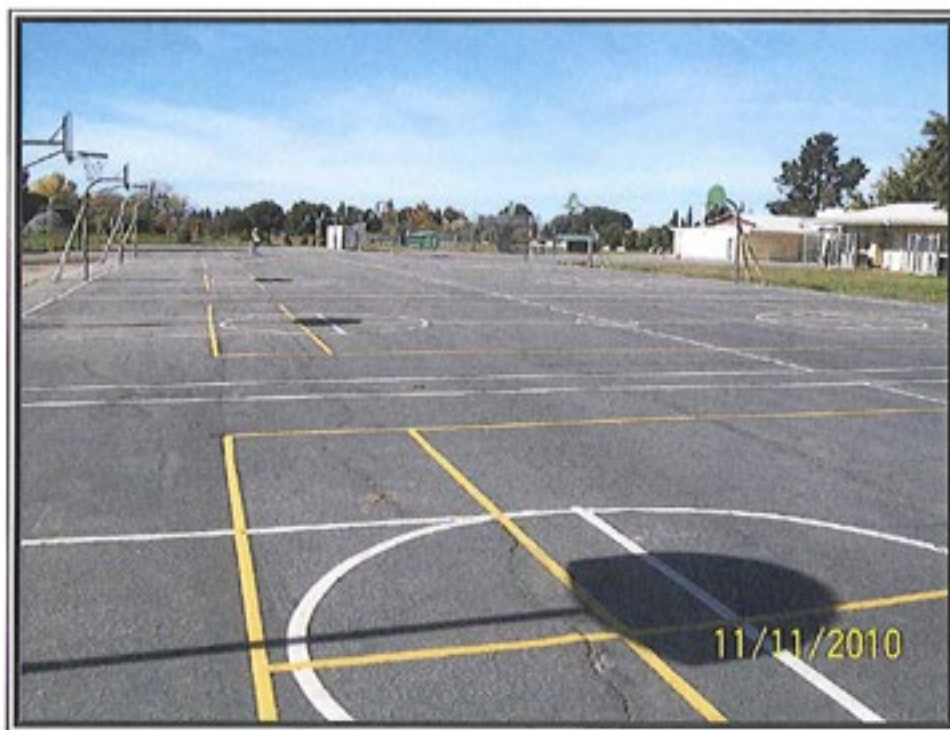
PIEDMONT MIDDLE SCHOOL - AREA G

School Name:	Piedmont Middle School	Area (sf):	50,196
Area Notation:	G	Buses:	No
Surface Type:	AC	Garbage Trucks:	No
Use:	Playground		
Defect Score:	37		
Recommended Treatment:	Dig out/ Crack Fill/ Seal Coat		
Year:	2011		
Visual Description:	Pavement exhibits slight raveling, previously sealed (approximately 3 years old), pavement failing adjacent to field (BOUND)		
Miscellaneous:	Slope = 0.5/ 1.4, Pavement sheet flows to lawn and field area.

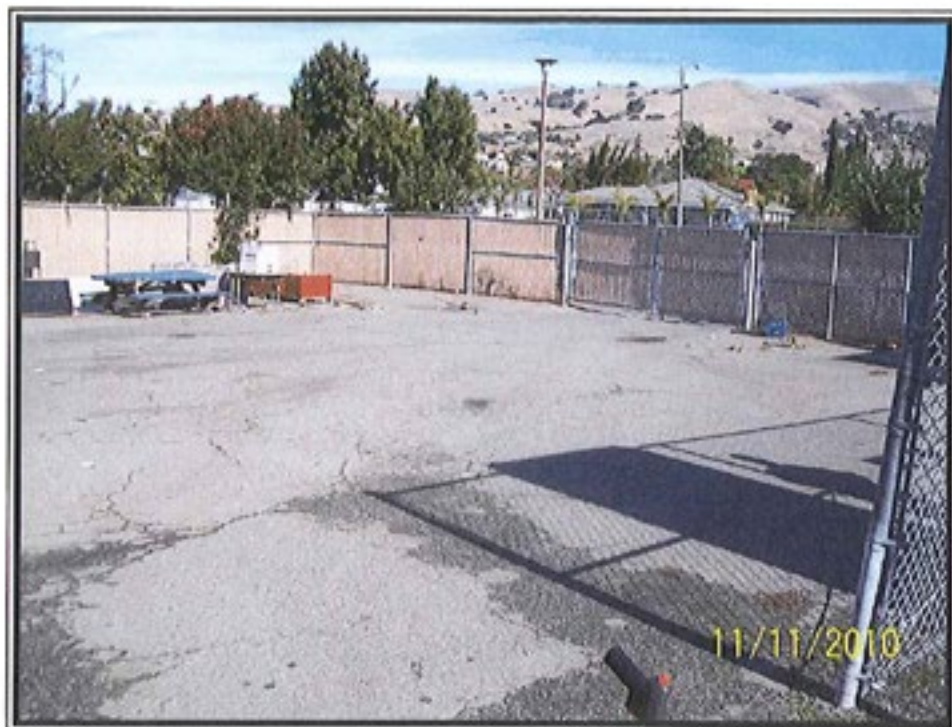
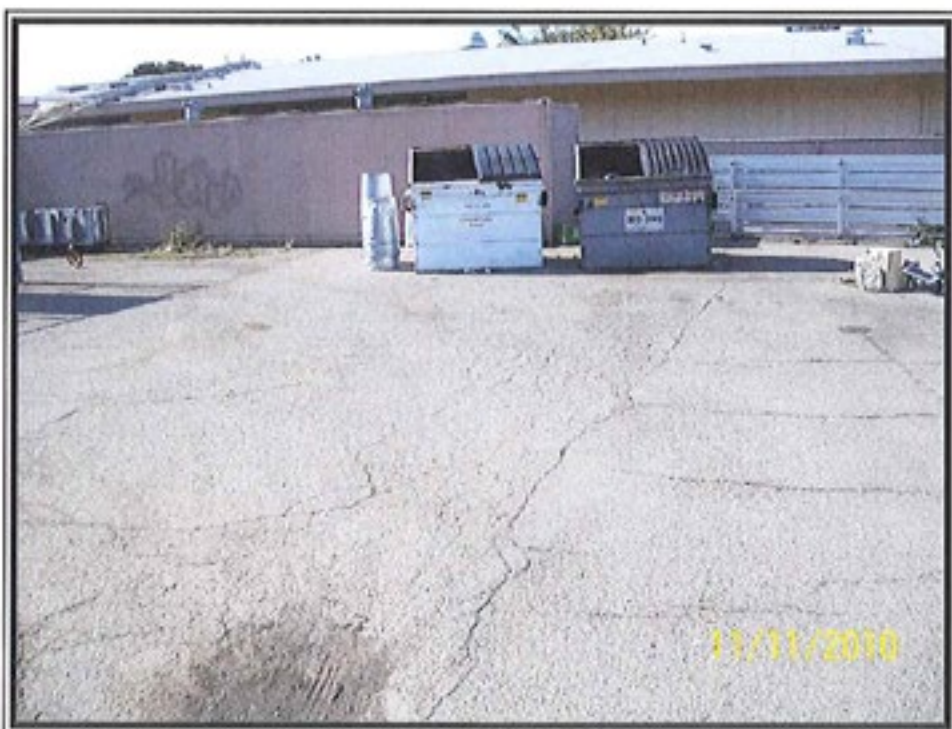
PIEDMONT MIDDLE SCHOOL - AREA H

School Name: Piedmont Middle School **Area (sf):** 6,750
Area Notation: H **Buses:** No
Surface Type: AC **Garbage Trucks:** Yes
Use: Storage, Dumpster, etc.
Defect Score: 221
Recommended Treatment: Remove & Replace
Year: 2011
Visual Description: Pavement exhibits severe raveling, alligator cracking, and rutting from garbage trucks.
Miscellaneous: Slope = 1.3/ 4.1. Needs dumpster pad.

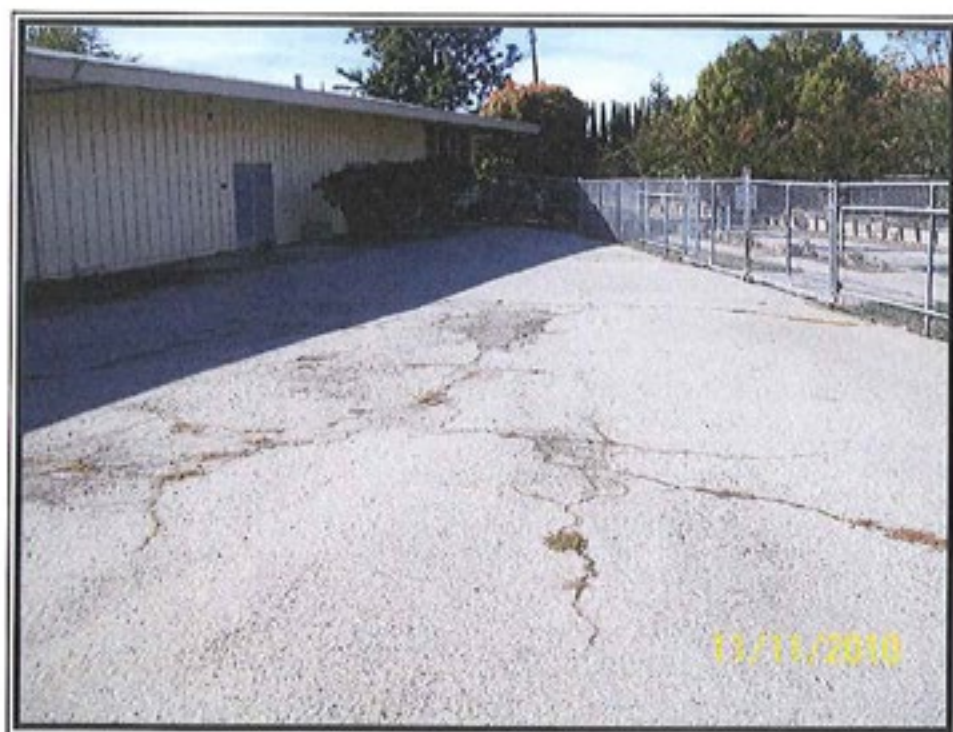
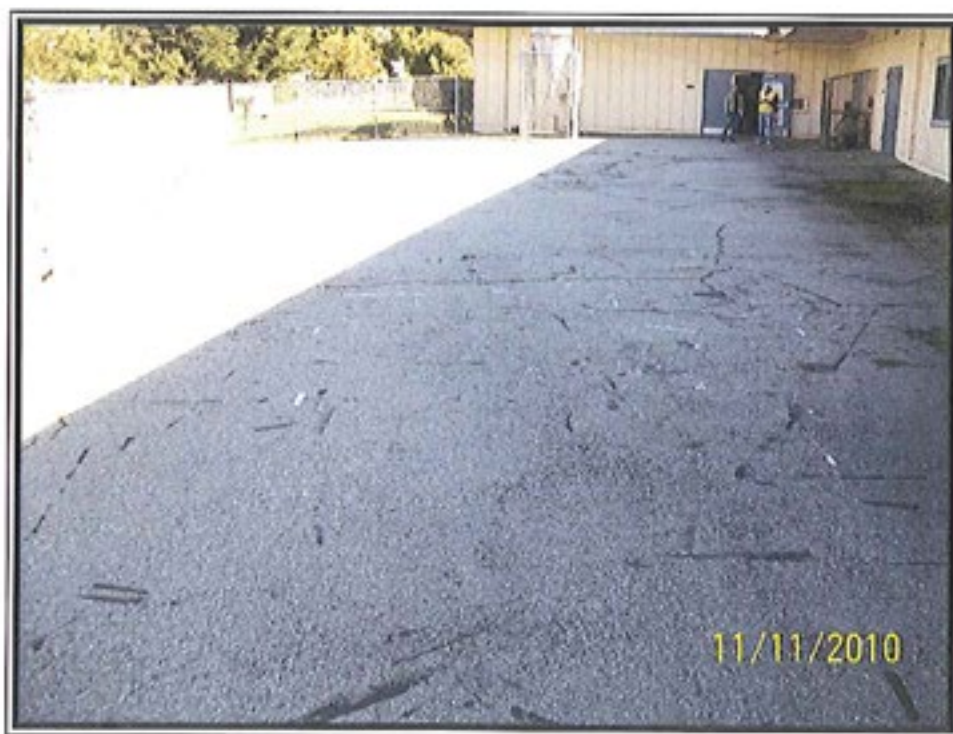
PIEDMONT MIDDLE SCHOOL - AREA I

School Name: Piedmont Middle School **Area (sf):** 4,900
Area Notation: I **Buses:** No
Surface Type: AC **Garbage Trucks:** No
Use: Parking Lots or Areas
Defect Score: 74
Recommended Treatment: Remove & Replace
Year: 2011
Visual Description: Pavement exhibits severe raveling and moderate alligator cracking with an area of base failure.
Miscellaneous: Slope = 2.4/ 6.2, Pavement drains to planter.

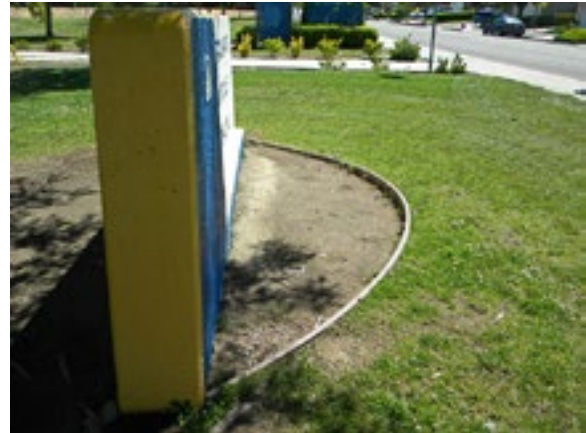
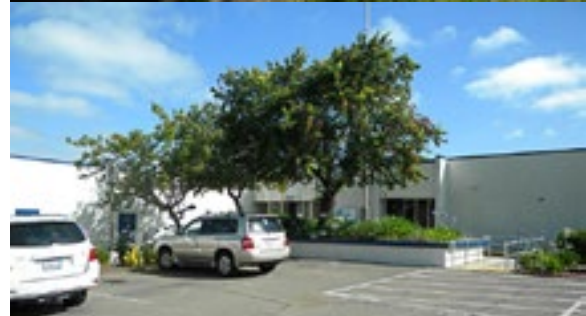
- While significant portions of this site have a perimeter fence in place, the site is largely open in the front.
- Building exterior lighting is insufficient.
- Existing doors often have windows in them.
- This site has many windows below door height.

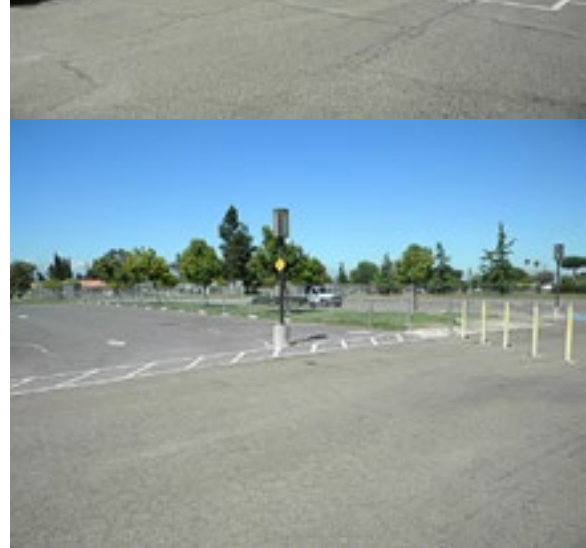
Parking lot and Drop-Off / Pick-Up:

- Circulation through the parking lot during pick-up and drop-off is inadequate, and creates problems with traffic congestion.
- Pick-up / Drop-off location sees considerable congestion during peak times, and does not allow traffic to flow through.
- Existing accessible parking does not meet current requirements.

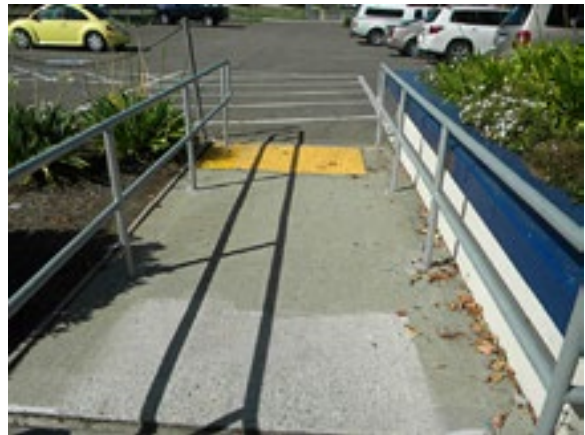
- General campus accessibility is good.
- Most door thresholds are too high to meet current accessibility requirements.
- Occasional areas of concrete or asphalt paving that have heaved or cracked cause accessibility issues.

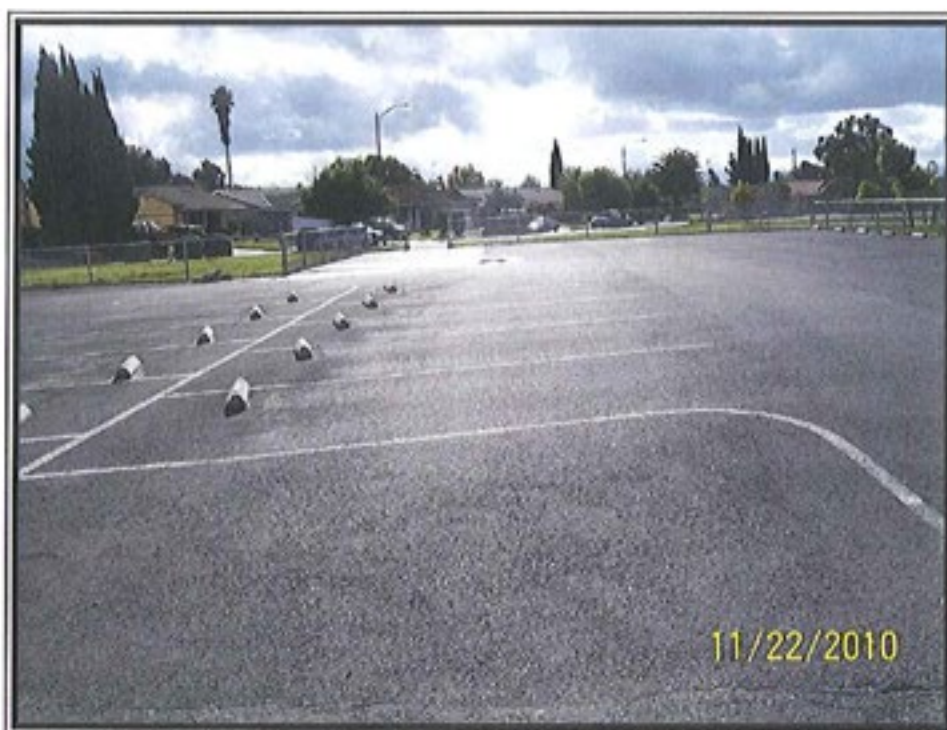
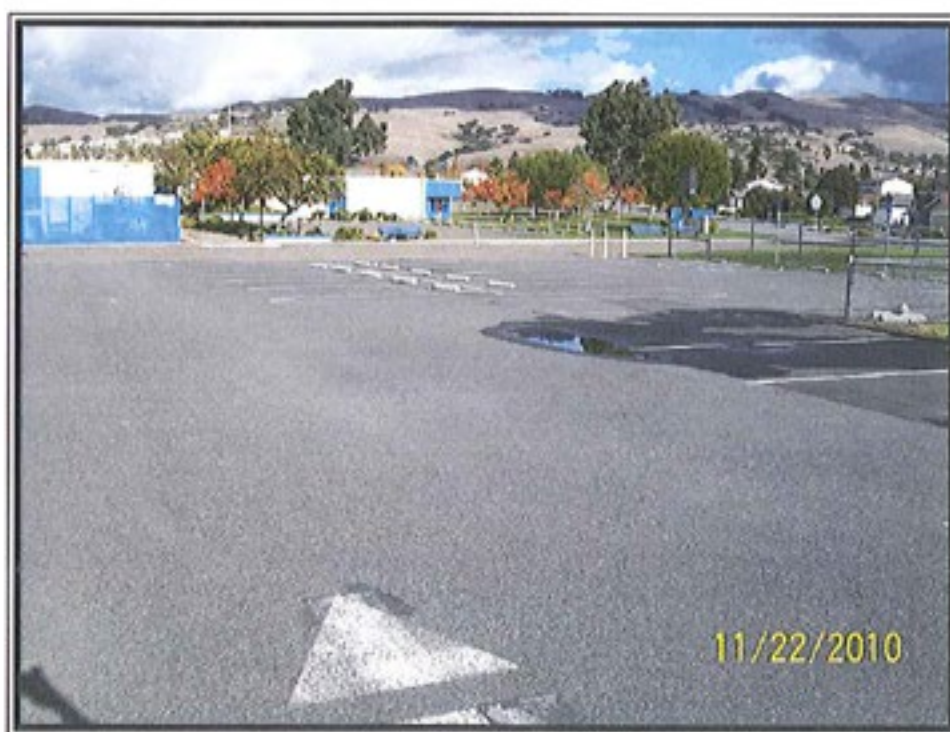
SIERRAMONT MIDDLE SCHOOL - AREA A

School Name:	Sierramont Middle School	Area (sf):	13,860
Area Notation:	A	Buses:	No
Surface Type:	AC	Garbage Trucks:	No
Use:	Parking Lots or Areas		
Defect Score:	18		
Recommended Treatment:	Crack Fill and Seal Coat		
Year:	2011		
Visual Description:	Pavement exhibits moderate raveling.		
Miscellaneous:	Slope = 1.1/ 0.7/ 4.5, Pavement drains to drop inlet and adjacent pavement area, areas of ponding are evident, ADA - 2.5% in stalls, no crosswalk to sidewalk.

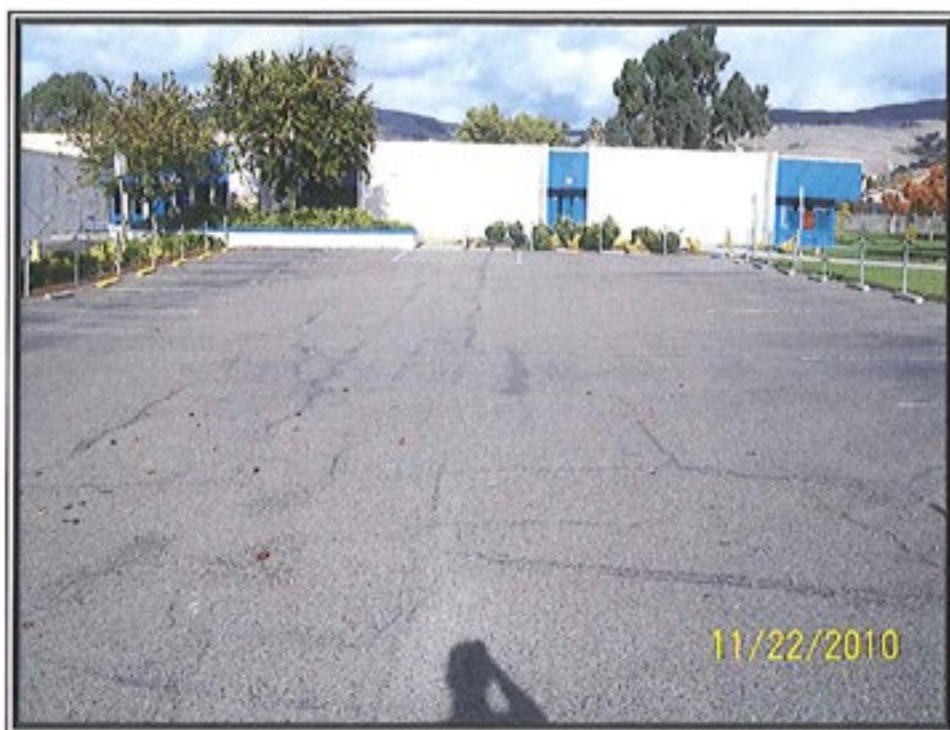
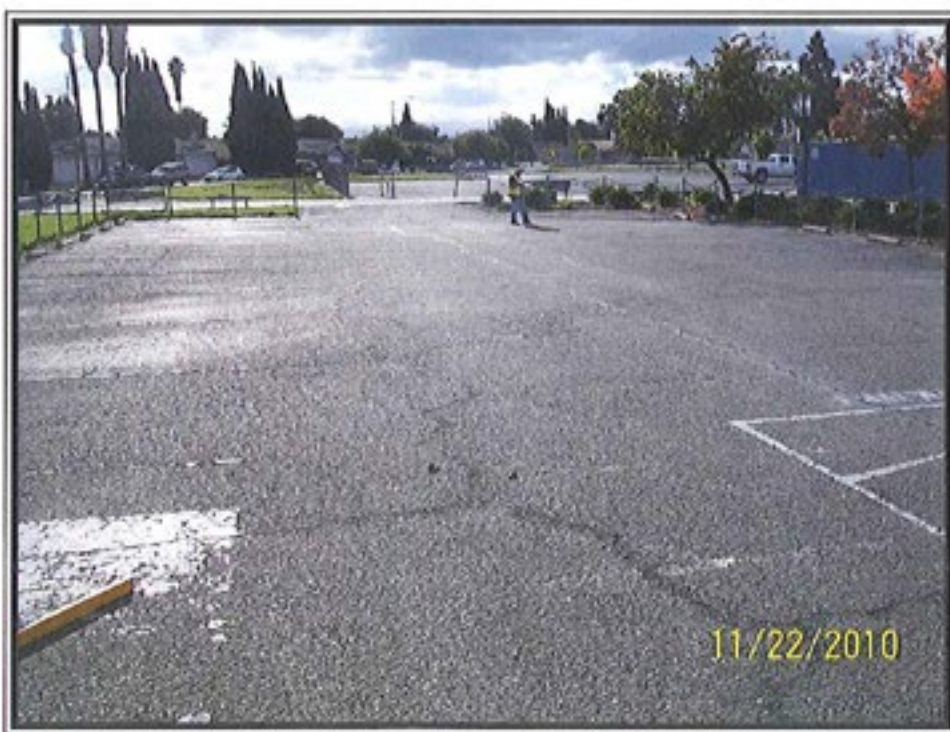
SIERRAMONT MIDDLE SCHOOL - AREA B

Defect Score: 81

Visual Description: Pavement exhibits severe raveling and shrinkage cracking.

Recommended Treatment: 1/2" level, fabric, & 1.5" overlay

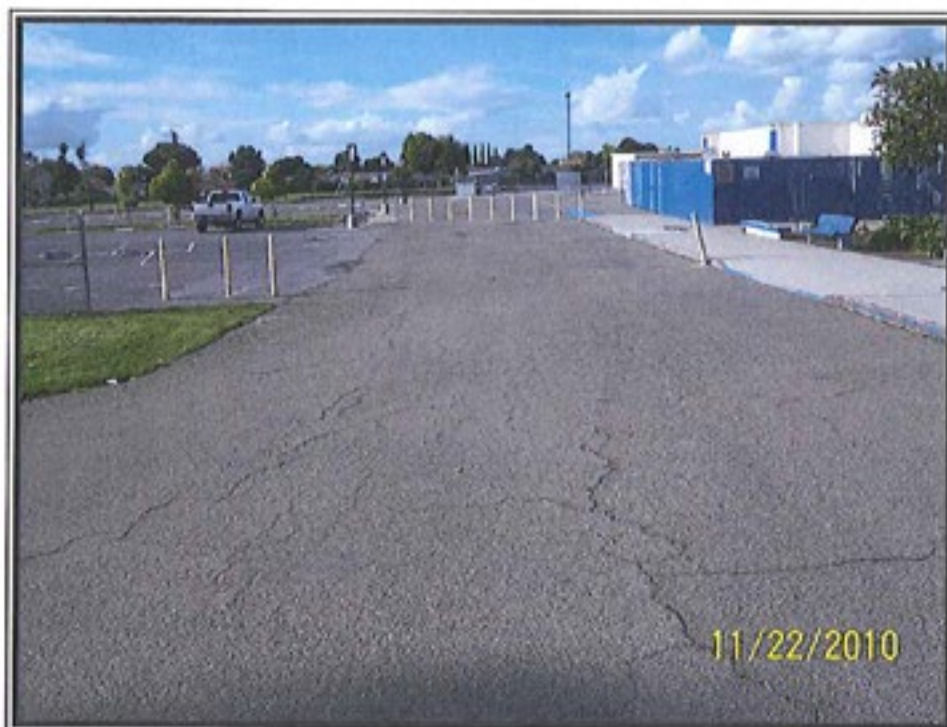
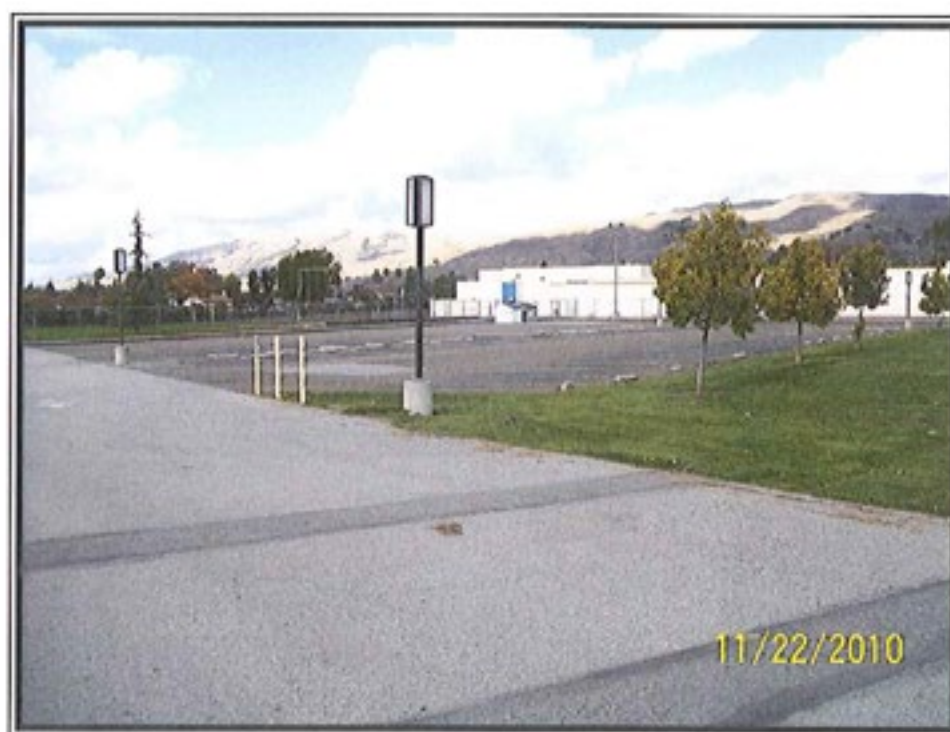
SIERRAMONT MIDDLE SCHOOL - AREA C

School Name:	Sierramont Middle School	Area (sf):	34,712	
Area Notation:	C	Buses:	Yes	
Surface Type:	AC	Garbage Trucks:	Yes	
Use:	Parking Lots or Areas			
Defect Score:	236			
Recommended Treatment:	Remove & Replace			
Year:	2011			
Visual Description:	Pavement exhibits severe raveling with areas of severe alligator cracking and severe shrinkage cracking.			
Miscellaneous:	Slope = 3.4/ 4.2/ 0.5, Pavement drains to drop inlets located within the pavement area, ponding observed, need sumpster pad, west driveway previous maintenance includes and overlay, ADA - no crosswalk to building, needs new signage			
Misc. AC Fill	Base Failure (%)	Alligator Cracking (%)	Crack Factor	Ravel
0	3%	15.0%	0.315	V
Crack Width		1/8 - 1/4"		
Cost Breakdown				
AC Cost:		\$173,560.00		
CF Cost:		\$0.00		
DO Cost:		\$0.00		
Misc. Cost:		\$0.00		
Total Cost:		\$173,560.00

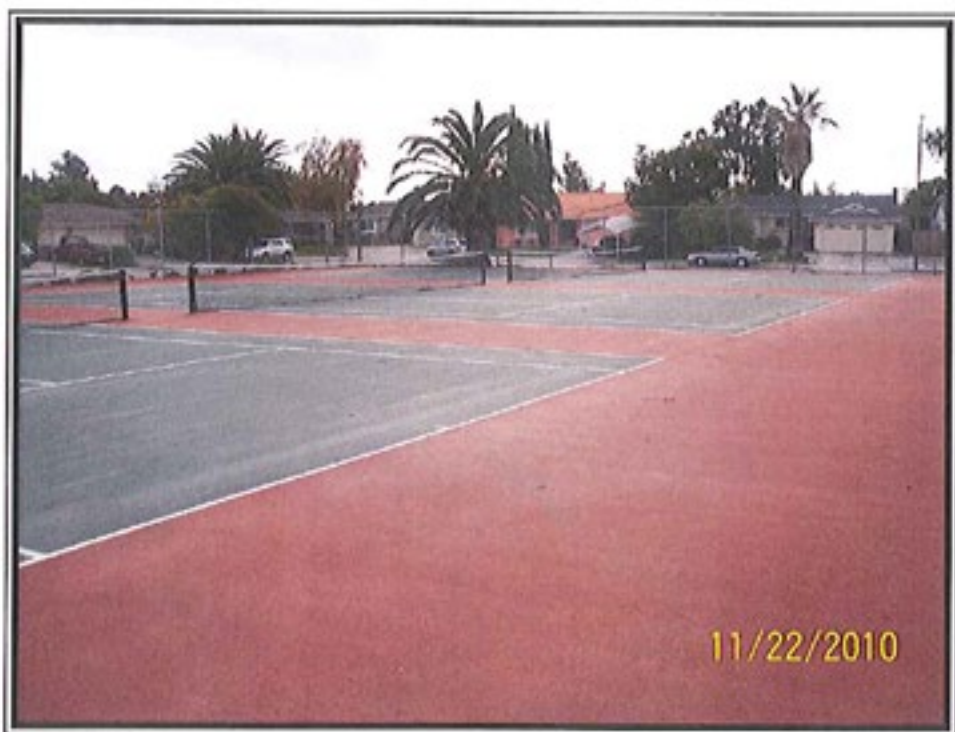
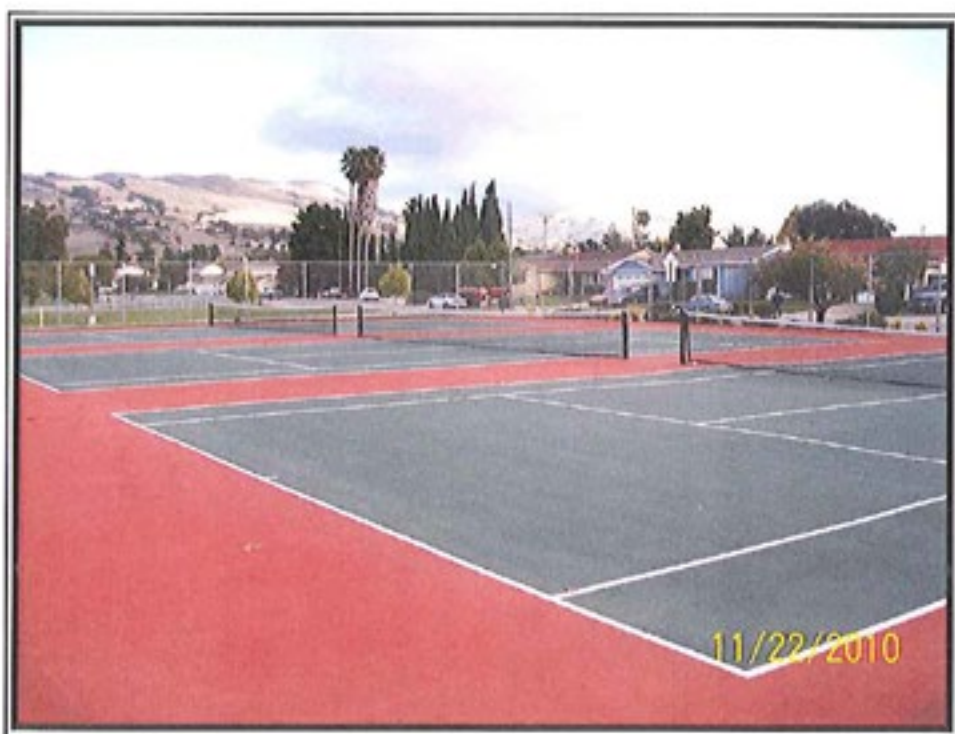
SIERRAMONT MIDDLE SCHOOL - AREA D

Defect Score: 16

Visual Description: Pavement exhibits expansion cracking at perimeter of tennis court area, acrylic seal is fairly new and in good condition.

Recommended Treatment: Reconstruct

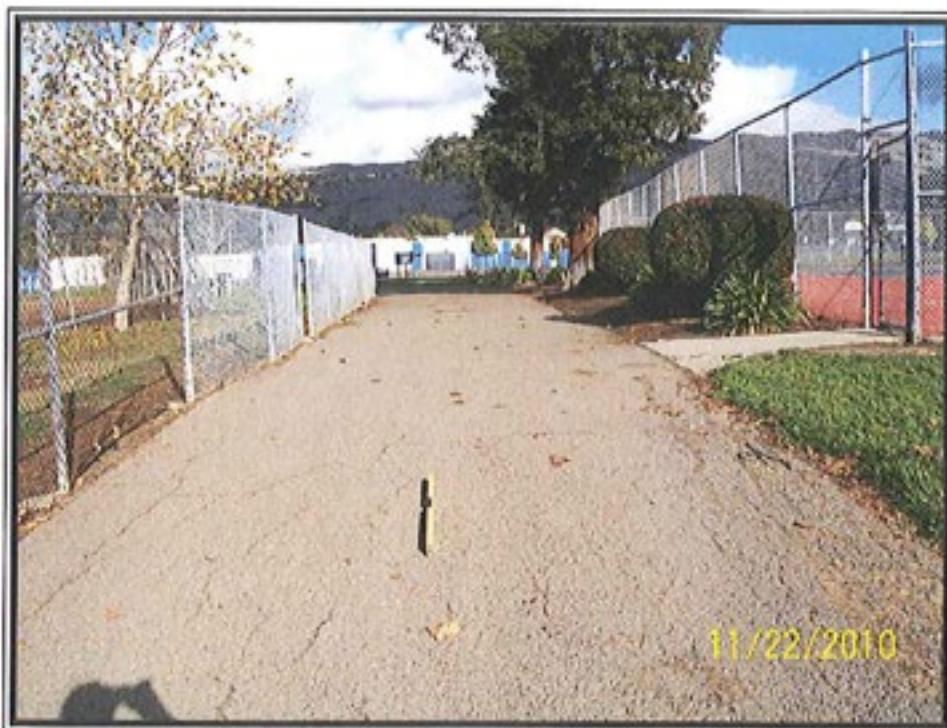
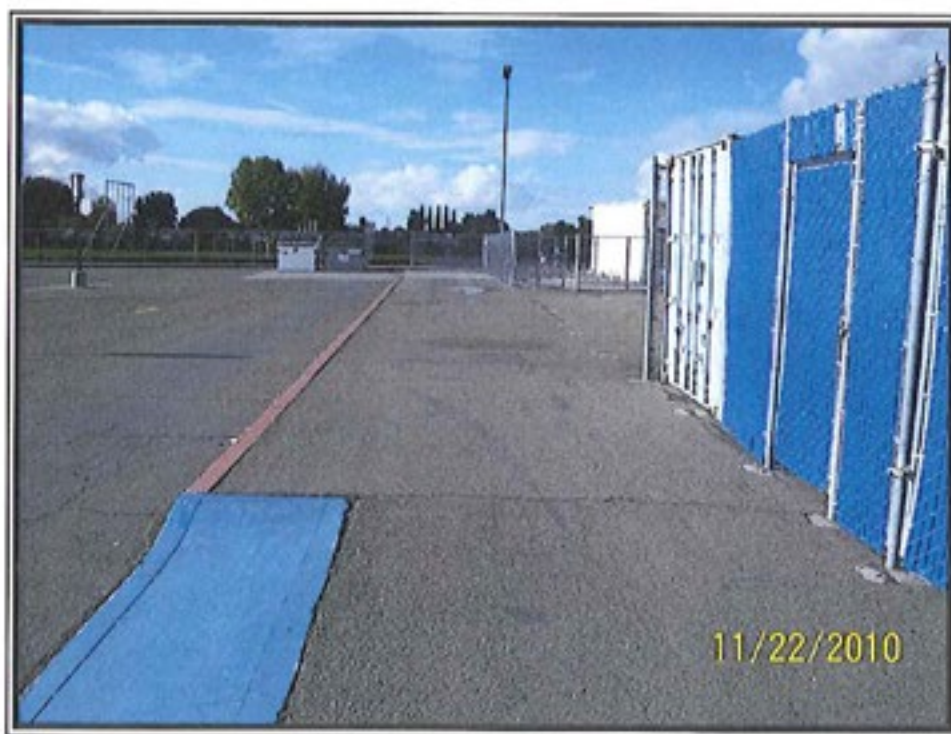
SIERRAMONT MIDDLE SCHOOL - AREA E

School Name: Sierramont Middle School **Area (sf):** 13,769
Area Notation: E **Buses:** No
Surface Type: AC **Garbage Trucks:** No
Use: Pedestrian Areas
Defect Score: 65
Recommended Treatment: Reconstruct
Year: 2013
Visual Description: Pavement exhibits severe raveling and expansion cracking along lawn edge.
Miscellaneous: Slope = 0.5/ 6.2, Pavement drains to lawn area.

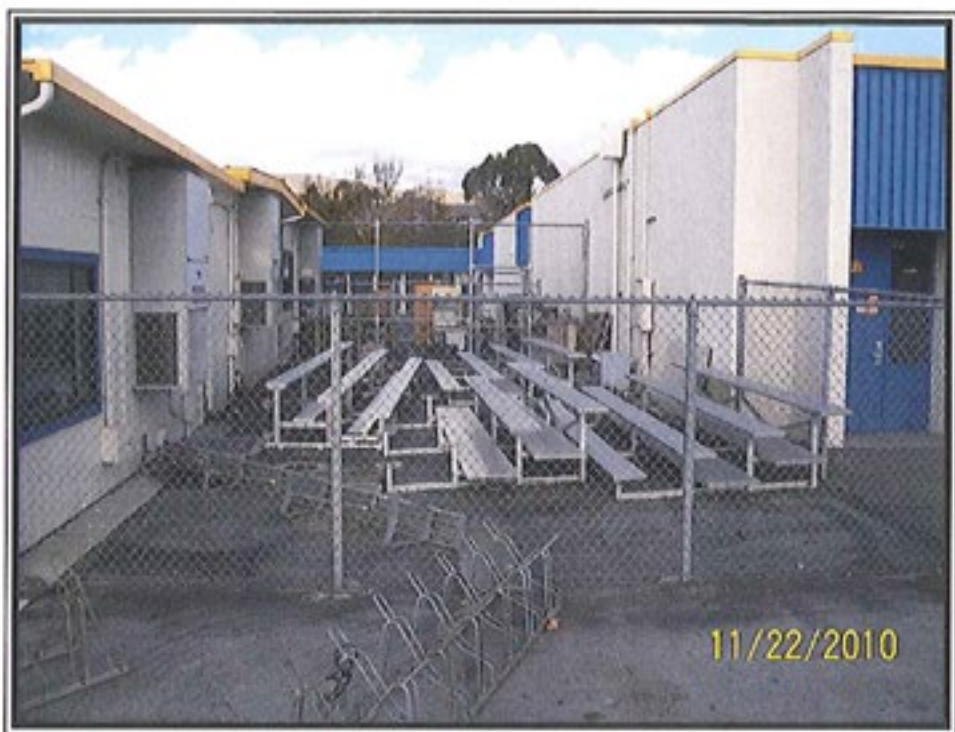
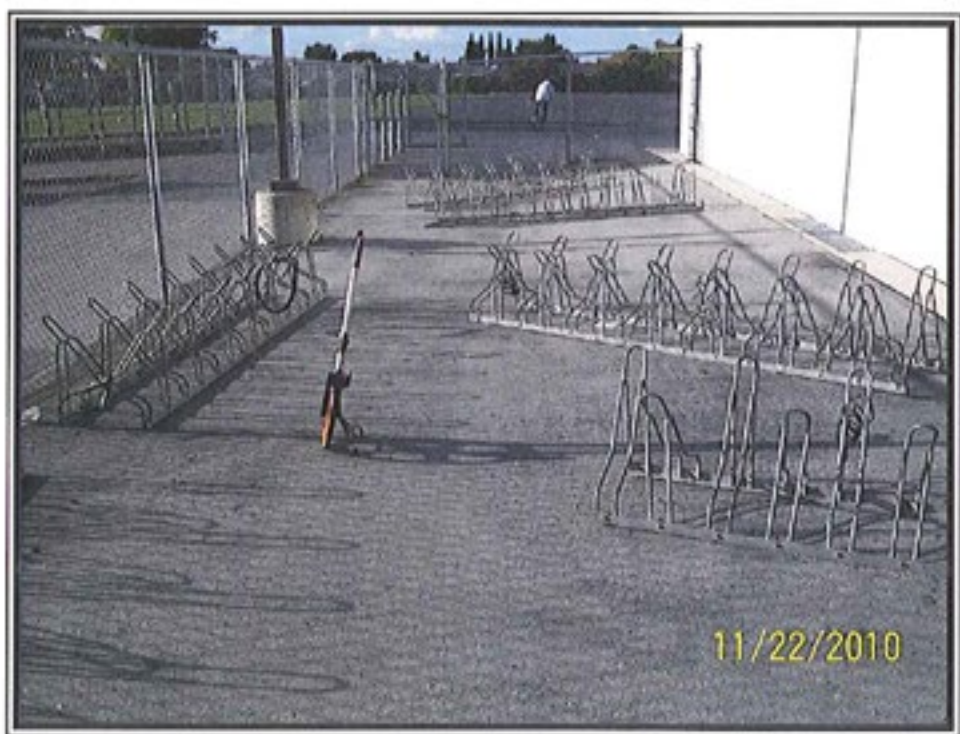
SIERRAMONT MIDDLE SCHOOL - AREA F

Defect Score: 10

Visual Description: Pavement exhibits slight raveling, previously sealed, in good condition.

Recommended Treatment: Crack Fill and Seal Coat

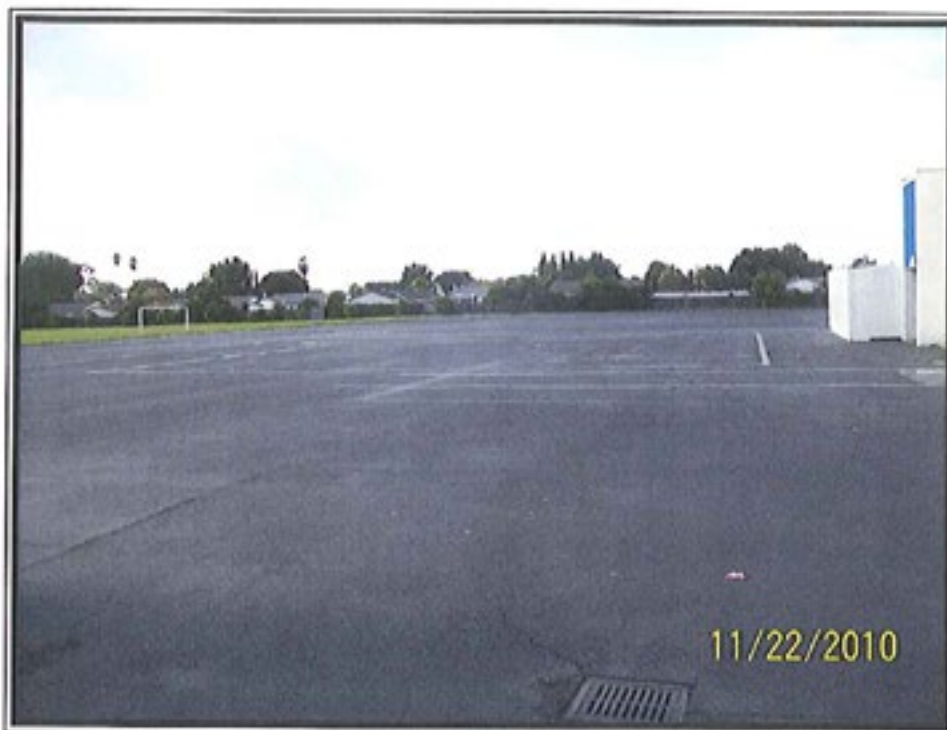
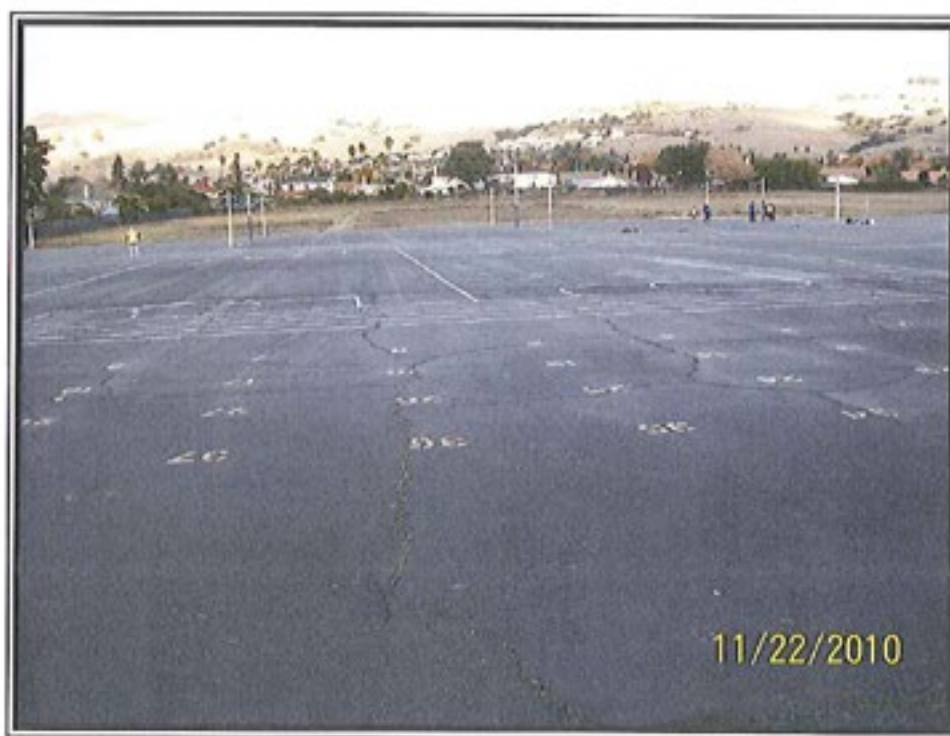
SIERRAMONT MIDDLE SCHOOL - AREA G

School Name: Sierramont Middle School **Area (sf):** 145,564
Area Notation: G **Buses:** No
Surface Type: AC **Garbage Trucks:** No
Use: Playground
Defect Score: 85
Recommended Treatment: Reconstruct
Year: 2013
Visual Description: Pavement exhibits moderate raveling, recently sealed, in good condition, severe block shrinkage cracking.
Miscellaneous: Slope = 0.9/ 2.6/ 4.0/ 1.1/ 2.4/ 1.9/ 5.2, Pavement sheet flows to planters.

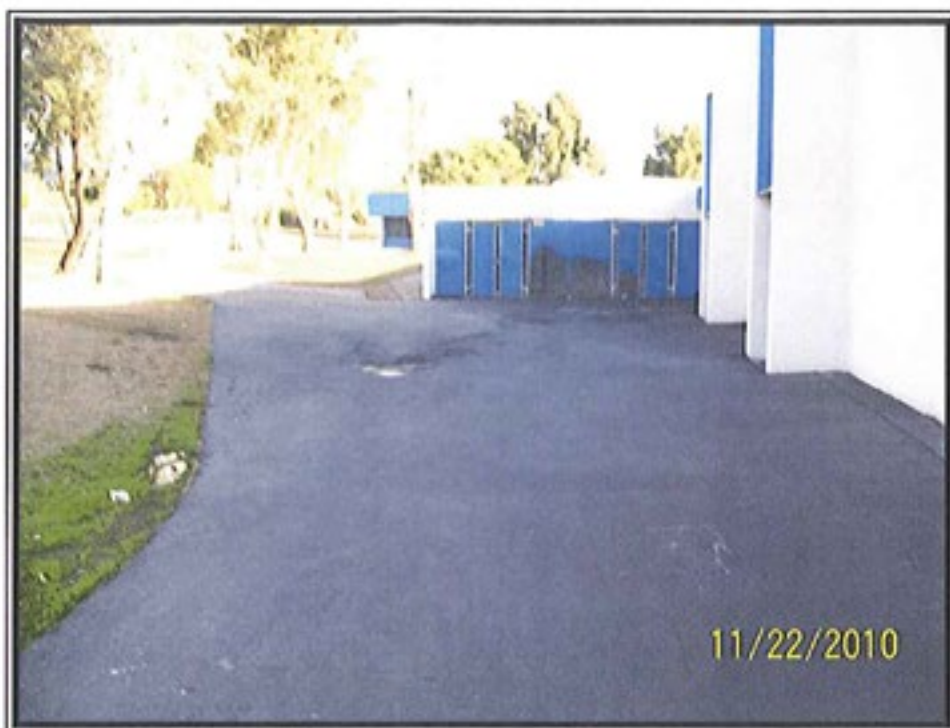
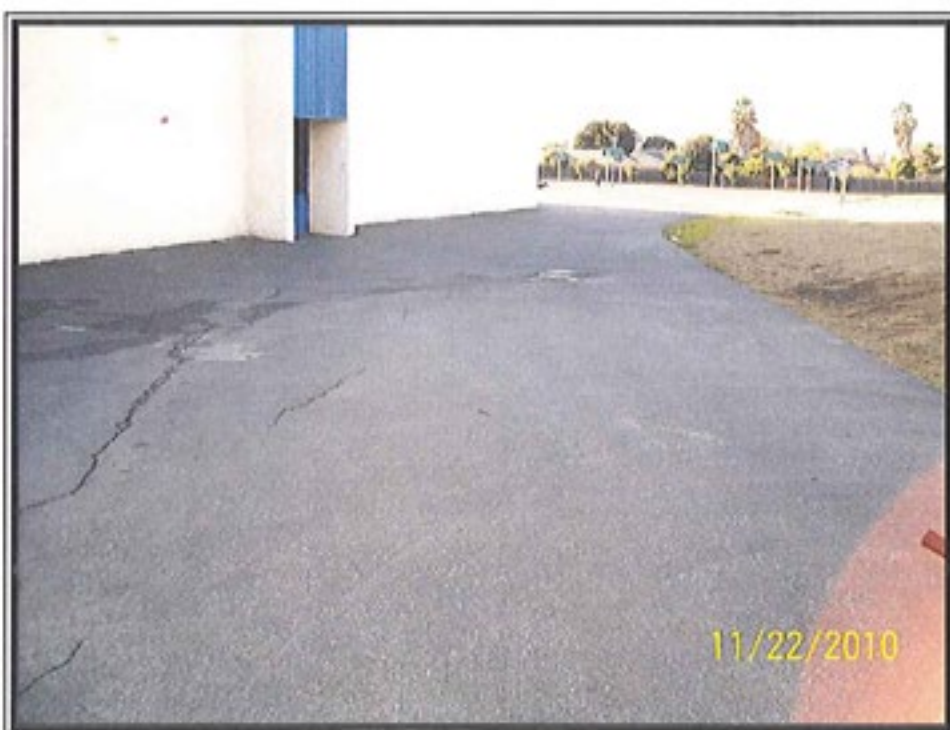
SIERRAMONT MIDDLE SCHOOL - AREA H

School Name: Sierramont Middle School **Area (sf):** 3,333
Area Notation: H **Buses:** No
Surface Type: AC **Garbage Trucks:** No
Use: Pedestrian Areas
Defect Score: 32
Recommended Treatment: Dig out/ Crack Fill/ Seal Coat
Year: 2013
Visual Description: Pavement exhibits moderate raveling with slight shrinkage cracking and one small area of alligator cracking, pavement around drain is failing
Miscellaneous: Slope = 3.0/ 4.4, Pavement drains to drop inlet in pavement area.

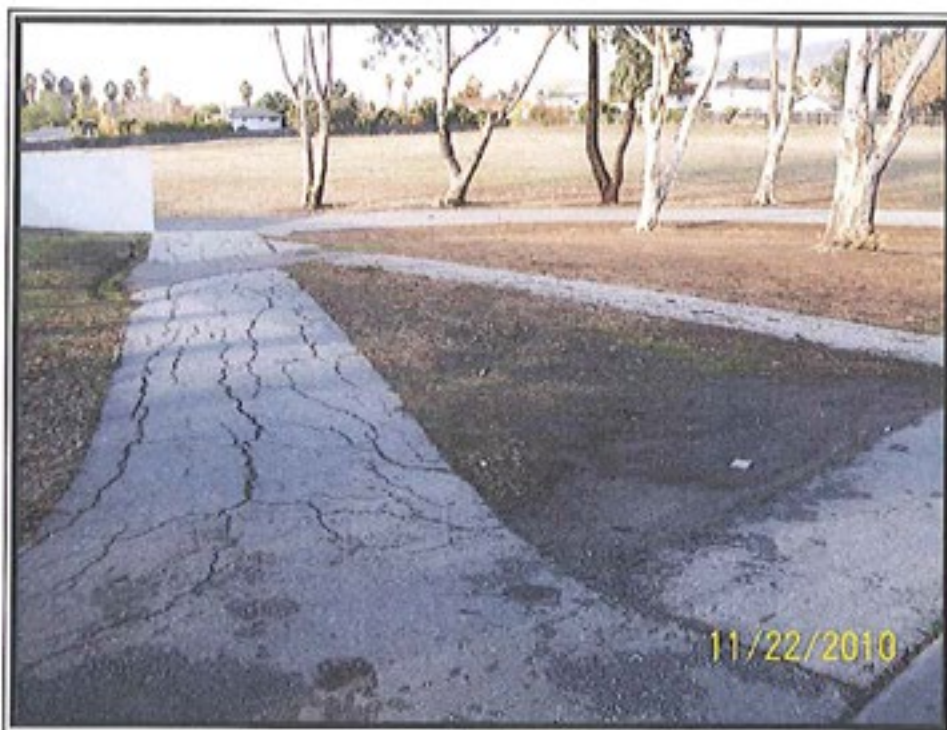
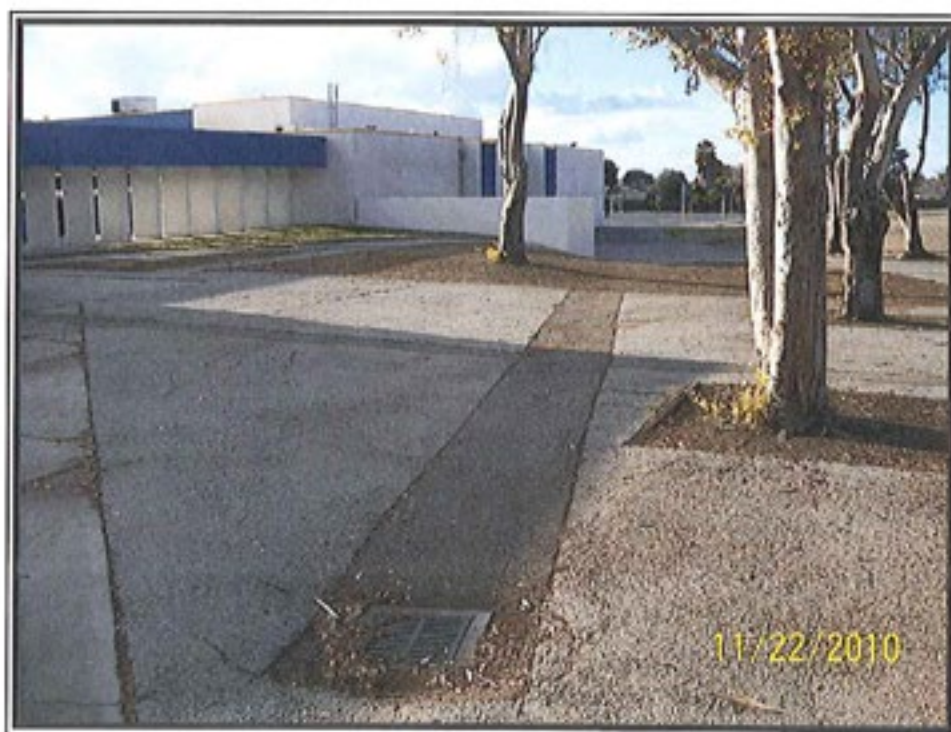
SIERRAMONT MIDDLE SCHOOL - AREA I

School Name:	Sierramont Middle School	Area (sf):	5,792
Area Notation:	I	Buses:	No
Surface Type:	AC	Garbage Trucks:	No
Use:	Pedestrian Areas		
Defect Score:	66		
Recommended Treatment:	Reconstruct		
Year:	2011		
Visual Description:	Pavement exhibits severe raveling and expansion cracking with numerous trenches.		
Miscellaneous:	Slope = 1.1/ 3.5/ 3.2, Pavement flows to drop inlets, planter, etc.

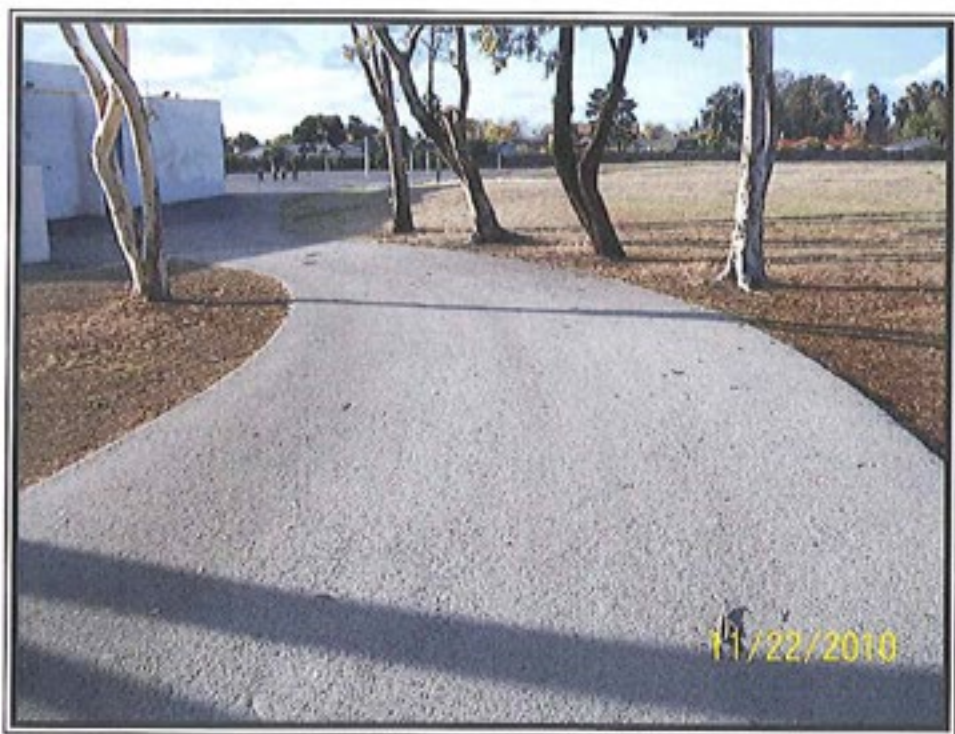
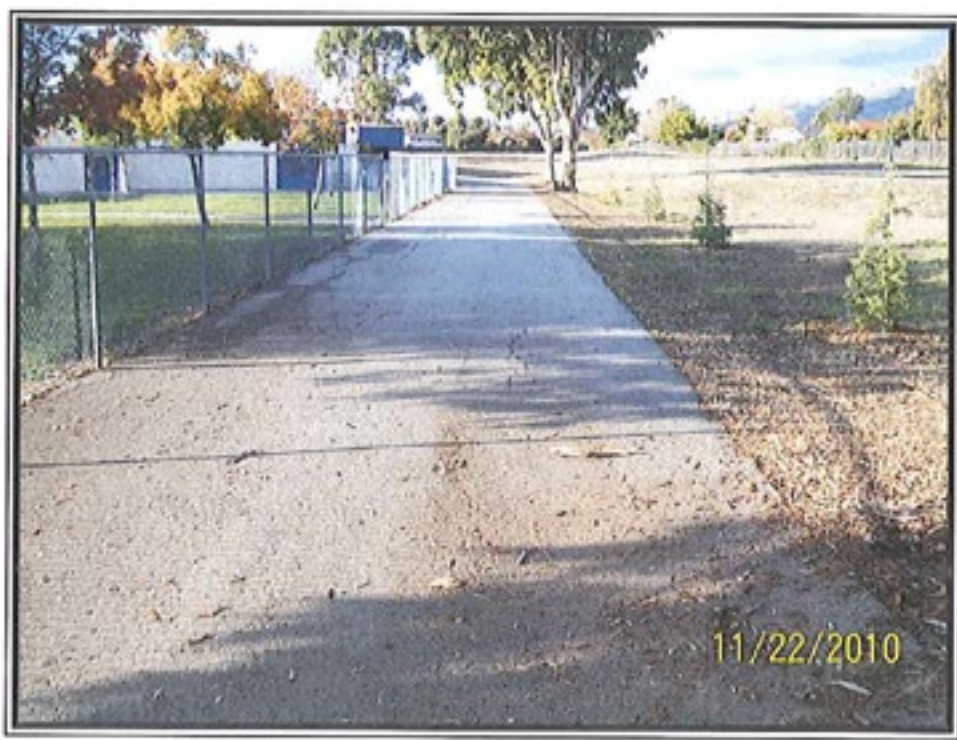
SIERRAMONT MIDDLE SCHOOL - AREA J

Defect Score: 26

Visual Description: Pavement exhibits moderate raveling with some tree root damage and expansion cracking adjacent to field.

Miscellaneous: Slope = 4.7/ 1.6/ 2.4/ 1.1, Pavement drains to adjacent field and planters, ponding observed.

Recommended Treatment: Dig out/ Crack Fill/ Seal Coat
