Berryessa Union School District Facilities Needs and Assessment Study

Prepared For
Berryessa Union School District

In April of 2013, Berryessa Union School District requested that Sugimura Finney Architects prepare a District-wide survey to assess the current status of the District's facilities, and to help guide upcoming decisions related to facility utilization and improvement.

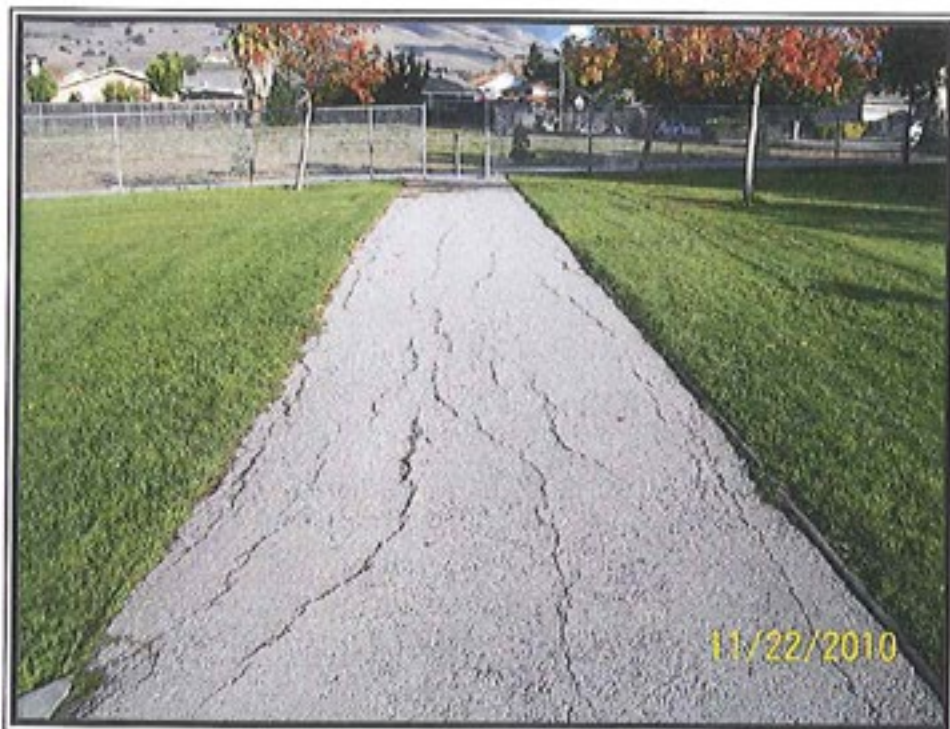
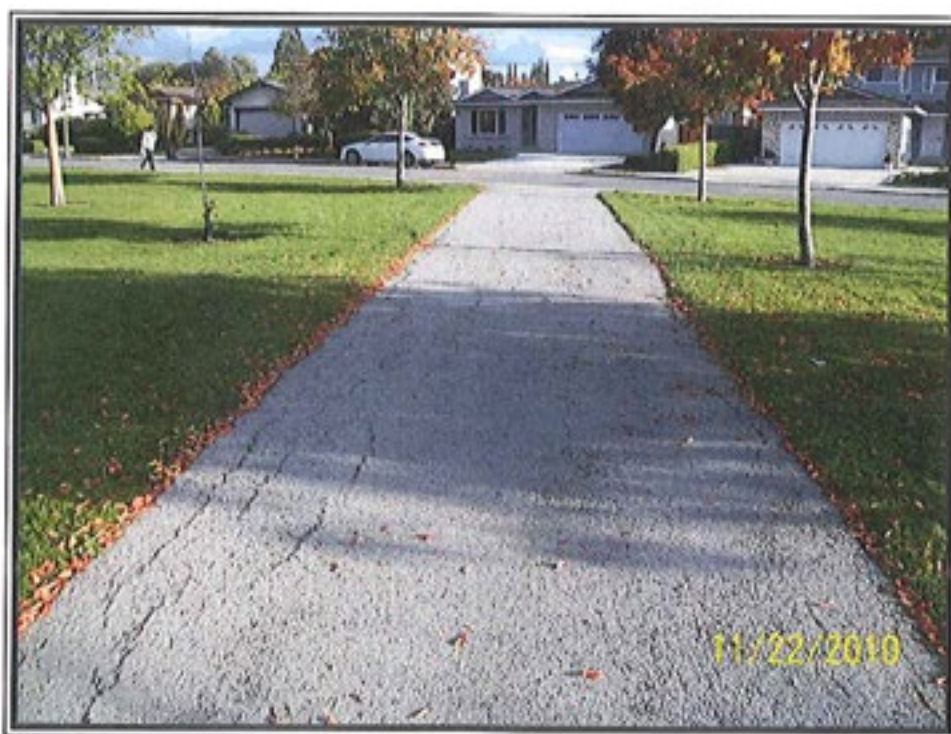
SIERRAMONT MIDDLE SCHOOL - AREA K

School Name: Sierramont Middle School **Area (sf):** 1,648
Area Notation: K **Buses:** No
Surface Type: AC **Garbage Trucks:** No
Use: Pedestrian Areas
Defect Score: 156
Recommended Treatment: Crack Fill and Seal Coat
Year: 2011
Visual Description: Pavement exhibits severe raveling and expansion cracking.
Miscellaneous: Slope = 1.7/ 5.1/ 2.1, Pavement drains to adjacent lawn and drop inlets in southwest area.

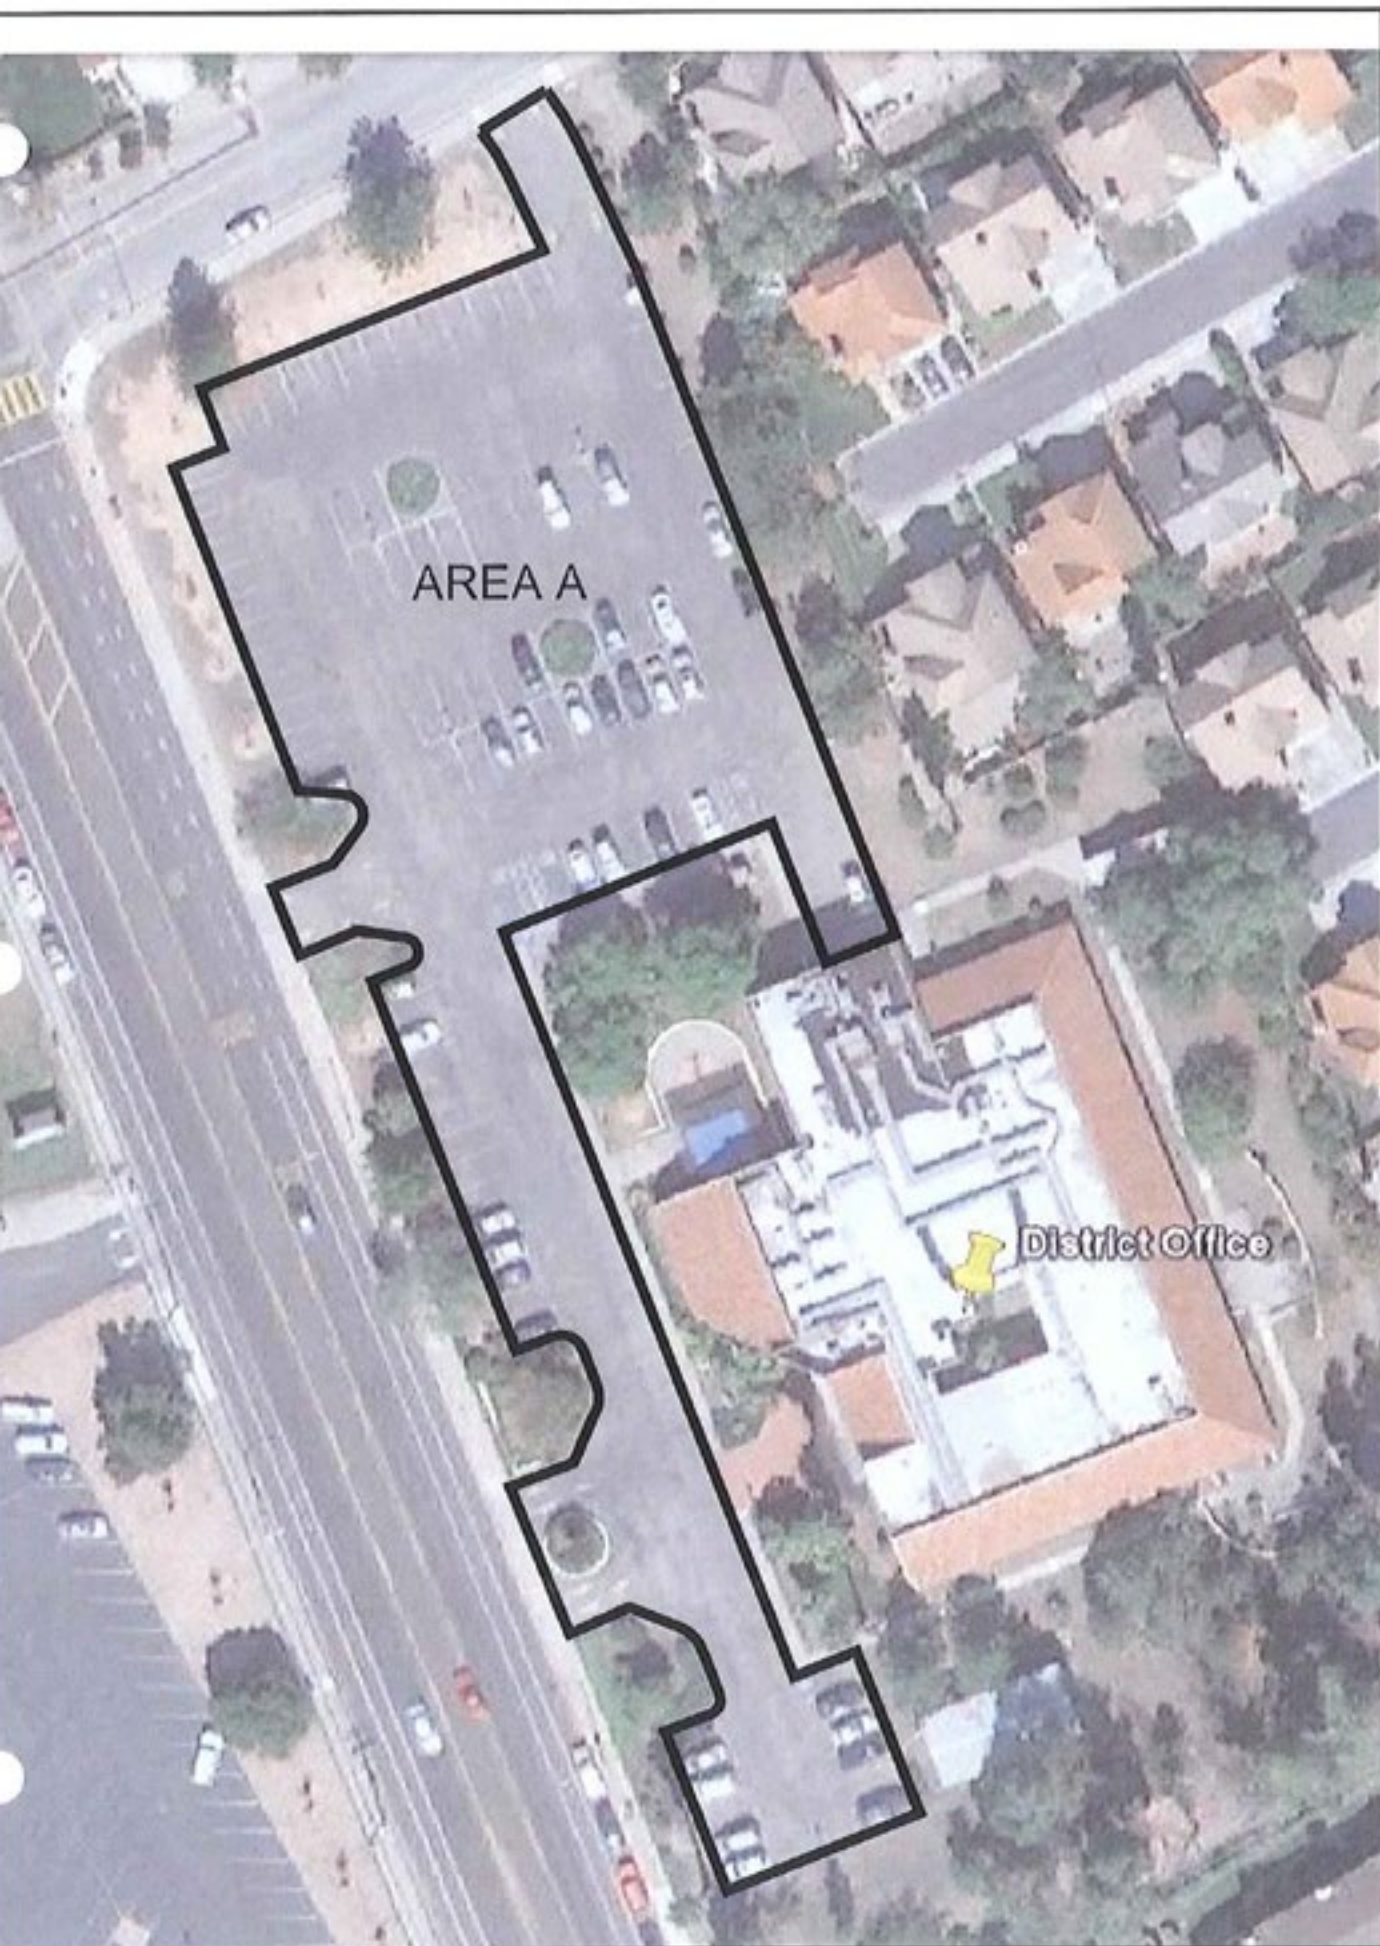
Paving Assessment Report

Area	Type	Use	Area (sq. ft.)	Defect Score	Recommendation	Cost	Year
A	DF	Park	46,437	105	Reconstruct	\$336,668.25	2011
Total:						\$336,668.25

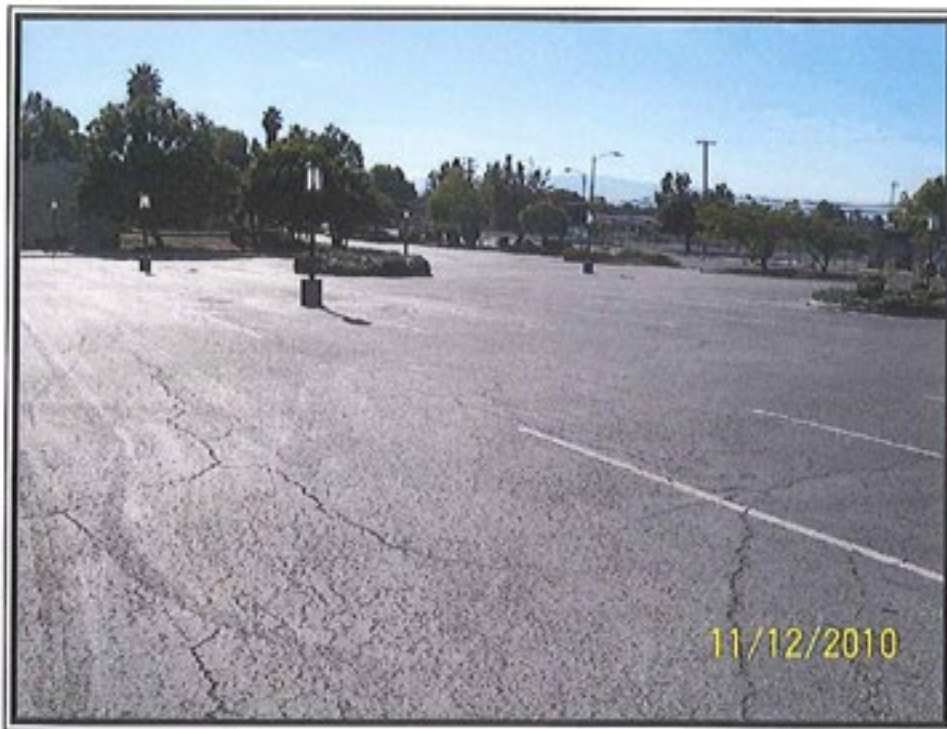
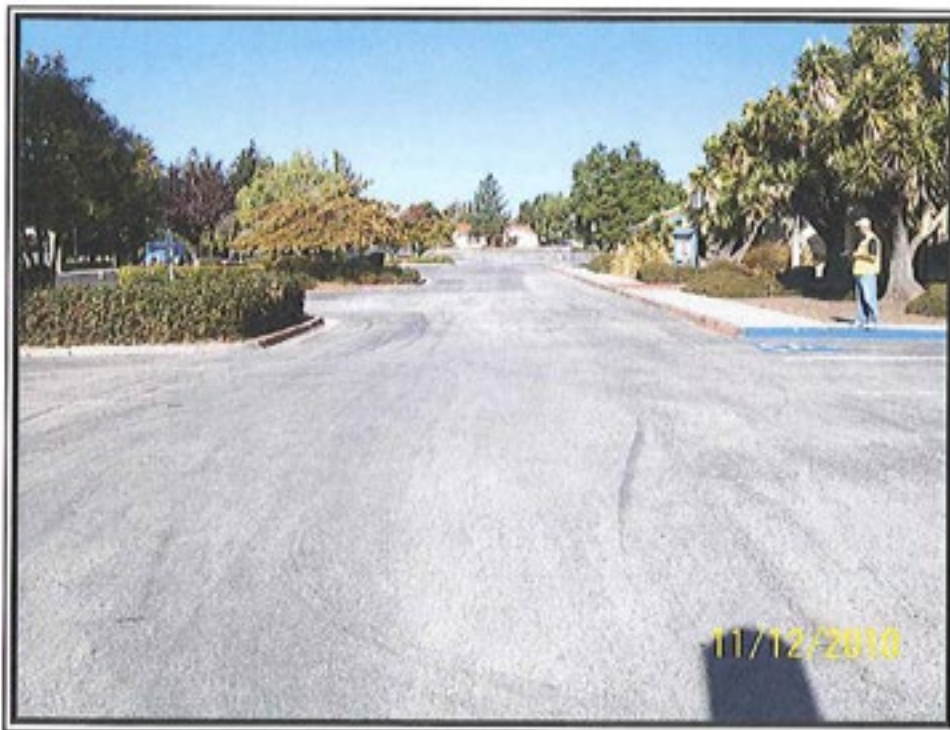
DISTRICT OFFICE - AREA A

School Name: District Office **Area (sf):** 46,437
Area Notation: A **Buses:** No
Surface Type: AC **Garbage Trucks:** Yes
Use: Parking Lots or Areas
Defect Score: 105
Recommended Treatment: Reconstruct
Year: 2011
Visual Description: Pavement exhibits moderate to severe shrinkage cracking and severe raveling, previously sealed, poor condition.
Miscellaneous: Slope = 1.7/ 3.9/ 3.0/ 3.9/ 4.3, Pavement drains to drop inlets and C&G which drains to drop inlets, ADA - slopes exceed 2% in stalls, no signage.

Misc. AC Fill	Base Failure (%)	Alligator Cracking (%)	Crack Factor	Ravel
600	0%	2.0%	0.273	V
		Crack Width	1/8 - 1/4"

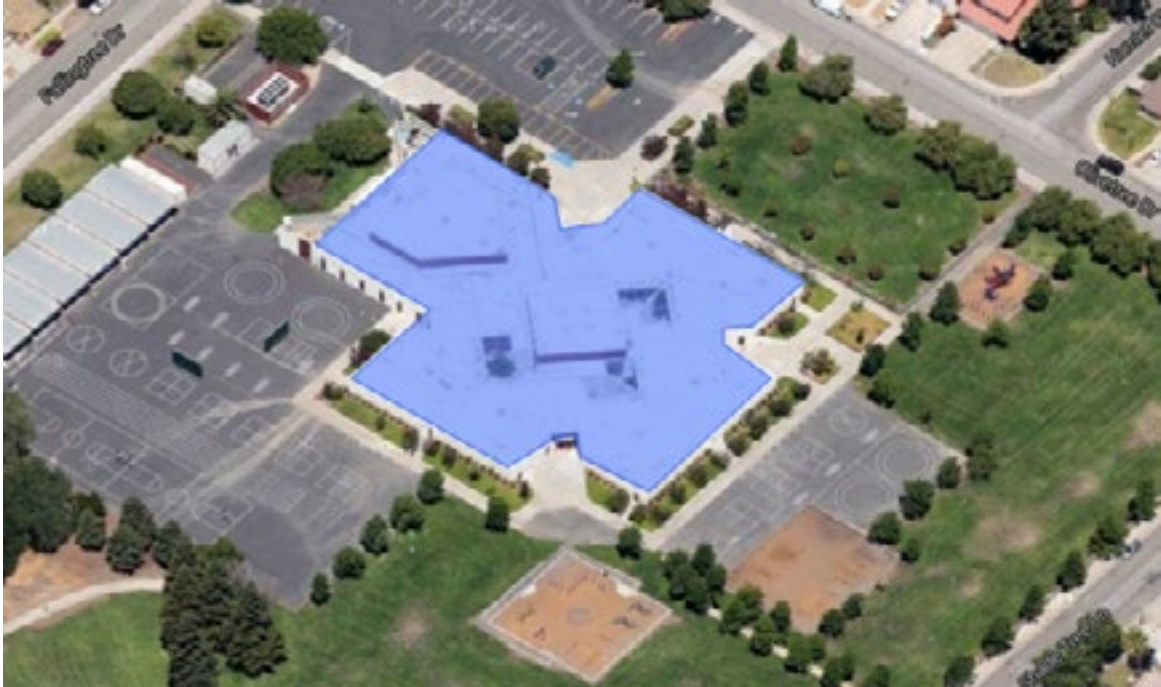
Key Plan

Brooktree Elementary School receives a subjective rating of 2.5.

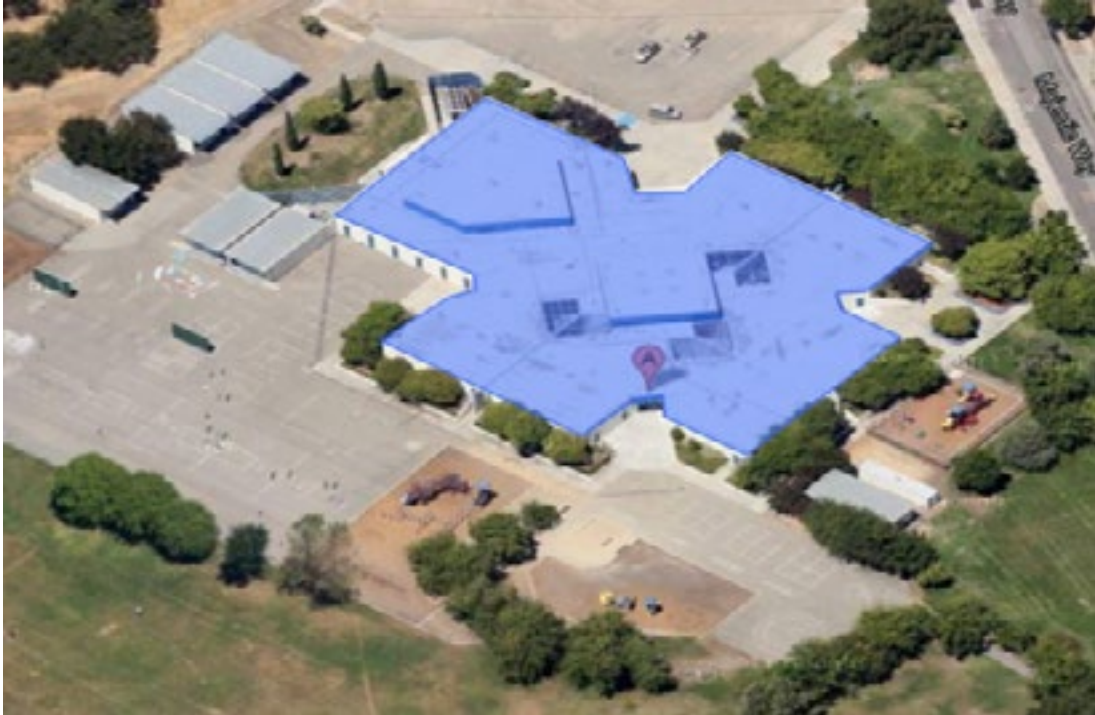
Key Plan

Majestic Elementary School receives a subjective rating of 2.5.

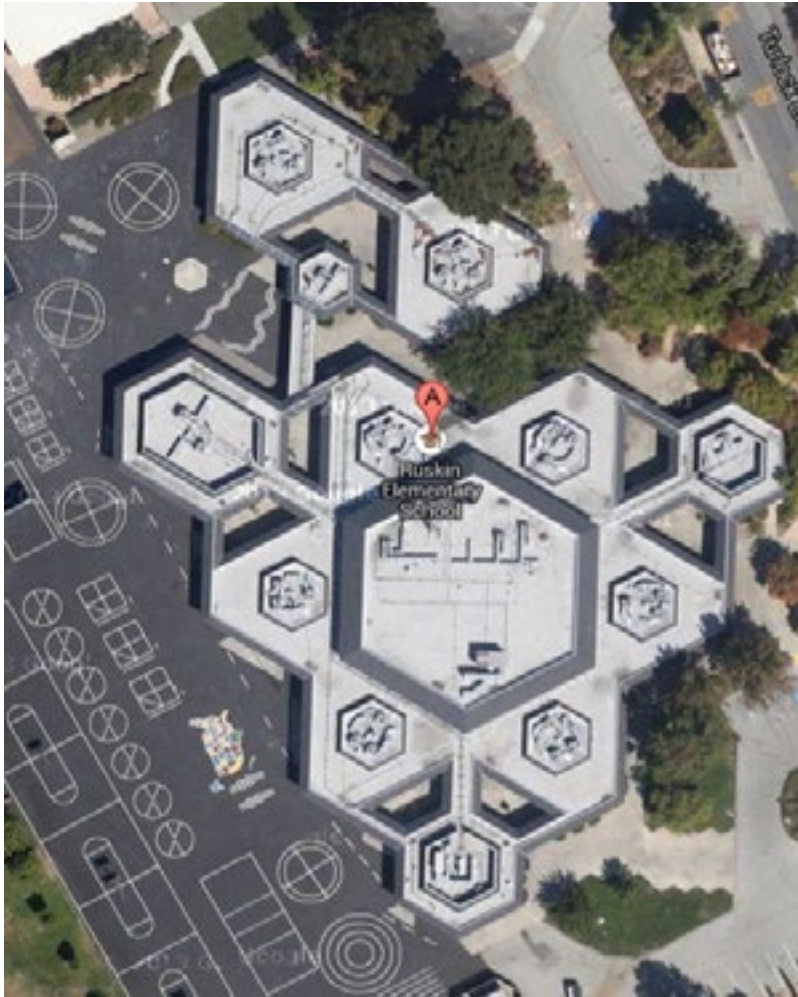
Key Plan

Ruskin Elementary School receives a subjective rating of 2.5.

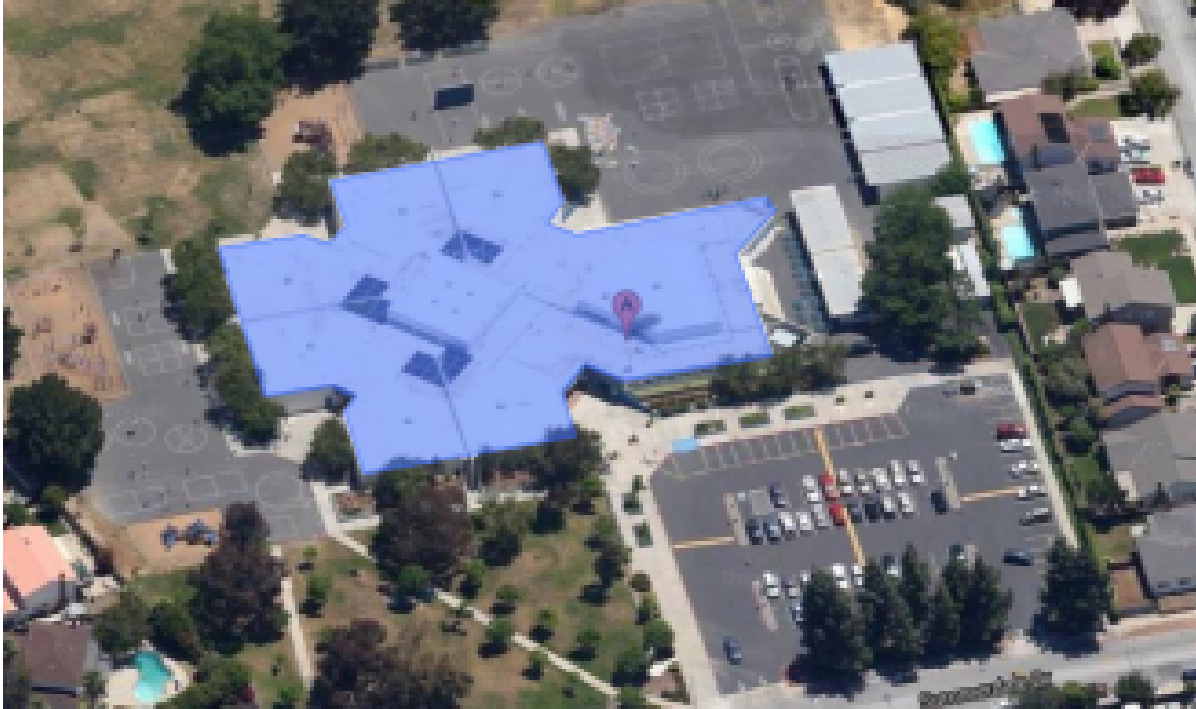
Key Plan

Summerdale Elementary School receives a subjective rating of 2.5.

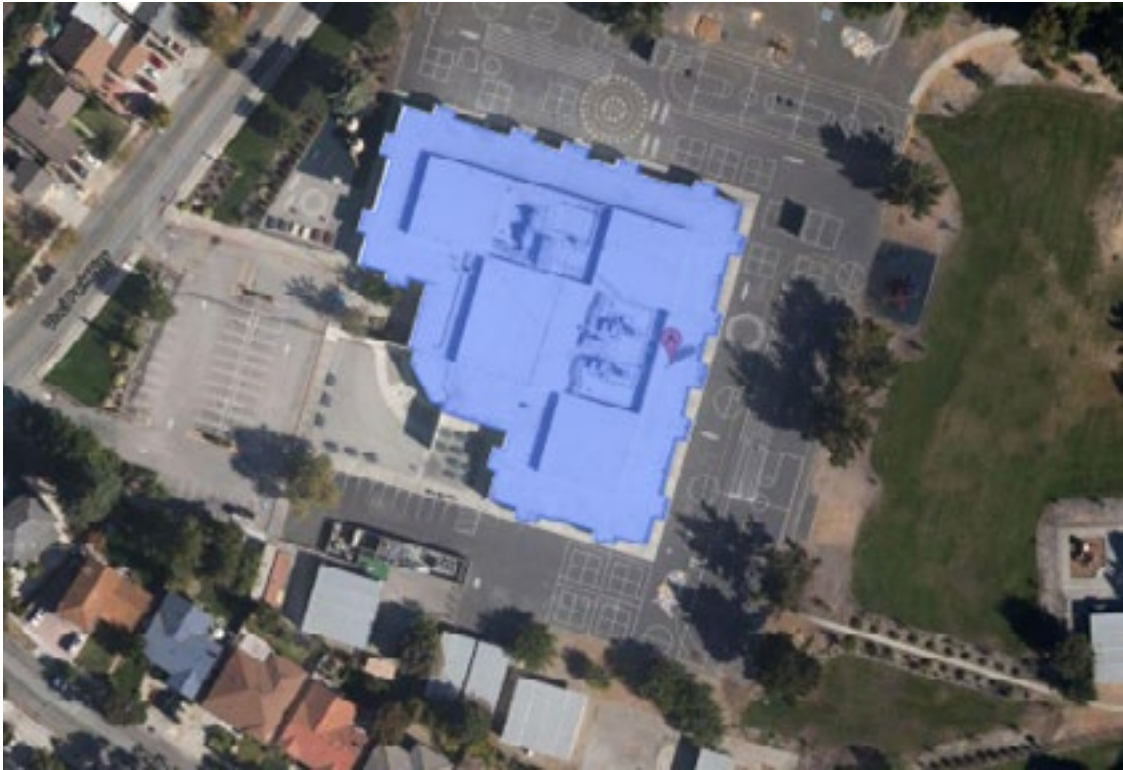
Key Plan

Vinci Park Elementary School receives a subjective rating of 2.5.

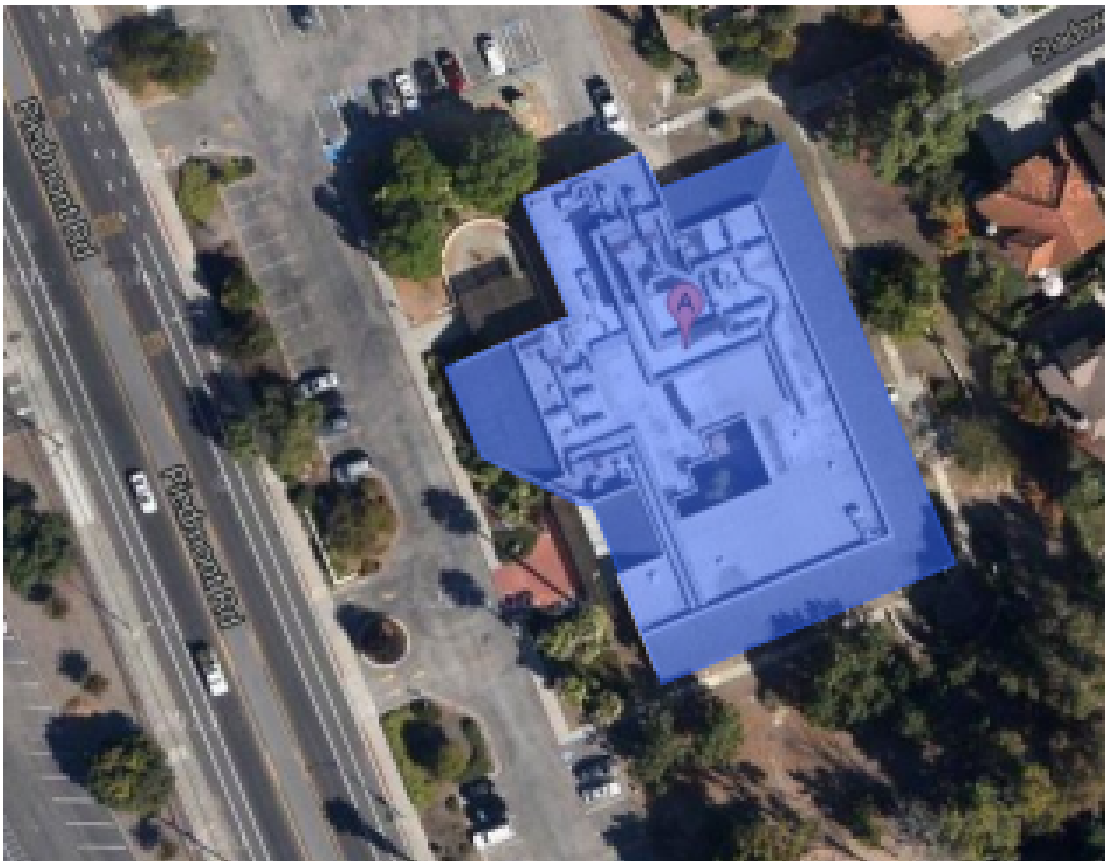
Key Plan

Educational Services Center Building receives a subjective rating of 2.0.
