2020 FACILITIES NEEDS ASSESSMENT UPDATED MAY 2024

BERRYESSA UNION SCHOOL DISTRICT

EXECUTIVE SUMMARY

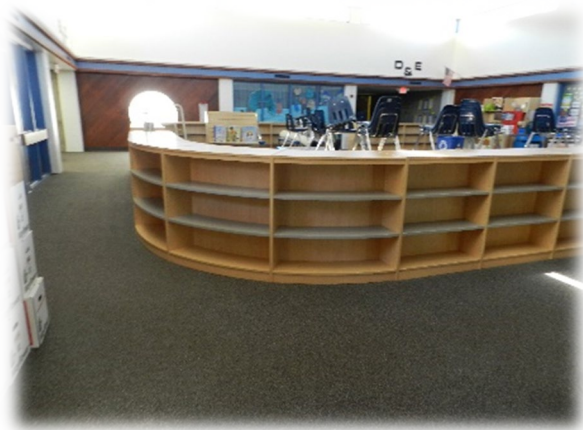
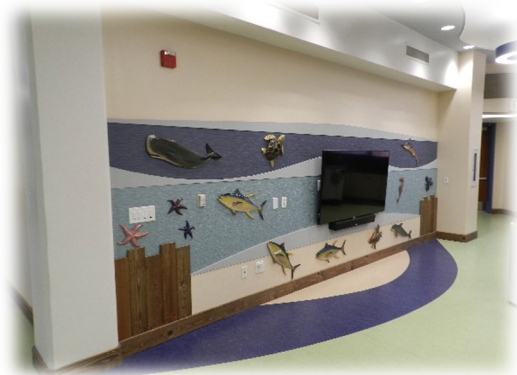
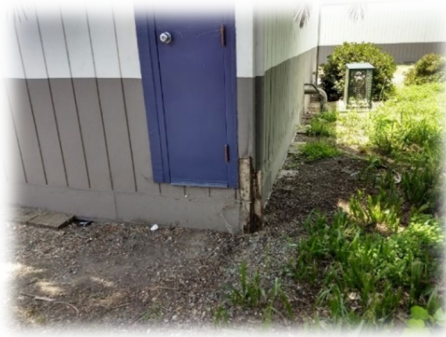
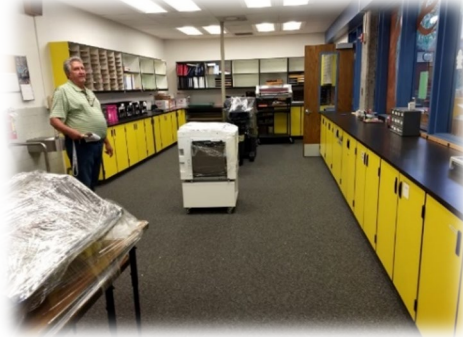
Specialty Classrooms

- Remove old swing brackets in RSP.
- Remove unused phones, wiring, coax. Patch, paint where necessary.
- Refurbish or remove worn wiremolds.
- Small multi-purpose: refurbish cabinets, remove or replace wire molds. Repair or replace delaminating cabinets.

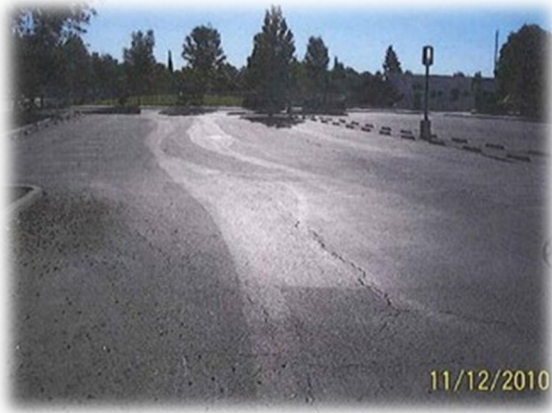
Paving Area A

School Name	Area	Work Description	SF Area	PCI Score
Brooktree Elementary School	A	Reconstruct	29,870	60
Brooktree Elementary School	B	Reconstruct	2,504	54
Brooktree Elementary School	C	Reconstruct	4,029	59
Brooktree Elementary School	D	Reconstruct	44,740	46
Brooktree Elementary School	E	Crack Fill and Seal Coat	1,764	95
Brooktree Elementary School	F	Crack Fill and Seal Coat	1,940	95
Brooktree Elementary School	G	Reconstruct	14,850	54
Brooktree Elementary School	H	Reconstruct	984	41

- Existing blacktop is aging, cracked. Refurbishment and replacement are needed. See attached pavement report. **Main play area - Complete**
- Pave dirt area near play equipment.
- Restore highly used areas of sports fields. Remove gophers and weeds. Reseed.
- Inspect playground equipment, refurbish as required. Replace safety surfacing. Add accessible ramps where needed.
- Existing benches should be refurbished with durable, low maintenance materials.
- Consider adding a perimeter running path.
- Repair, paint ball walls.
- Repair basketball poles, replace nets, replace backboards.
- Paint tetherball poles.
- Remove, refurbish, or replace baseball backstops, dugouts, benches, seating.

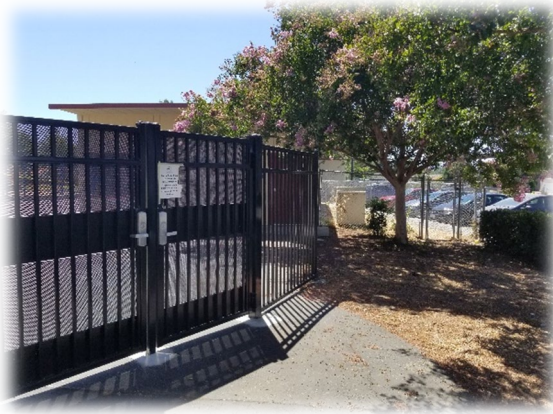
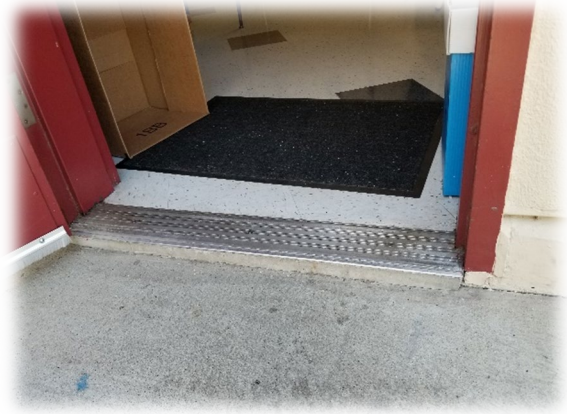
Parking lot and Drop-Off / Pick-Up

- Maintain ADA-accessible parking compliance as required by code.
- Existing curbs and striping need repainting.

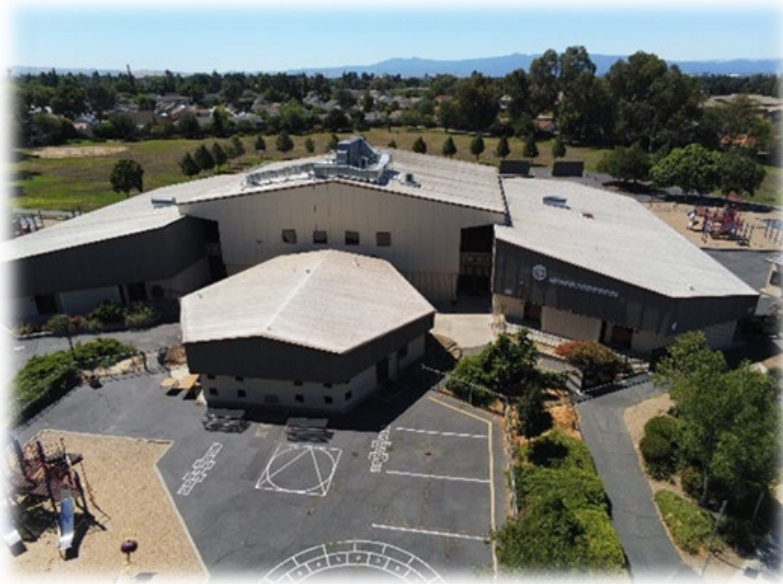
Roofing and Building Protection

- The existing roof is a multi-ply built-up-roofing system. Installed in 2010, it has a 20 year warranty, and has an estimated remaining life of 10-15 years.
-

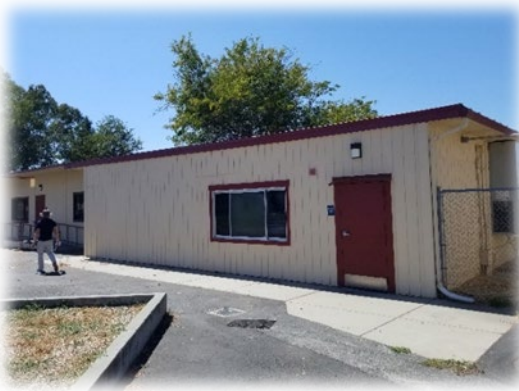
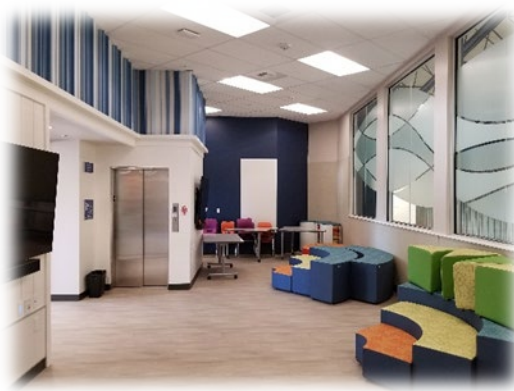
Specialty Classrooms

- If the computer lab is underutilized, consider conversion to classroom.
- Remove old wiring, conduit, unused devices.
- Repair cabinets in classrooms and common areas.
- Refurbish or remove worn wiremolds.
- Repair delaminating cabinets where found. Consider replacement of counter tops with durable solid surfaces.

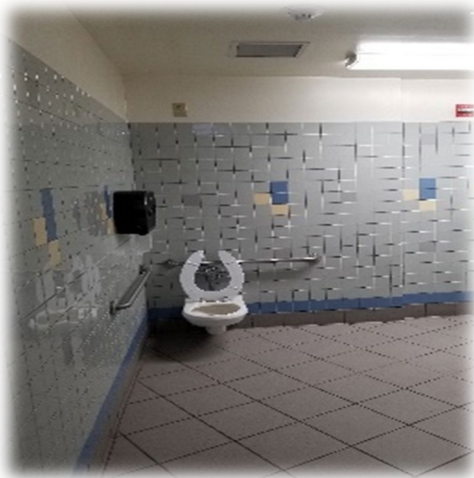
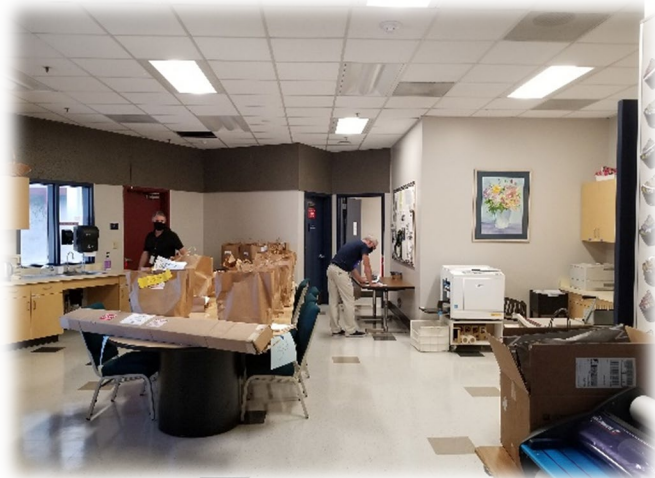
Staff Work Areas

- Repair cabinets, repair or replace countertops with solid surface.
- Replace or clean HVAC ceiling registers, vents.

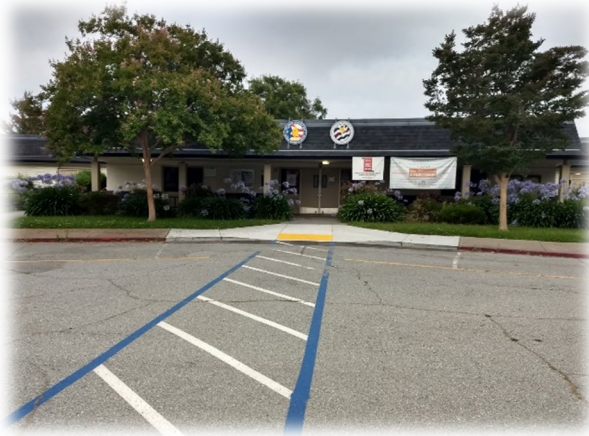
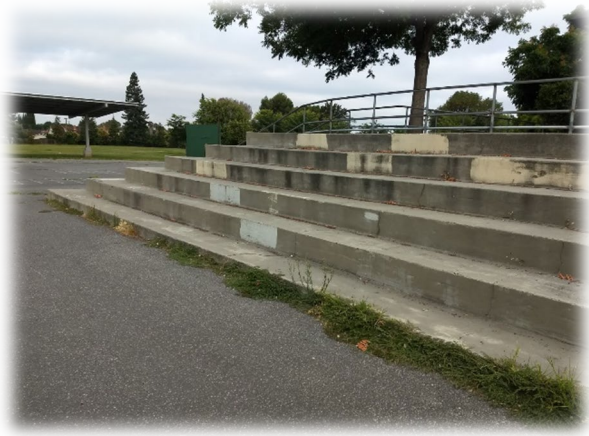
- Consider new wayfinding signage and displays site-wide.
- Complete retrofit of non-accessible drinking fountains with ADA fountains.
- Exterior ramps and outdoor seating have accessibility issues from an equal accommodation standpoint.
- The cracked concrete seating at the rear of the school does not appear to be accessible to the disabled. Consider repairs, replacement, and modifications to meet code **Complete**

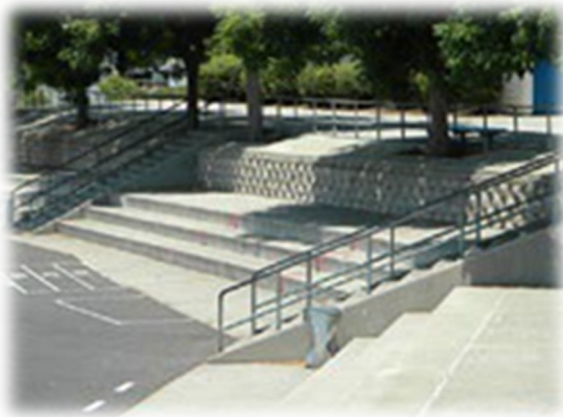
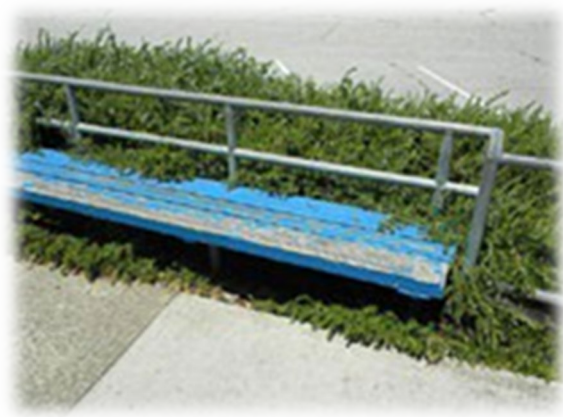
- The existing exterior paint is generally in good condition, although it is aged, and shows many locations where re-painting has occurred over time.
- Paint campus exterior prior to the conclusion of the bond measure.

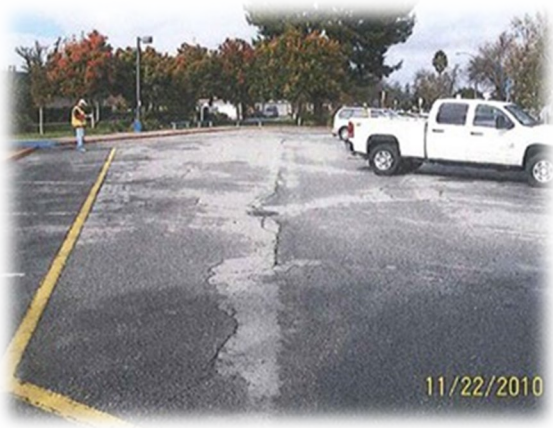
Paving Area A

School Name	Area	Work Description	SF Area	PCI Score
Laneview School	A	Reconstruct	8,000	38
Laneview School	B	Reconstruct	15,308	23
Laneview School	C	Seal Coat	2,898	95
Laneview School	D	Remove & Replace	1,550	67
Laneview School	E	Reconstruct	35,740	52
Laneview School	F	Digout, Crack Fill & Seal Coat	7,763	59
Laneview School	G	Remove & Replace	2,173	48
Laneview School	H	Remove & Replace	1,684	61

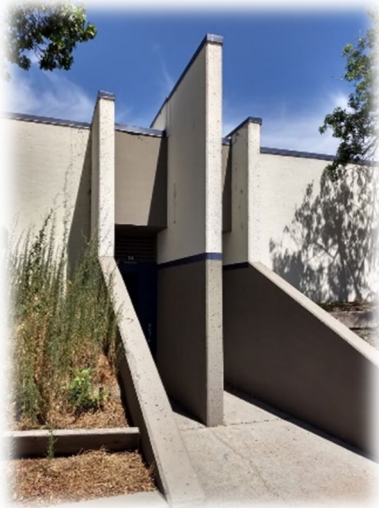
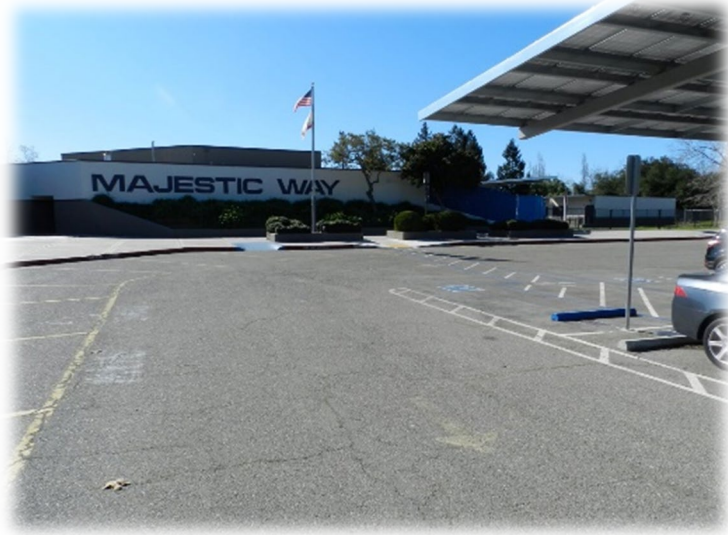
- Existing curbs and striping need repainting.
- Parking lot is small. Consider adding compact spaces to increase parking count.
- Maintain existing accessible parking code compliance.
- Explore opportunities to improve flow of traffic through parking lot during peak hours.

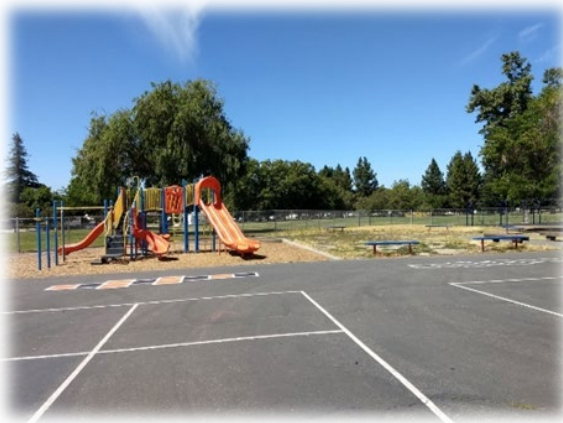
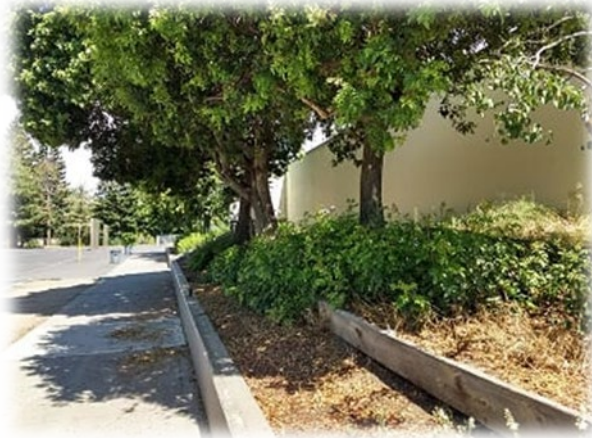
- Redesign landscaping to ease maintenance and improve visibility.
- Add networked irrigation system with remote operation and moisture sensing. **Complete**
- The landscaping in the sloped planters adjacent to the building is causing moisture intrusion problems, as well as creating a security issue by assisting students in accessing the roof of the building. Simplify landscaping and reduce irrigation.
- Arborist should inspect large trees, especially eucalyptus trees in playgrounds. Trim trees of entire campus. Clear away low-lying branches to improve supervision.
- Re-seed grass under trees and add redwood or other type of edging to create clear boundary for grass.
- Ensure that backflow preventers are installed and working properly. **Complete**
- Switch irrigation systems to grey water when it becomes available.

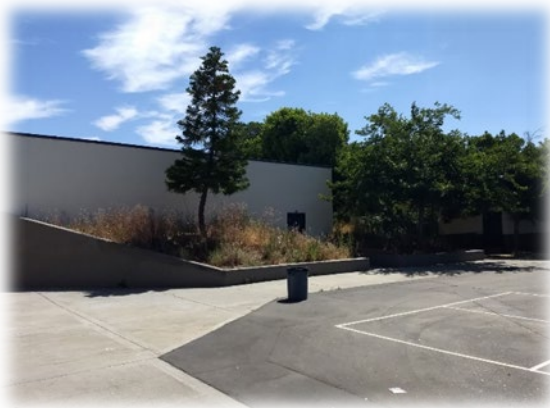
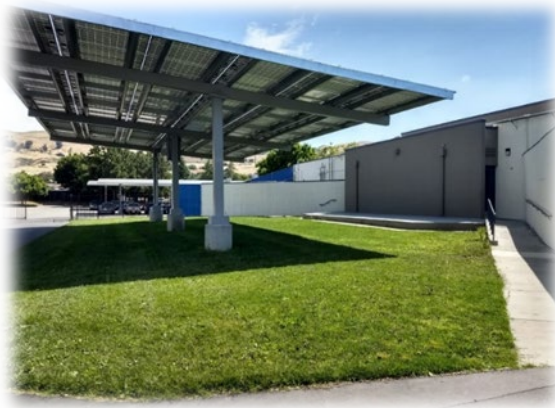
- The existing exterior paint is generally in good condition, although it is aged, and shows many locations where re-painting has occurred over time.
- Paint campus exterior prior to the conclusion of the bond measure.

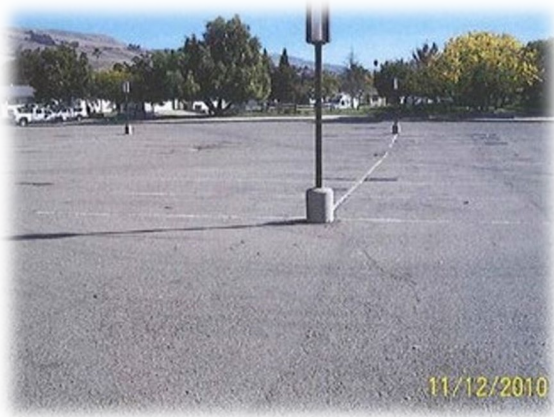
Paving Area A

School Name	Area	Work Description	SF Area	PCI Score
Majestic Way School	A	Reconstruct	36,556	32
Majestic Way School	B	Reconstruct	5,305	49
Majestic Way School	C	Reconstruct	800	62
Majestic Way School	D	Reconstruct	41,335	58
Majestic Way School	E	Remove & Replace	11,333	46
Majestic Way School	F	Remove & Replace	995	47
Majestic Way School	G	Crack Fill and Seal Coat	599	76

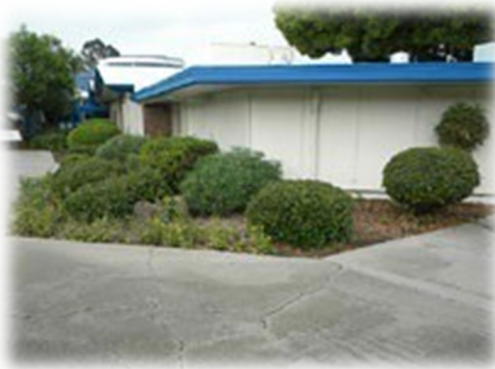
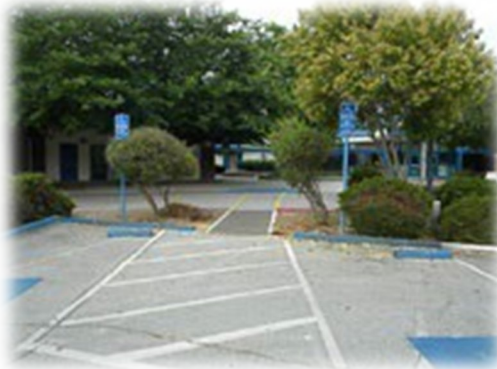
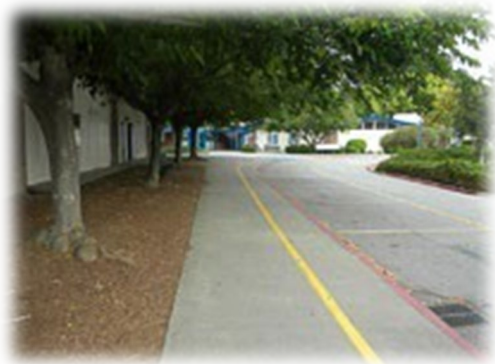
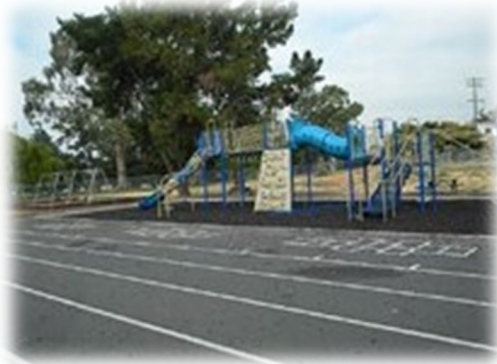
Play Surface / Fields / Play Structures

- Some blacktop and is aging, cracked. Refurbishment and replacement are needed. See attached pavement report.
- Inspect playground equipment, refurbish as required. Replace safety surfacing. Add accessible ramps where needed. **Complete**
- Existing benches should be refurbished with durable, low maintenance materials.
- Consider adding a perimeter running path.

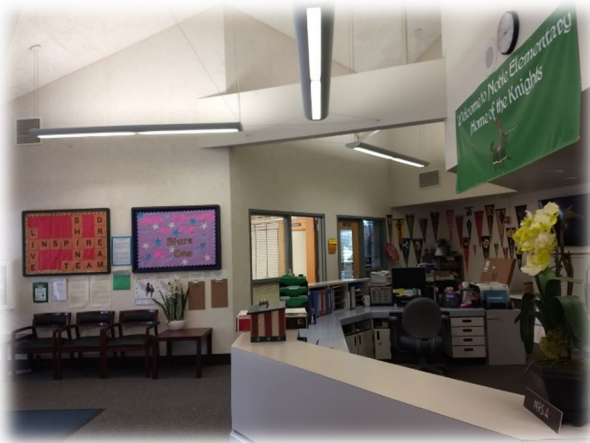
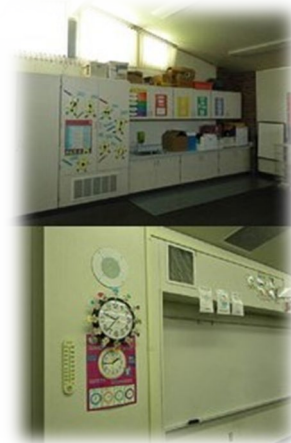
Classrooms

- Refurbish or remove worn wiremolds.
- Patch or replace damaged, worn tackable panels.
- Repair delaminating cabinets where found. Consider replacement of counter tops with durable solid surfaces.

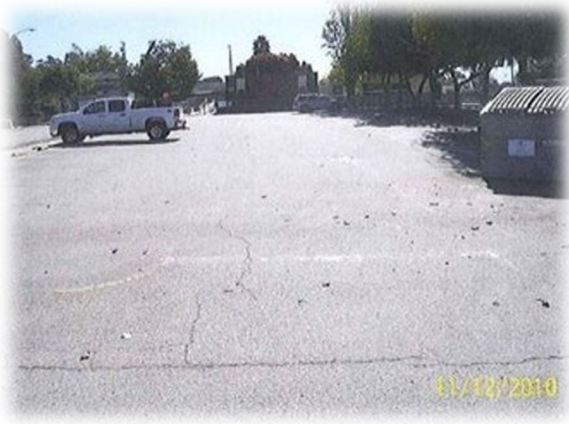
Paving Area A

School Name	Area	Work Description	SF Area	PCI Score
Noble School	A	Reconstruct	15,600	50
Noble School	B	Reconstruct	7,572	48
Noble School	C	Reconstruct	10,220	43
Noble School	D	Reconstruct	3,615	53
Noble School	E	Reconstruct	10,590	67
Noble School	F	Reconstruct	13,989	63
Noble School	G	Reconstruct	47,286	41

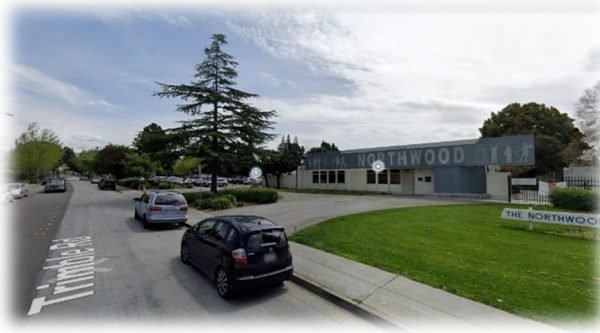
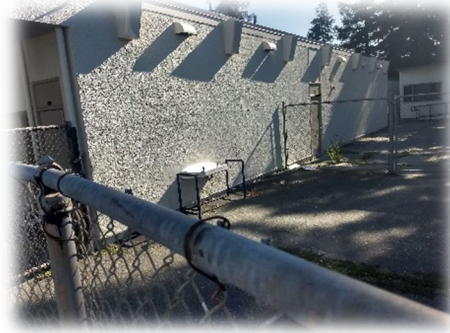
Play Surface / Fields / Play Structures

- Refurbishment or replacement of some blacktop areas is needed. **Quad Complete**
See attached pavement report.
- Restore highly used areas of sports fields. Remove gophers and weeds.
- Inspect playground equipment, refurbish as required. Replace safety surfacing. Add accessible ramps where needed. **Complete**
- Determine if existing benches should be refurbished with durable, low maintenance materials.
- Consider adding a perimeter running path.
- Repair, paint ball walls, tetherball poles.
- Repair basketball poles, replace nets, replace backboards.
- Remove, refurbish or replace baseball backstops, dugouts, benches, seating.

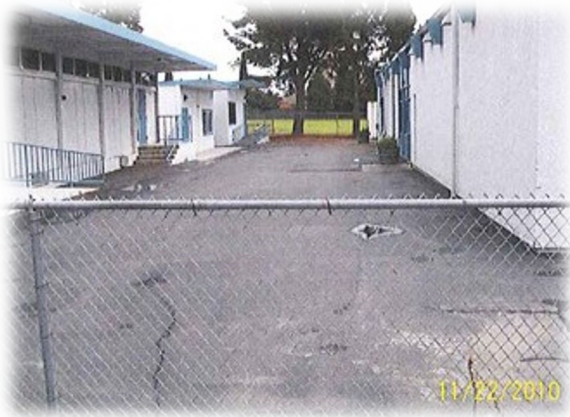
Paving Area B

School Name	Area	Work Description	SF Area	PCI Score
Northwood School	A	Seal Coat	18,179	95
Northwood School	B	Reconstruct	15,131	61
Northwood School	C	Crack Fill & Seal Coat	2,530	93
Northwood School	D	Reconstruct	3,696	18
Northwood School	E	Reconstruct	6,320	60
Northwood School	F	Reconstruct	64,426	53
Northwood School	G	Reconstruct	5,292	57
Northwood School	H	Reconstruct	30,534	35
Northwood School	I	Reconstruct	10,831	23

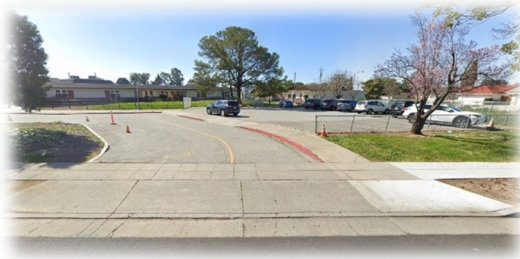
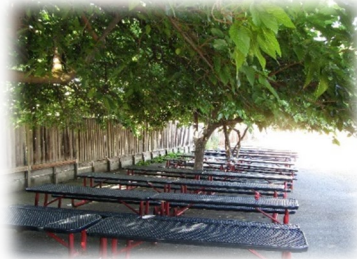
- The existing outdoor lunch area is sloped (not accessible) and is in a remote location with poor supervision.
- Consider the addition of an ideally located covered lunch structure to protect from rain.

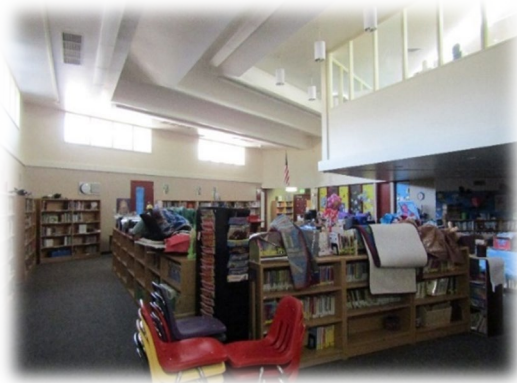
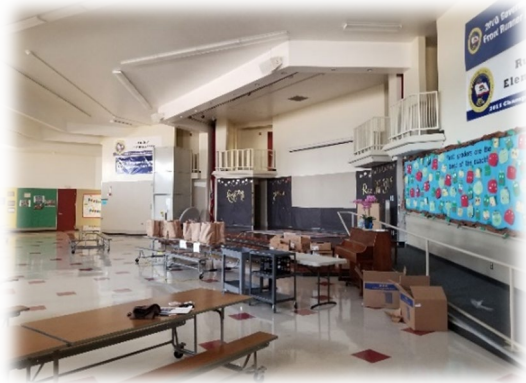
- Consider relocation of the music program located in the multi-purpose room, to another location.
- Remove unused phones, wiring, coax. Patch, paint where necessary.
- Refurbish or remove worn wiremolds.
- Repair cabinets as needed. Consider replacement of countertops.

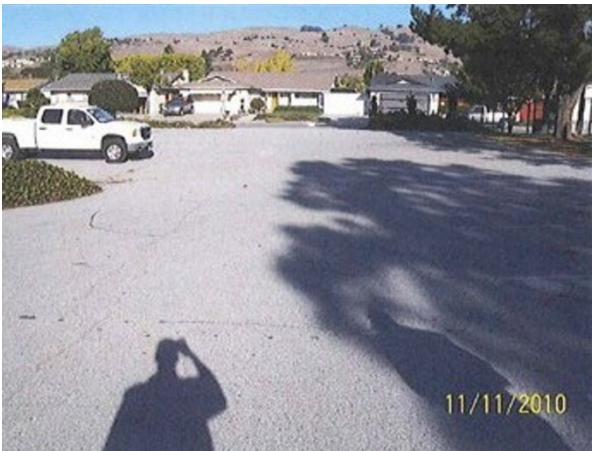
Paving Area A

School Name	Area	Work Description	SF Area	PCI Score
Ruskin School	A	Reconstruct	20,691	42
Ruskin School	B	Reconstruct	5,369	62
Ruskin School	C	Reconstruct	63,168	41
Ruskin School	D	Reconstruct	1,765	49
Ruskin School	E	Reconstruct	558	41
Ruskin School	F	Reconstruct	7,663	45
Ruskin School	G	Reconstruct	5,550	59

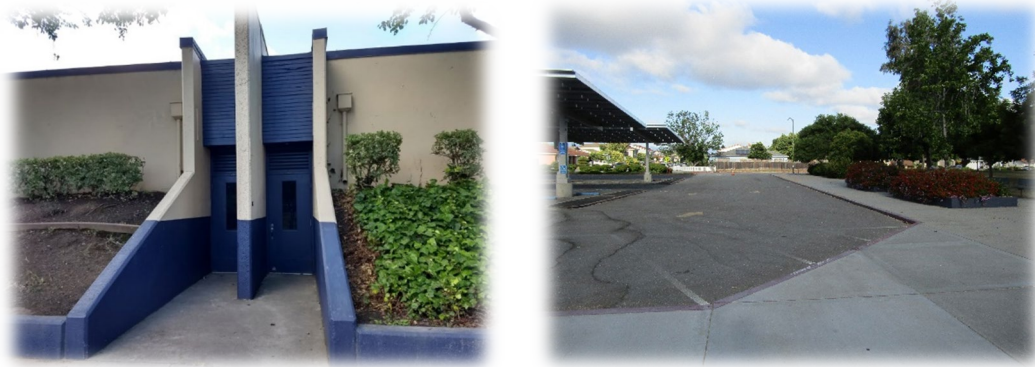
- Redesign landscaping to ease maintenance and improve visibility.
- Add networked irrigation system with remote operation and moisture sensing.
- The landscaping in the sloped planters adjacent to the building is causing moisture intrusion problems, as well as creating a security issue by assisting students in accessing the roof of the building. Simplify landscaping and reduce irrigation.
- Arborist should inspect large trees, especially eucalyptus trees in playgrounds. Trim trees of entire campus. Clear away low-lying branches to improve supervision.
- Reseed under trees, add redwood edging around trees.
- Ensure that backflow preventers are installed and working properly. **Complete**
- Switch irrigation systems to grey water when it becomes available. **Complete**

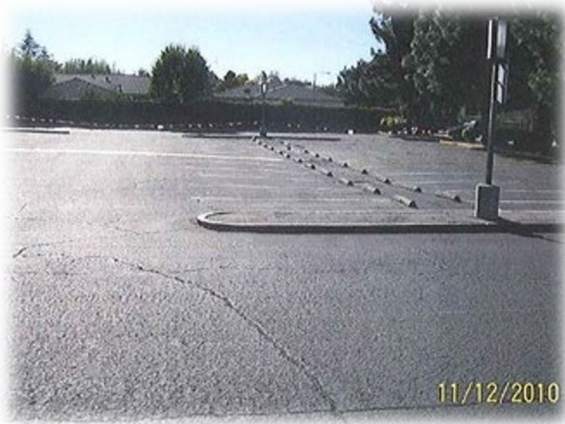
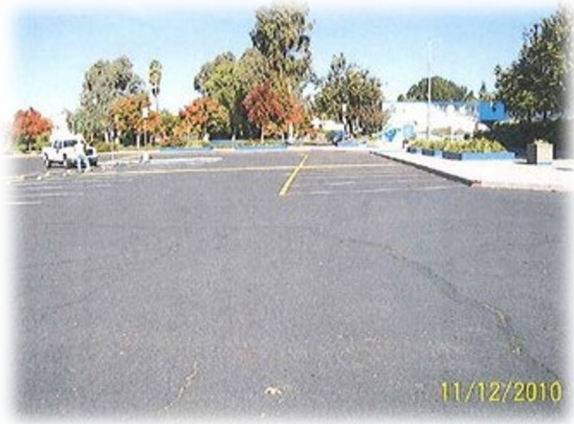
Paving Area A

School Name	Area	Work Description	SF Area	PCI Score
Summerdale School	A	Seal Coat	34,696	85
Summerdale School	B	Reconstruct	14,544	56
Summerdale School	C	Crack Fill and Seal Coat	33,725	85
Summerdale School	D	Reconstruct	5,808	57
Summerdale School	E	Reconstruct	2,435	62

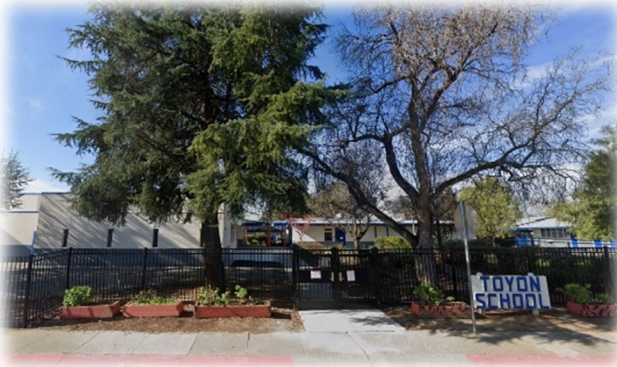
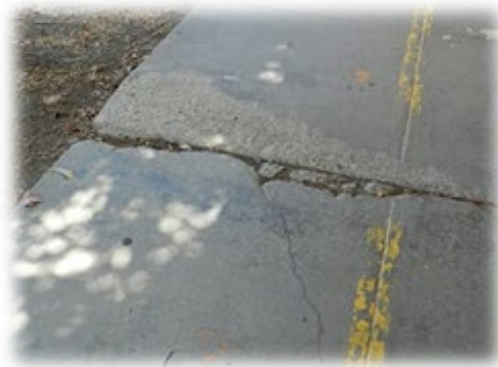
- Existing accessible parking does not meet current requirements. **Complete**
- Maintain ADA accessible parking compliance as required by code **Complete**
- Existing curbs and striping need repainting. **Complete**

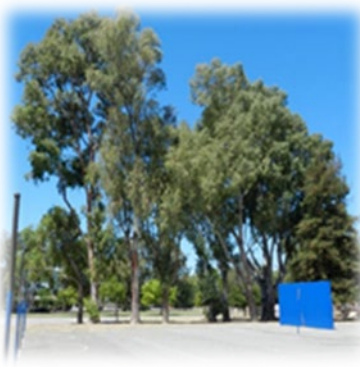
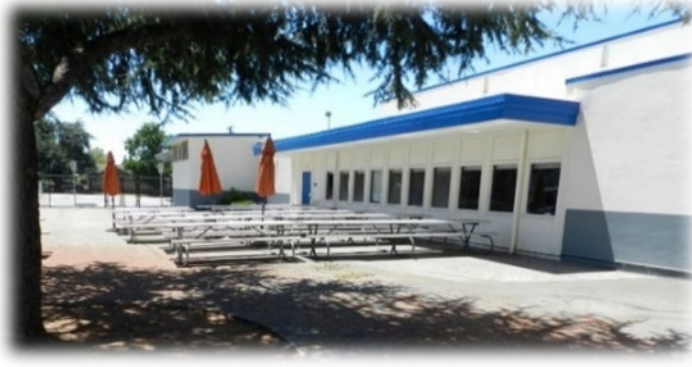
- Existing blacktop and is aging, cracked. Refurbishment and replacement are needed. See attached pavement report.
- Restore highly used areas of sports fields. Remove gophers and weeds. Reseed.
- Inspect playground equipment, refurbish as required. Replace safety surfacing. Add accessible ramps where needed.
- Existing benches should be refurbished with durable, low maintenance materials.
- Consider adding a perimeter running path.
- Repair, paint ball walls.
- Repair basketball poles, replace nets, replace backboards.
- Paint tetherball poles.
- Remove, refurbish, or replace baseball backstops, dugouts, benches, seating.

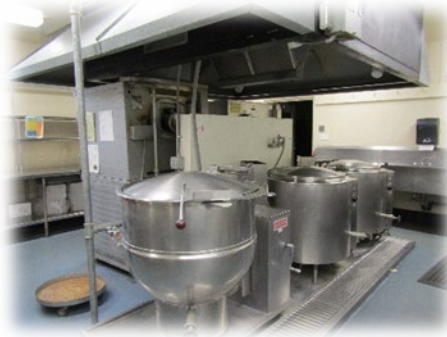
Kitchen / Food Service

- Note, prior to the central kitchen on the Piedmont Middle school site, this kitchen served as the District's central kitchen.
- The existing kitchen layout and equipment do not meet current Department of Health requirements.
- Remove unused equipment.
- In kitchen storage area, consider upgrading cabinets, storage.
- Provide clear acrylic at serving area, point of sale.
- Consider conversion of kitchen to dedicated 'speed-line' style serving space.
- Consider removal of storage area behind kitchen.

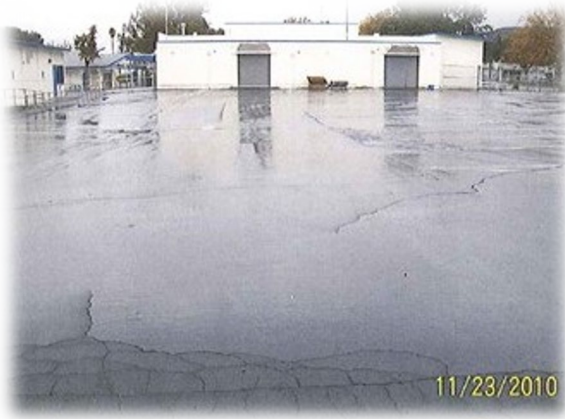
Paving Area A

School Name	Area	Work Description	SF Area	PCI Score
Toyon School	A	Reconstruct	21,336	41
Toyon School	B	Reconstruct	1,909	47
Toyon School	C	Crack Fill and Seal Coat	4,644	72
Toyon School	D	Reconstruct	17,479	55
Toyon School	E	Crack Fill and Seal Coat	19,556	85
Toyon School	F	Reconstruct	1,087	59
Toyon School	G	Crack Fill and Seal Coat	2,145	85
Toyon School	H	Crack Fill and Seal Coat	14,140	85
Toyon School	I	Digout, Crack Fill & Seal Coat	9,089	85
Toyon School	J	Crack Fill and Seal Coat	1,970	85

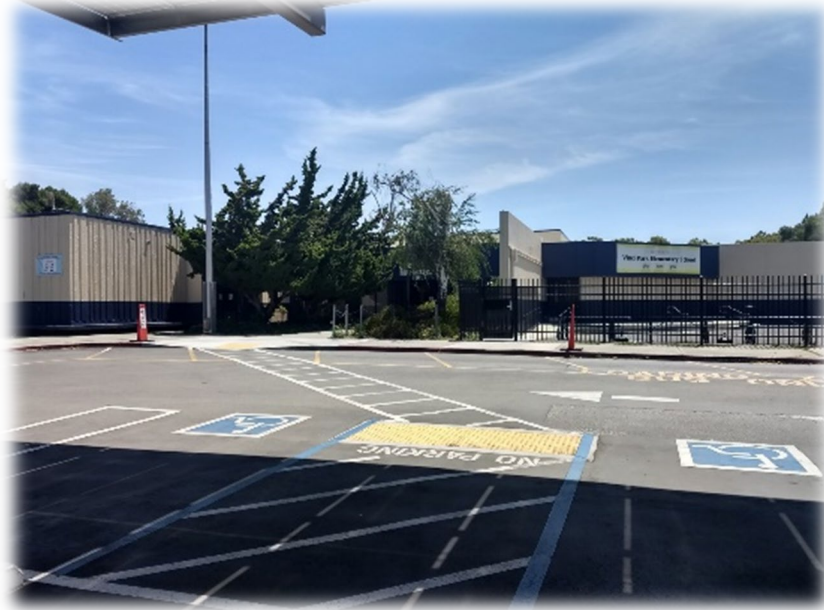
Parking lot and Drop-Off / Pick-Up

- Maintain ADA accessible parking compliance as required by code.

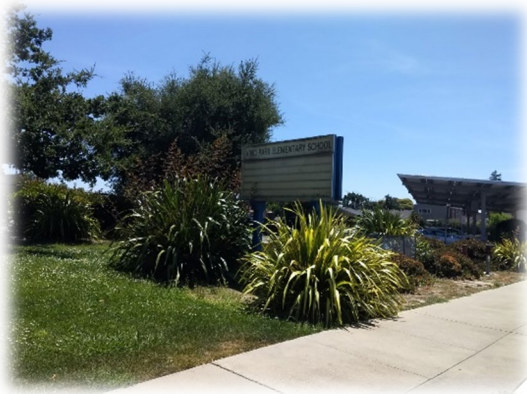
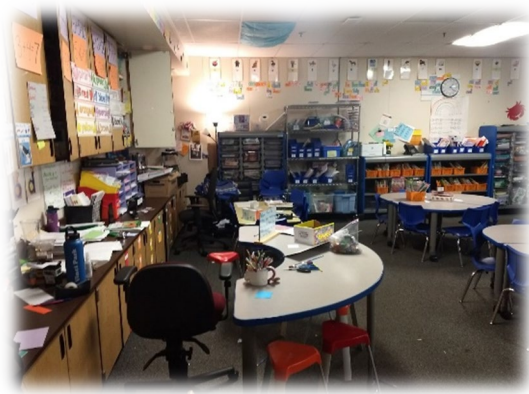
All Buildings

- Ensure that all door hardware meets district standards, safety, security, and accessibility codes. Install new rubber feet on kick-down hold-opens or replace
- Remove unused coax cable, network wire, t-stat wire, etc.
- Add stainless-steel corner guards and chair rails to high traffic areas to ease maintenance.
- Include and allowance for touchup painting, patching.
- Include allowance to install new outlets, cover plates, switches in most areas.
- Stain or paint interior wooden doors.
- Replace dented steel exterior doors.
- Include allowance to replace ceiling tiles.

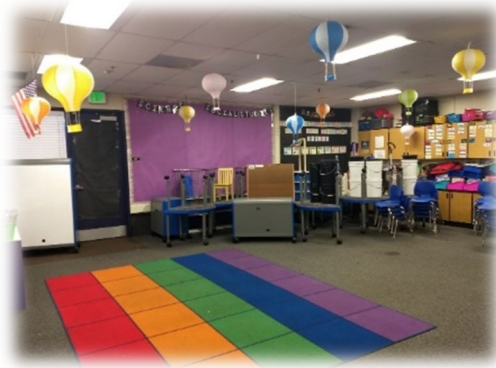
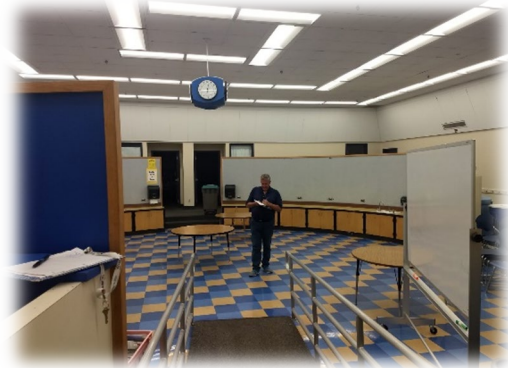
Classrooms

- Refurbish or remove worn wiremolds.
- Repair cabinets as needed. Consider replacement of counter tops.

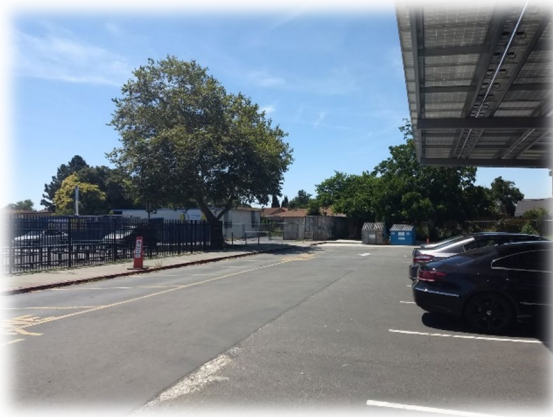
Paving Area A

School Name	Area	Work Description	SF Area	PCI Score
Vinci Park School	A	Reconstruct	25,252	40
Vinci Park School	B	Reconstruct	6,604	63
Vinci Park School	C	Reconstruct	5,112	49
Vinci Park School	D	Crack Fill & Seal Coat	4,135	74
Vinci Park School	E	Crack Fill & Seal Coat	3,964	74
Vinci Park School	F	Reconstruct	83,630	47
Vinci Park School	G	Crack Fill & Seal Coat	632	79
Vinci Park School	H	Crack Fill & Seal Coat	2,744	75

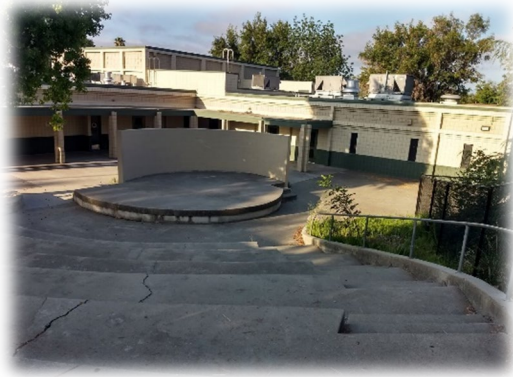
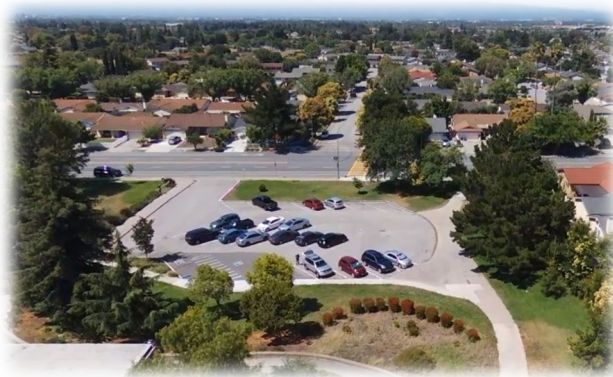
Parking lot and Drop-Off / Pick-Up

- Existing curbs and striping need repainting.
- Maintain ADA accessible parking compliance as required by code.

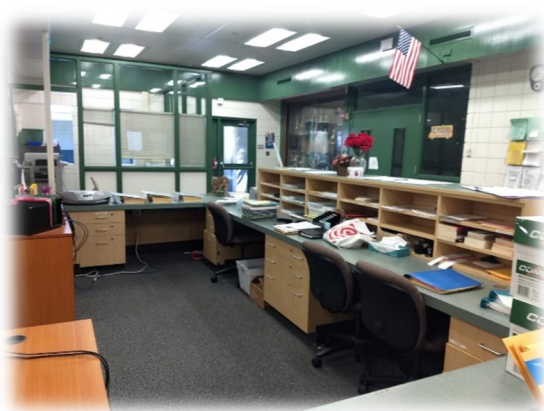
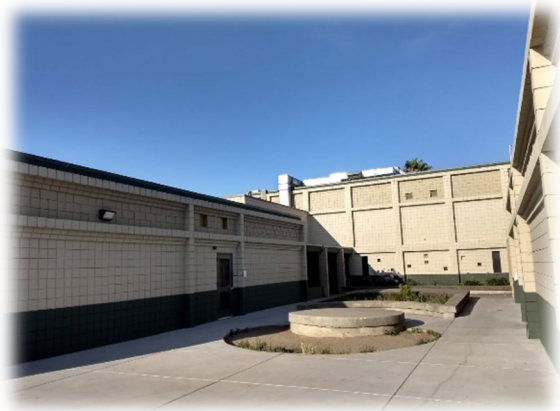
Administration

- Front desk: Make repairs, Modify to maximize healthy, safety, security. Modify desk if necessary, to meet accessibility code.
- Paint interior space. Replace worn finishes.

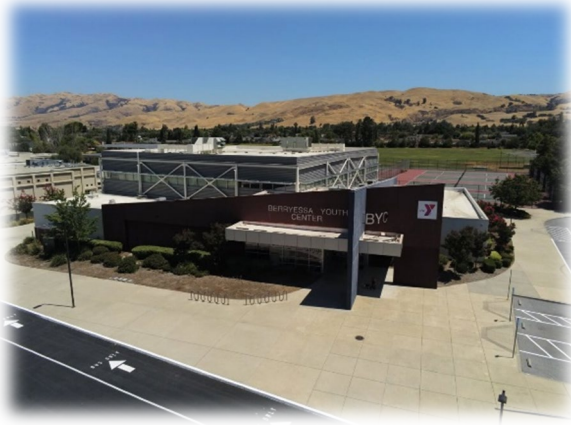
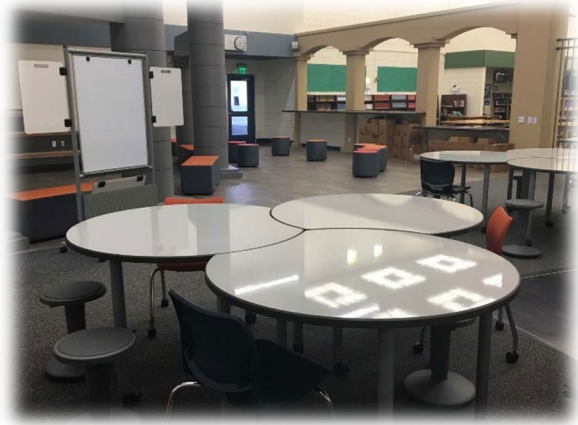
Multi-Purpose

- Replace worn interior finishes, paint.
- Replace and remaining folding cafeteria tables that are in poor condition **Complete**.
- Remove old wiring, conduit, patch and paint room.
- Replace stage lighting.
- Replace clock/speaker unit.

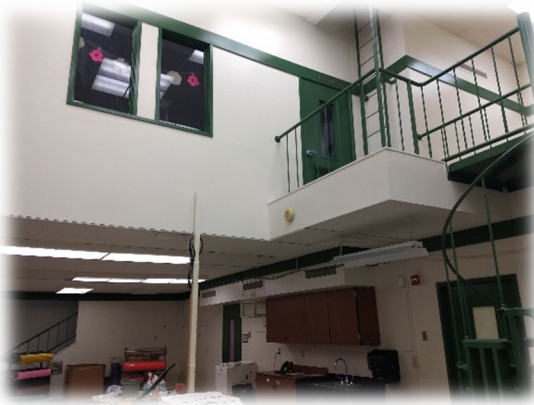
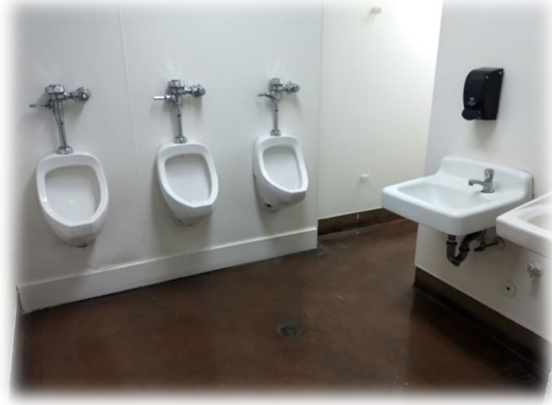
Staff Work Areas

- Replace worn finishes, paint.
- Repair cabinets, repair or replace countertops with solid surface.

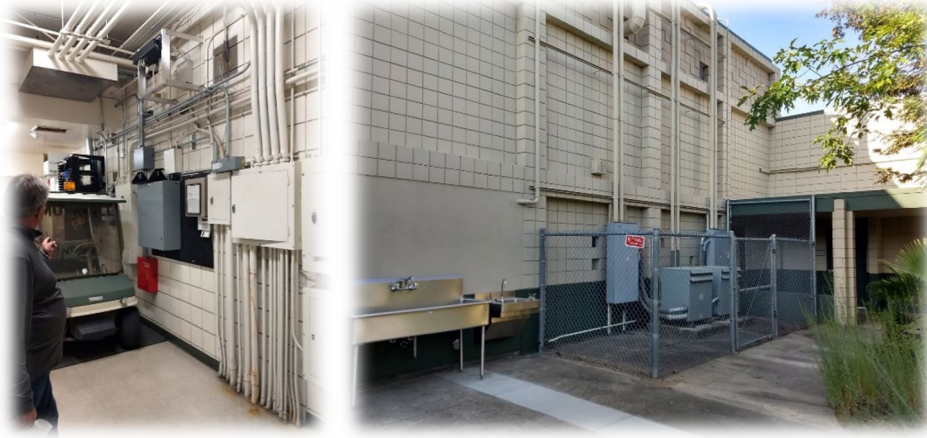
Storage and Custodial

- Overall general storage capacity is good.
- Paint these spaces.
- Evaluate usage and shelving in storage rooms to improve storage capacity, etc.
- Install new exhaust fans and controls in custodial rooms. **Complete**

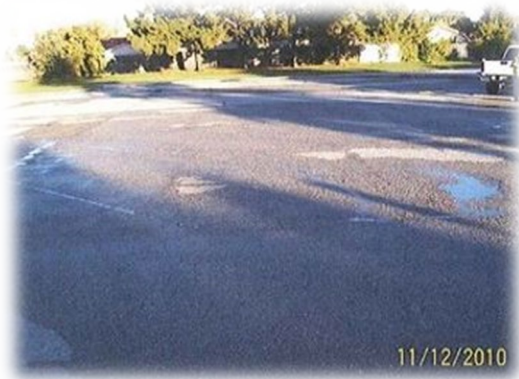
Paving Area A

School Name	Area	Work Description	SF Area	PCI Score
Morrill Middle School	A	Reconstruct	14,832	28
Morrill Middle School	B	Reconstruct	30,172	26
Morrill Middle School	C	Crack Fill & Seal Coat	10,709	82
Morrill Middle School	D	Acrylic Seal Coat	35,636	95
Morrill Middle School	E	Crack Fill & Seal Coat	27,118	90
Morrill Middle School	F	Crack Fill & Seal Coat	12,000	82
Morrill Middle School	G	Crack Fill & Seal Coat	34,118	81

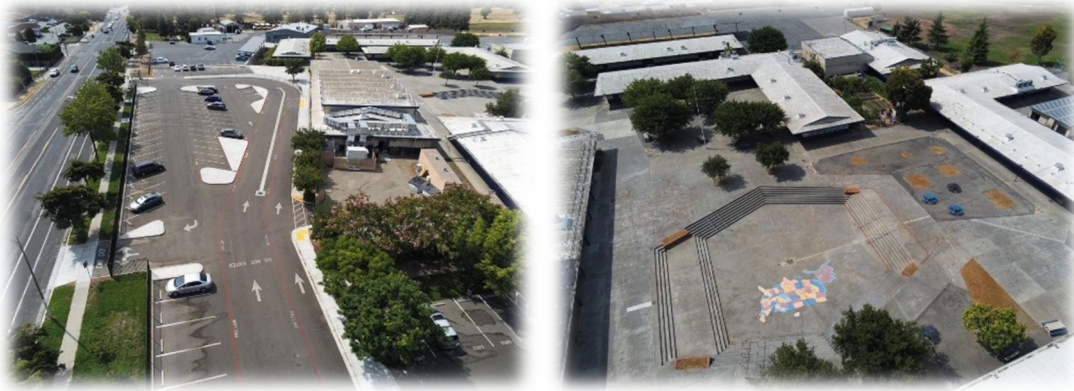
Play Surface / Fields / Play Structures

- Some blacktop and is aging, cracked. Refurbishment and replacement are needed. See attached pavement report.
- Existing benches should be refurbished with durable, low maintenance materials.
- Repair basketball poles, replace nets, replace backboards.
- Remove, refurbish or replace baseball backstops, dugouts, benches, seating.
- Restore sports fields. Remove gophers and weeds. Reseed.
- Restore track.

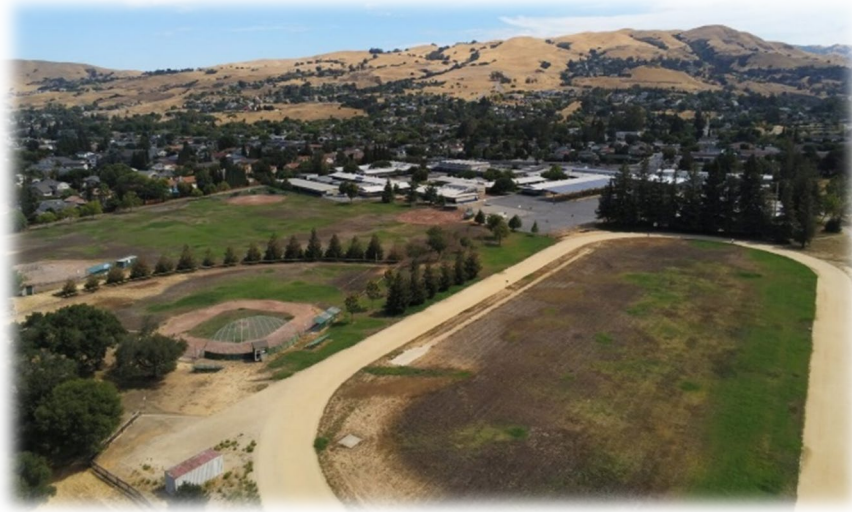
Exterior Paint

- Existing paint is in fair condition.
- Paint campus exterior prior to the conclusion of the bond measure.

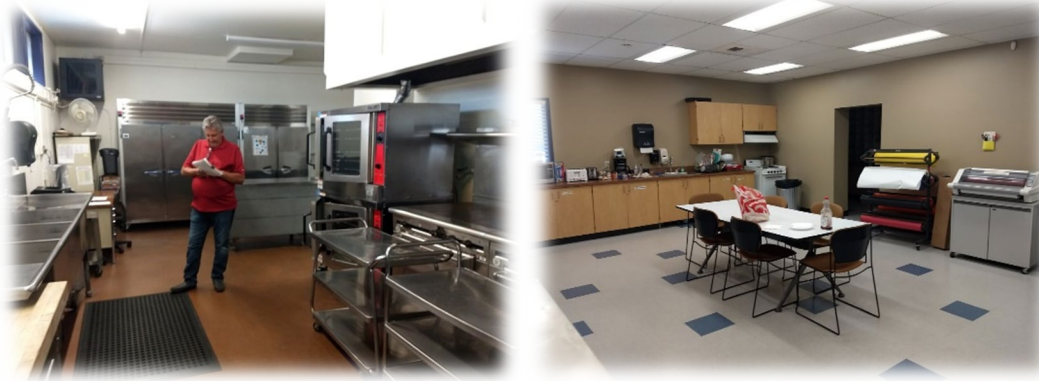
Food Services

- Observation: The existing kitchen layout and equipment do not meet current Department of Health requirements.
- Remove unused equipment.
- Provide clear acrylic at serving area, point of sale.
- Remove unused coax, low voltage wiring, conduit.
- Provide touch-up painting, wall finish repairs as needed.
- Storage area: Upgrade shelving, cabinets.

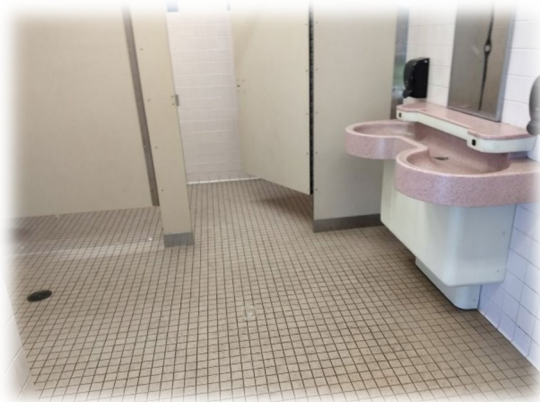
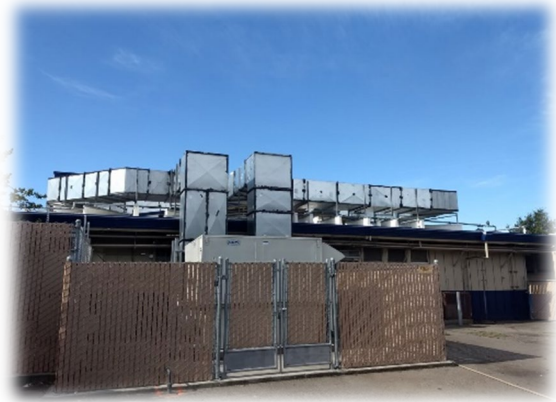
Electrical Systems

- If additional power loads are needed, it is recommended to upgrade the existing PG&E transformer.
- Inspect the existing PG&E transformer. Service as required. Paint.
- Inspect the existing switchgear. Service as required.
- See attached electrical report for additional information.
- Consider re-routing power and low-voltage pathways to underground conduit.
- Install new classroom lighting in all portables to remain.

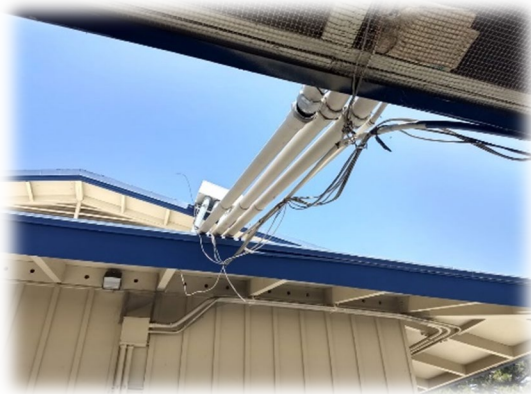
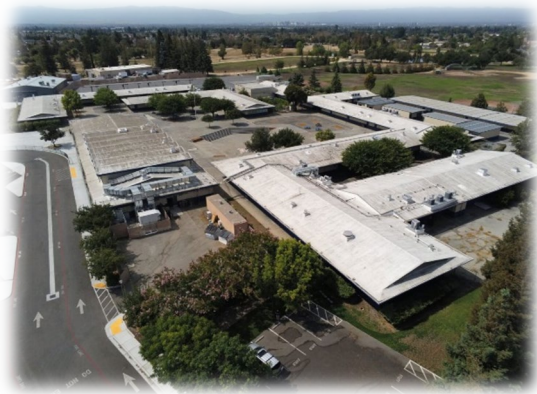
- Install new, fully addressable, automatic FA systems with new notification devices. Remove older FACP control panel. **Complete**
- The existing Bogen Multicom 2000 PA and master clock system located in the administration storage room is in good and functioning condition. Existing speaker and clock units are can be considered for reuse if budget does not allow replacement.
- Replace the existing energy management system with a simple to maintain but effective networked system.
- Confirm that all lighting is on timers, motion sensors, or networked.
- Install new security systems and cameras. **Complete**

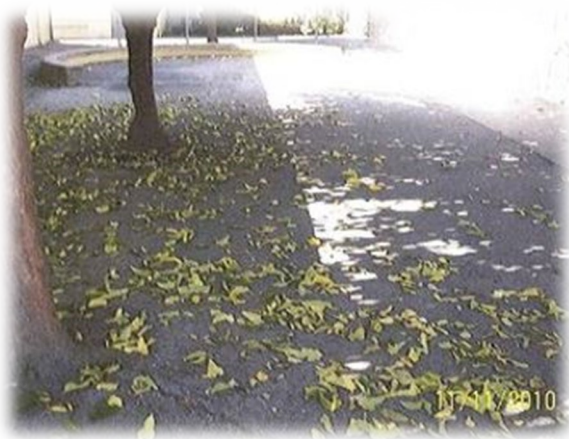
Paving Area E

School Name	Area	Work Description	SF Area	PCI Score
Piedmont Middle School	A	Seal Coat	38,560	95
Piedmont Middle School	B	Crack Fill and Seal Coat	6,690	86
Piedmont Middle School	C	Remove & Replace	5,334	52
Piedmont Middle School	D	Remove & Replace	6,432	52
Piedmont Middle School	E	Remove & Replace	3,583	46
Piedmont Middle School	F	Remove & Replace	8,481	59
Piedmont Middle School	G	Reconstruct	50,196	43
Piedmont Middle School	H	Reconstruct	6,750	37
Piedmont Middle School	I	Reconstruct	4,900	45

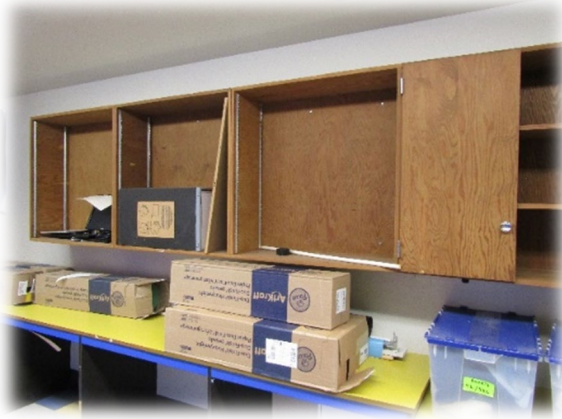
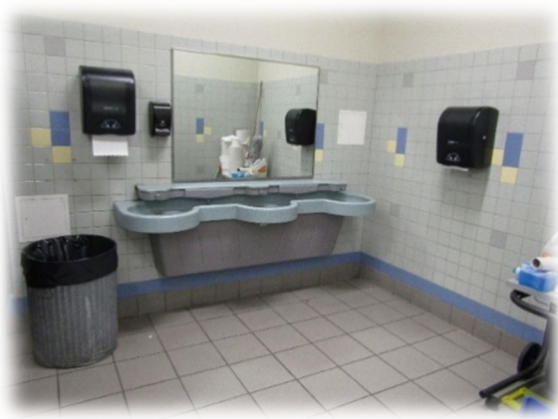
Staff Lounge

- Provide touch-up painting, wall finish repairs as needed.
- Repair cabinets, repair or replace countertops with solid surface.
- Consider new magnetic markerboards to make this space more flexible.
- Consider moveable furniture to encourage flexible use.
- Replace aging appliances.
- Add a stove if possible.

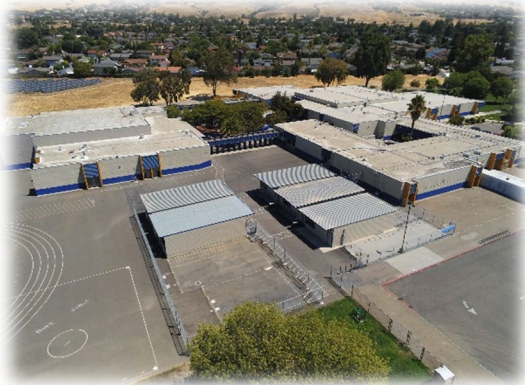
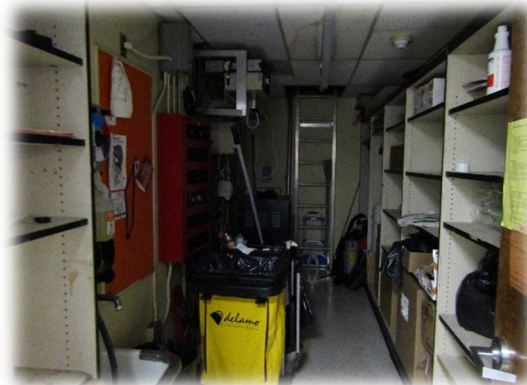
Low Voltage Systems

- Install new, fully addressable, automatic FA systems with new notification devices. Remove older FACP control panel. Provide new horn and strobes in areas required by ADA, NFPA, CEC and CFC.
- The existing Bogen Multicom 2000 PA and master clock system located in the administration storage room is in good and functioning condition. Existing speaker and clock units can be considered for reuse if budget does not allow replacement.
- Replace the existing energy management system with a simple to maintain but effective networked system.
- Confirm that all lighting is on timers, motion sensors, or networked.
- Consider updating or revising room numbering before upgrading any low voltage systems.
- Install new security systems and cameras. **Complete**
