2020 FACILITIES NEEDS ASSESSMENT UPDATED MAY 2024

BERRYESSA UNION SCHOOL DISTRICT

EXECUTIVE SUMMARY

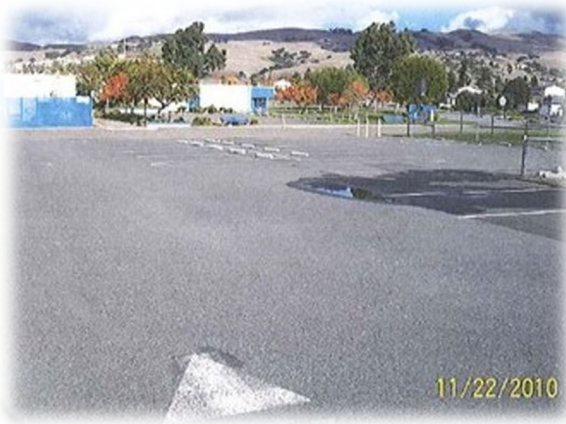
Paving Area A

School Name	Area	Work Description	SF Area	PCI Score
Sierramont Middle School	A	Reconstruct	13,860	64
Sierramont Middle School	B	Reconstruct	8,659	63
Sierramont Middle School	C	Crack Fill and Seal Coat	34,712	95
Sierramont Middle School	D	Reconstruct	18,369	32
Sierramont Middle School	E	Reconstruct	13,769	44
Sierramont Middle School	F	Reconstruct	2,394	53
Sierramont Middle School	G	Crack Fill and Seal Coat	145,564	95
Sierramont Middle School	H	Crack Fill and Seal Coat	3,333	95
Sierramont Middle School	I	Crack Fill and Seal Coat	5,792	95
Sierramont Middle School	J	Reconstruct	9,056	57
Sierramont Middle School	K	Crack Fill and Seal Coat	1,648	95
