SIX-MONTH SURVEILLANCE AHERA REPORT

**BUESD DISTRICT OFFICE
1376 PIEDMONT ROAD
SAN JOSE, CA 95132**

**PREPARED FOR:
BERRYESSA UNION ELEMENTARY SCHOOL DISTRICT
1376 PIEDMONT ROAD
SAN JOSE, CA 95132**

HAZMAT DOC PROJECT #22-025

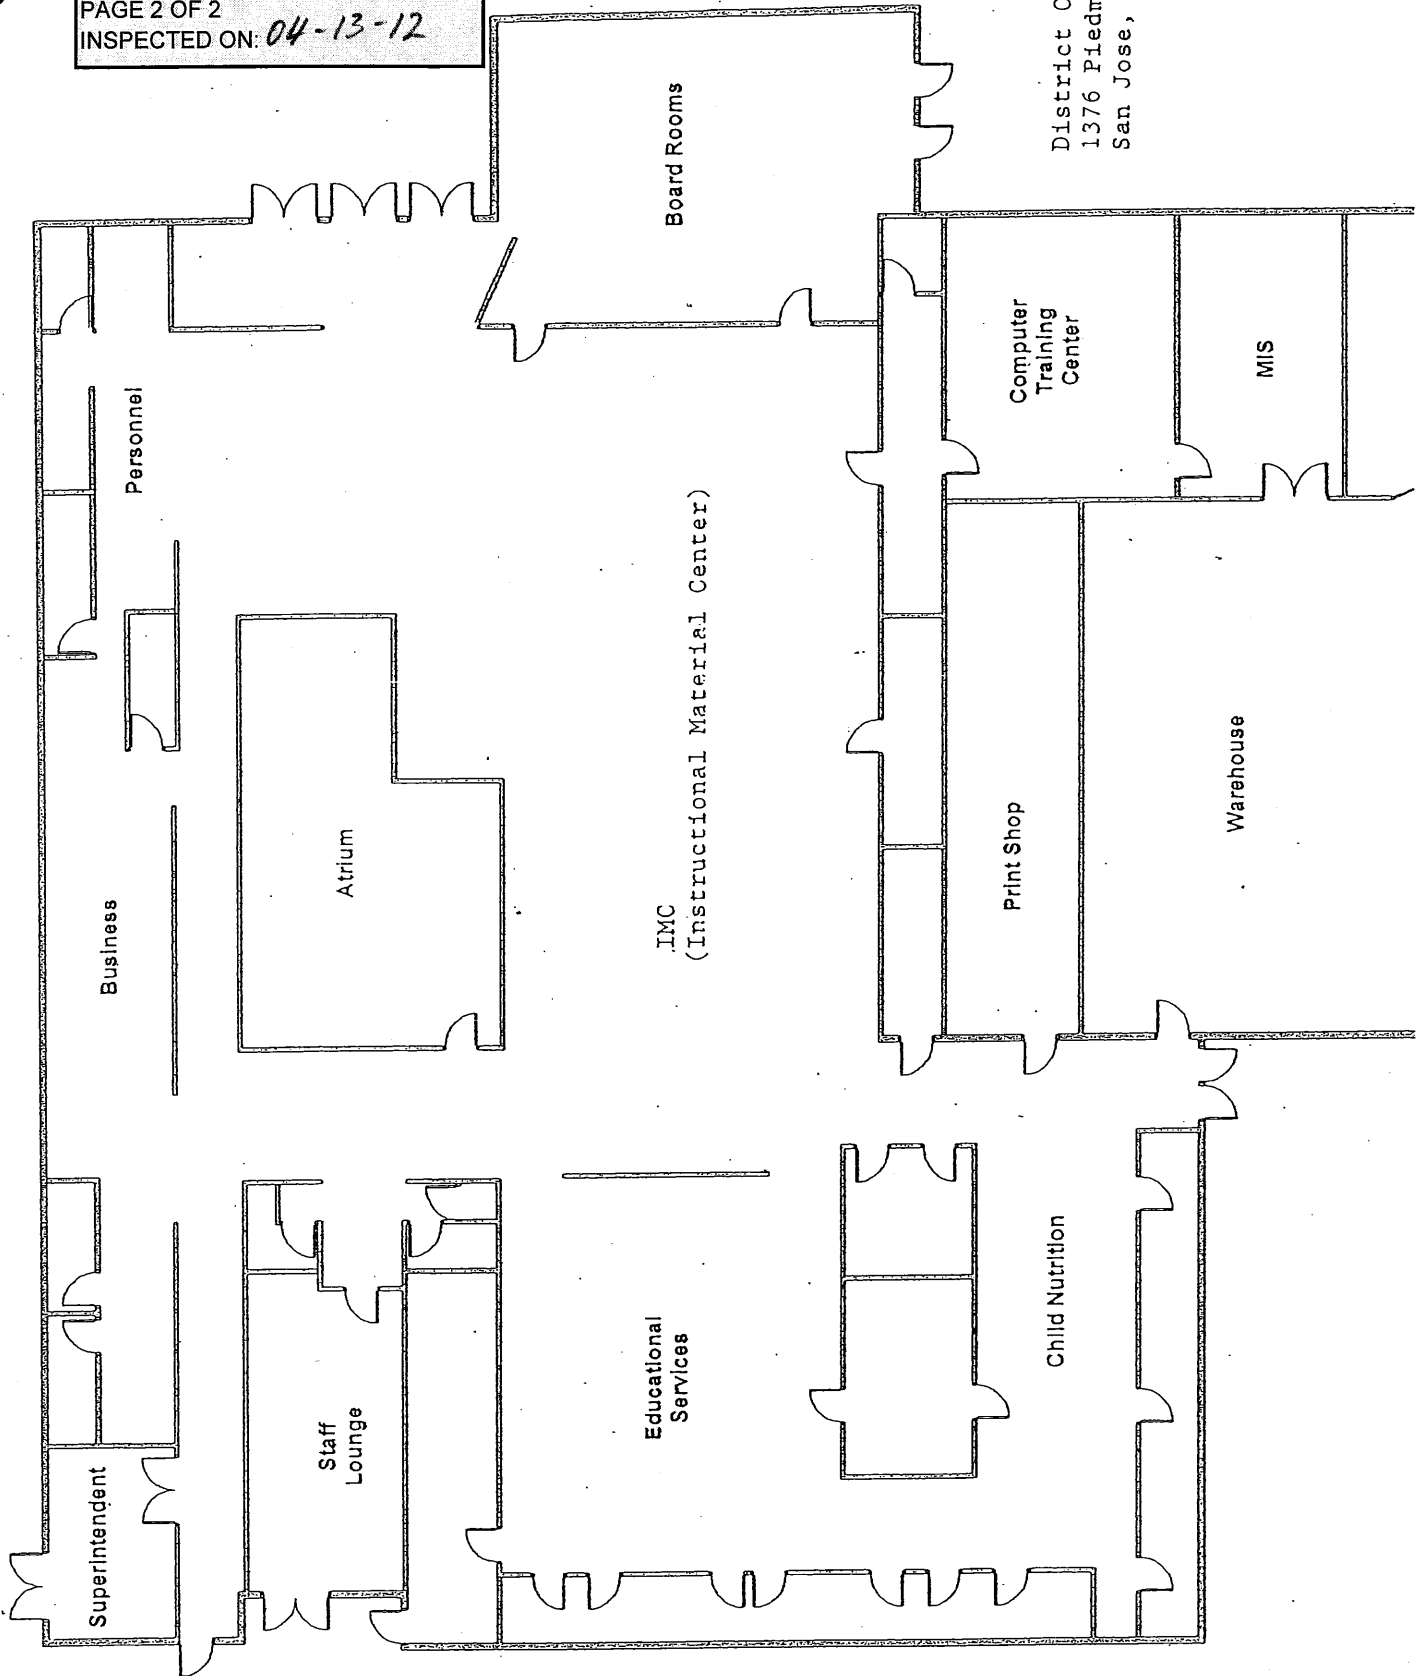
District Office
1376 Piedmont Rd.
San Jose, Ca. 95132

A simple rectangular box representing a metal container. An arrow points from the text "Metal Container" to the box.
