## **SIX-MONTH SURVEILLANCE AHERA REPORT**

**BUESD MAINTENANCE AND TRANSPORTATION YARD  
945 PIEDMONT ROAD  
SAN JOSE, CA 95132**

**PREPARED FOR:  
BERRYESSA UNION ELEMENTARY SCHOOL DISTRICT  
1376 PIEDMONT ROAD  
SAN JOSE, CA 95132**

**HAZMAT DOC PROJECT #22-025**

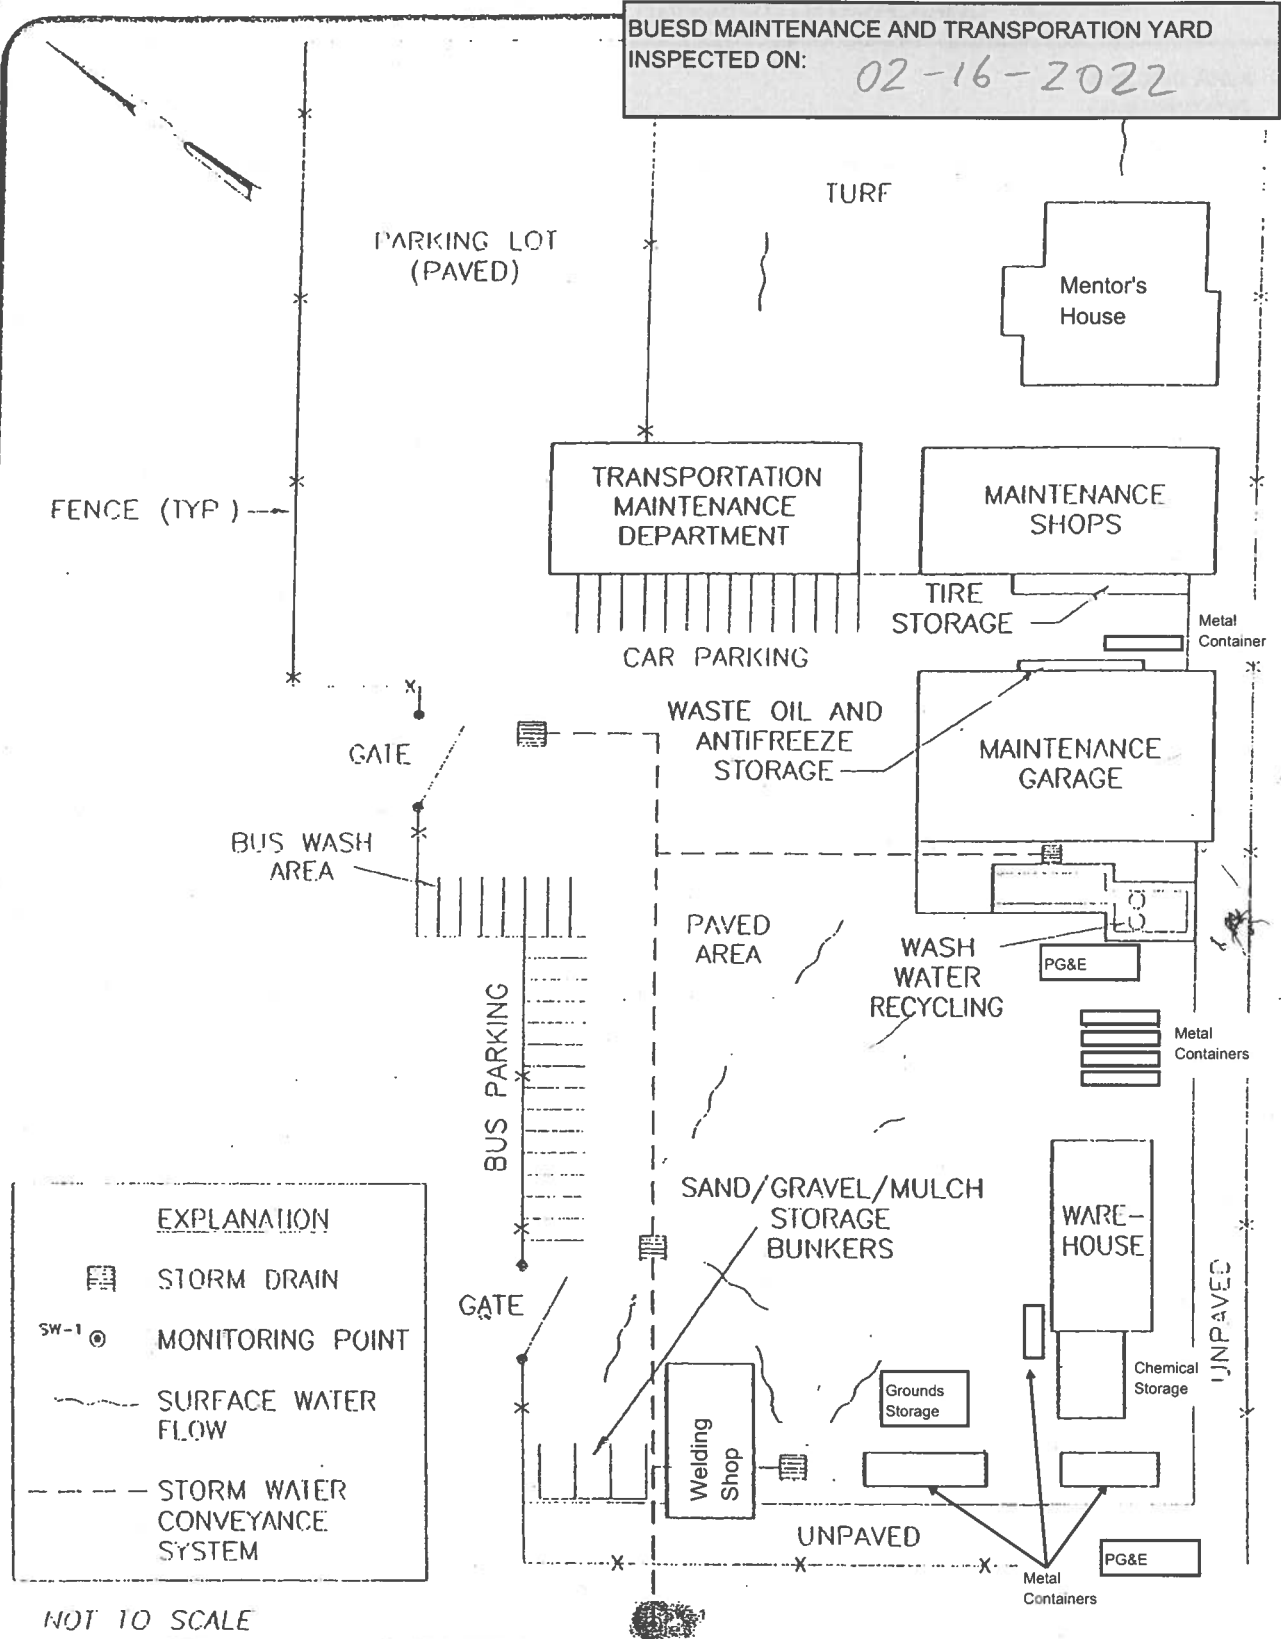
BUESD MAINTENANCE AND TRANSPORTATION YARD  
 INSPECTED ON: 02-16-2022

EXPLANATION	
	STORM DRAIN
SW-1	MONITORING POINT
	SURFACE WATER FLOW
	STORM WATER CONVEYANCE SYSTEM

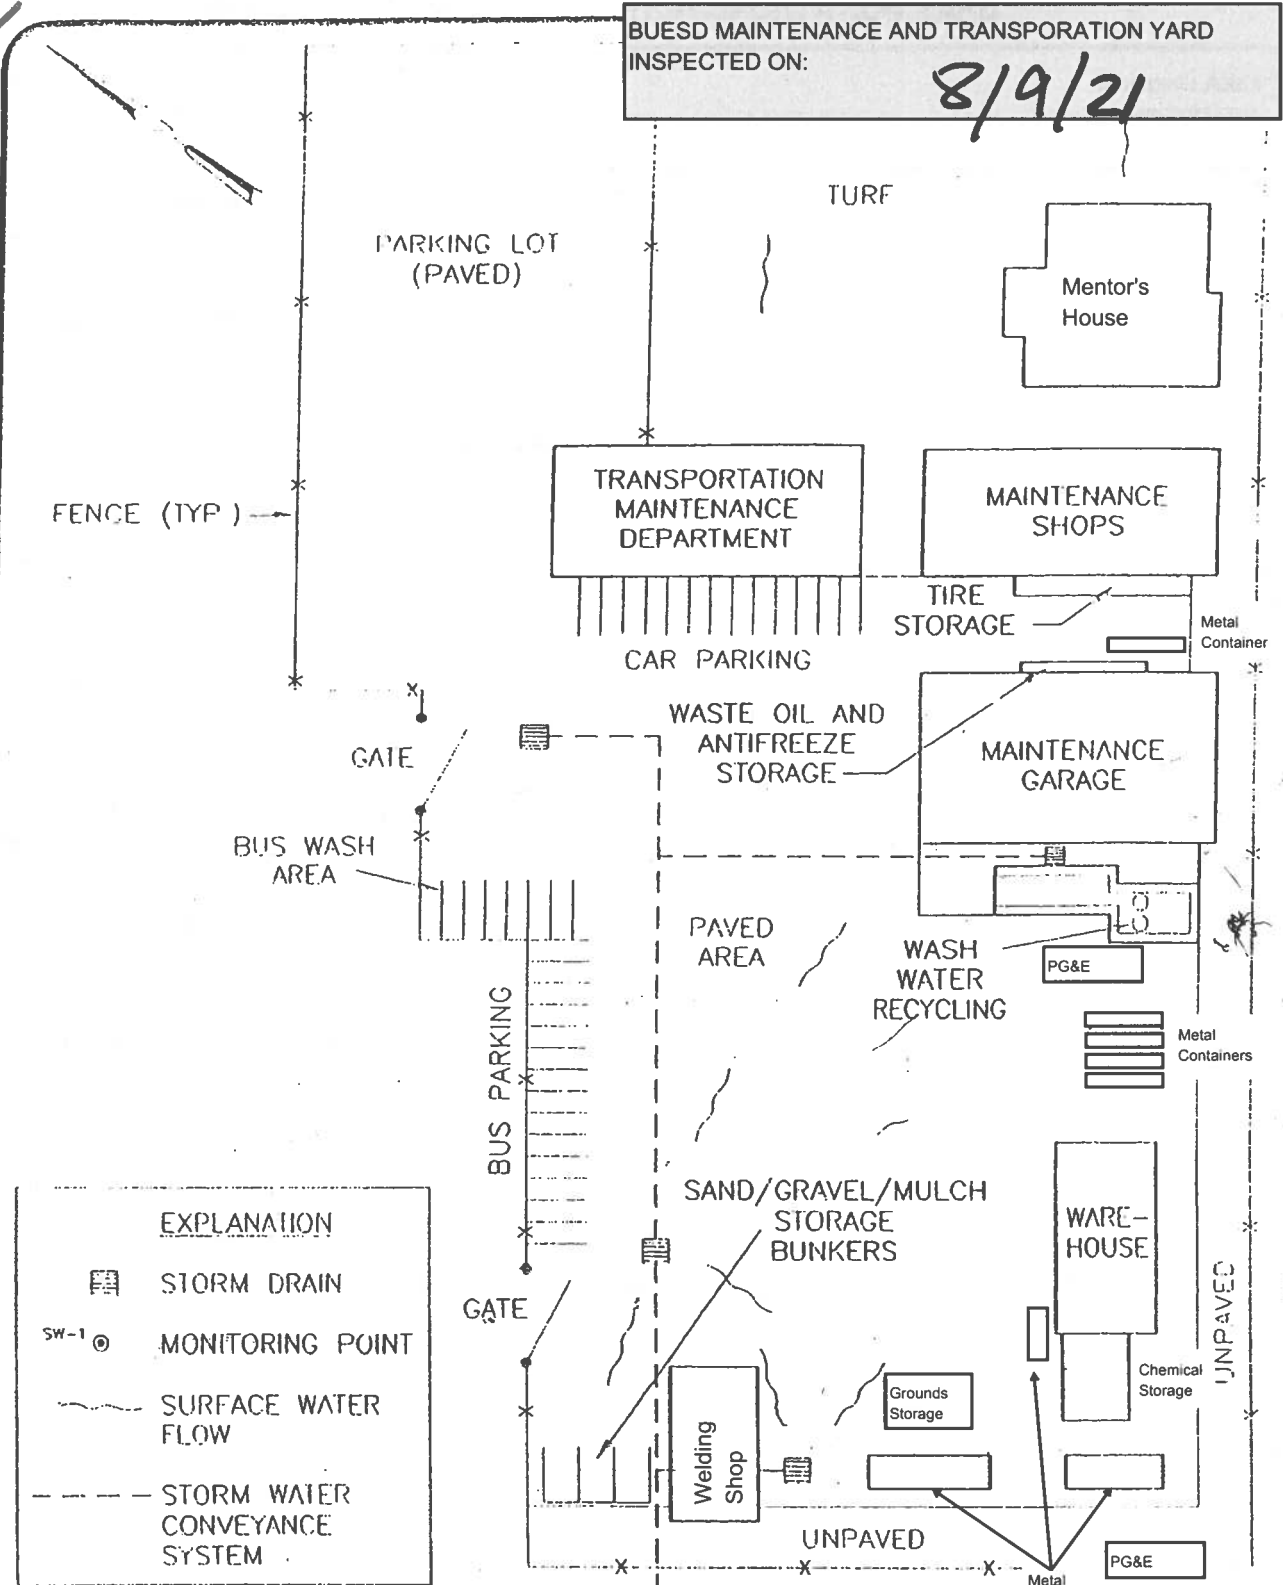
BUESD MAINTENANCE AND TRANSPORTATION YARD  
INSPECTED ON:

EXPLANATION	
	STORM DRAIN
SW-1	MONITORING POINT
	SURFACE WATER FLOW
	STORM WATER CONVEYANCE SYSTEM

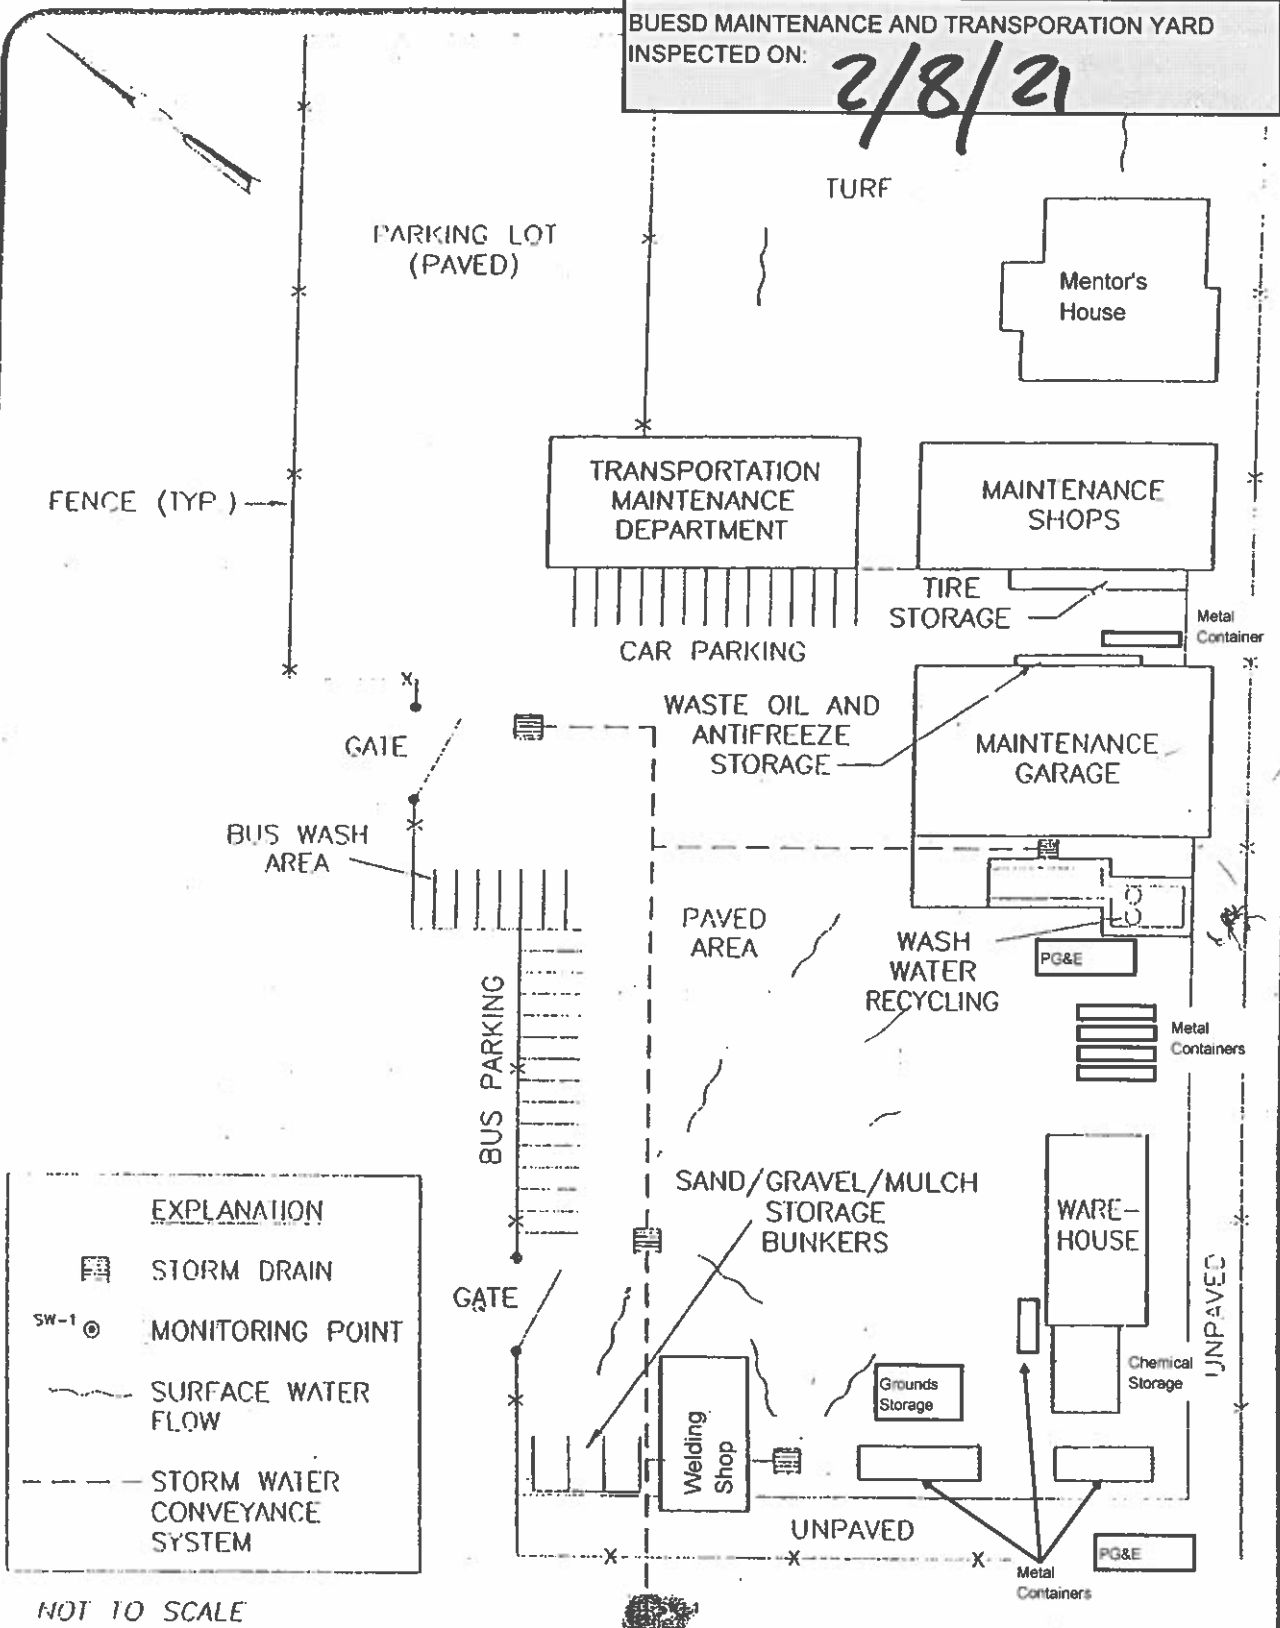
BUESD MAINTENANCE AND TRANSPORTATION YARD  
 INSPECTED ON: 2/8/21

EXPLANATION	
	STORM DRAIN
SW-1	MONITORING POINT
	SURFACE WATER FLOW
	STORM WATER CONVEYANCE SYSTEM

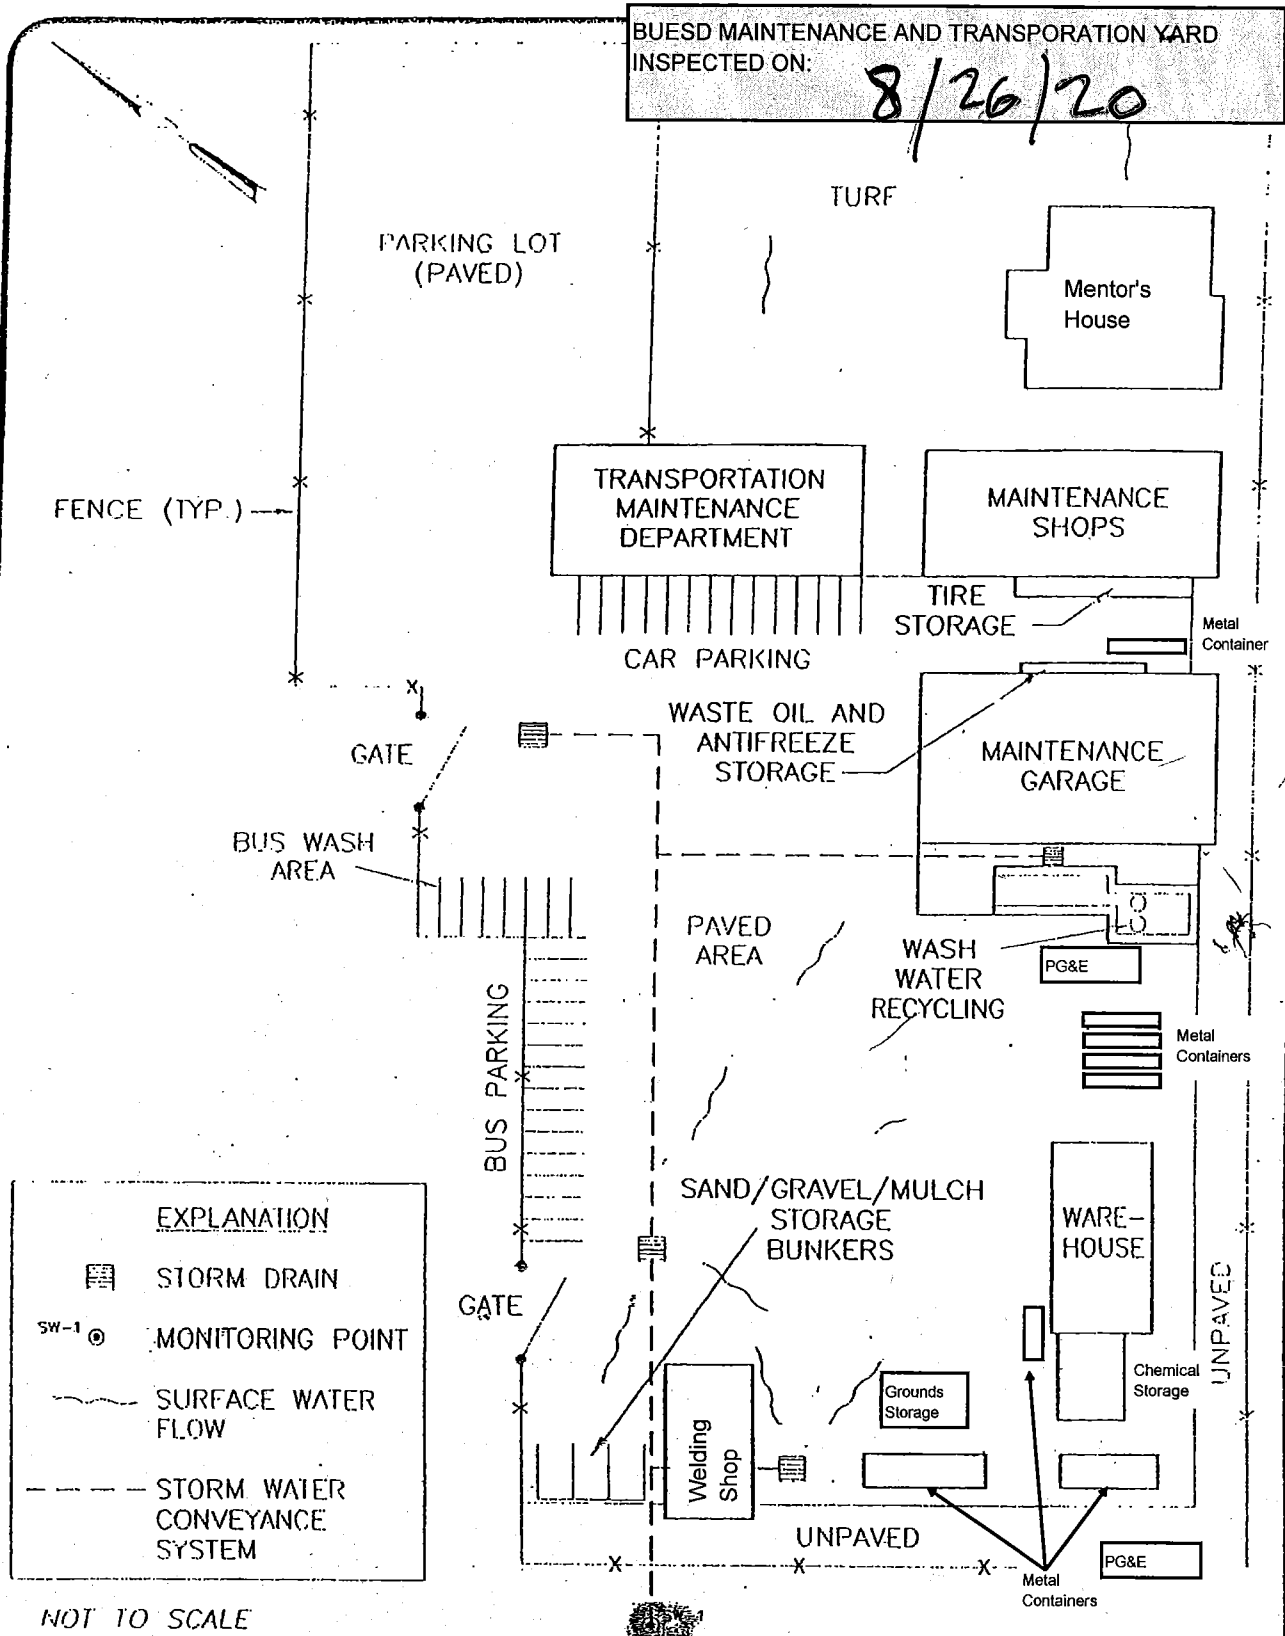
BUESD MAINTENANCE AND TRANSPORTATION YARD  
 INSPECTED ON: 8/26/20

EXPLANATION	
	STORM DRAIN
SW-1	MONITORING POINT
	SURFACE WATER FLOW
	STORM WATER CONVEYANCE SYSTEM

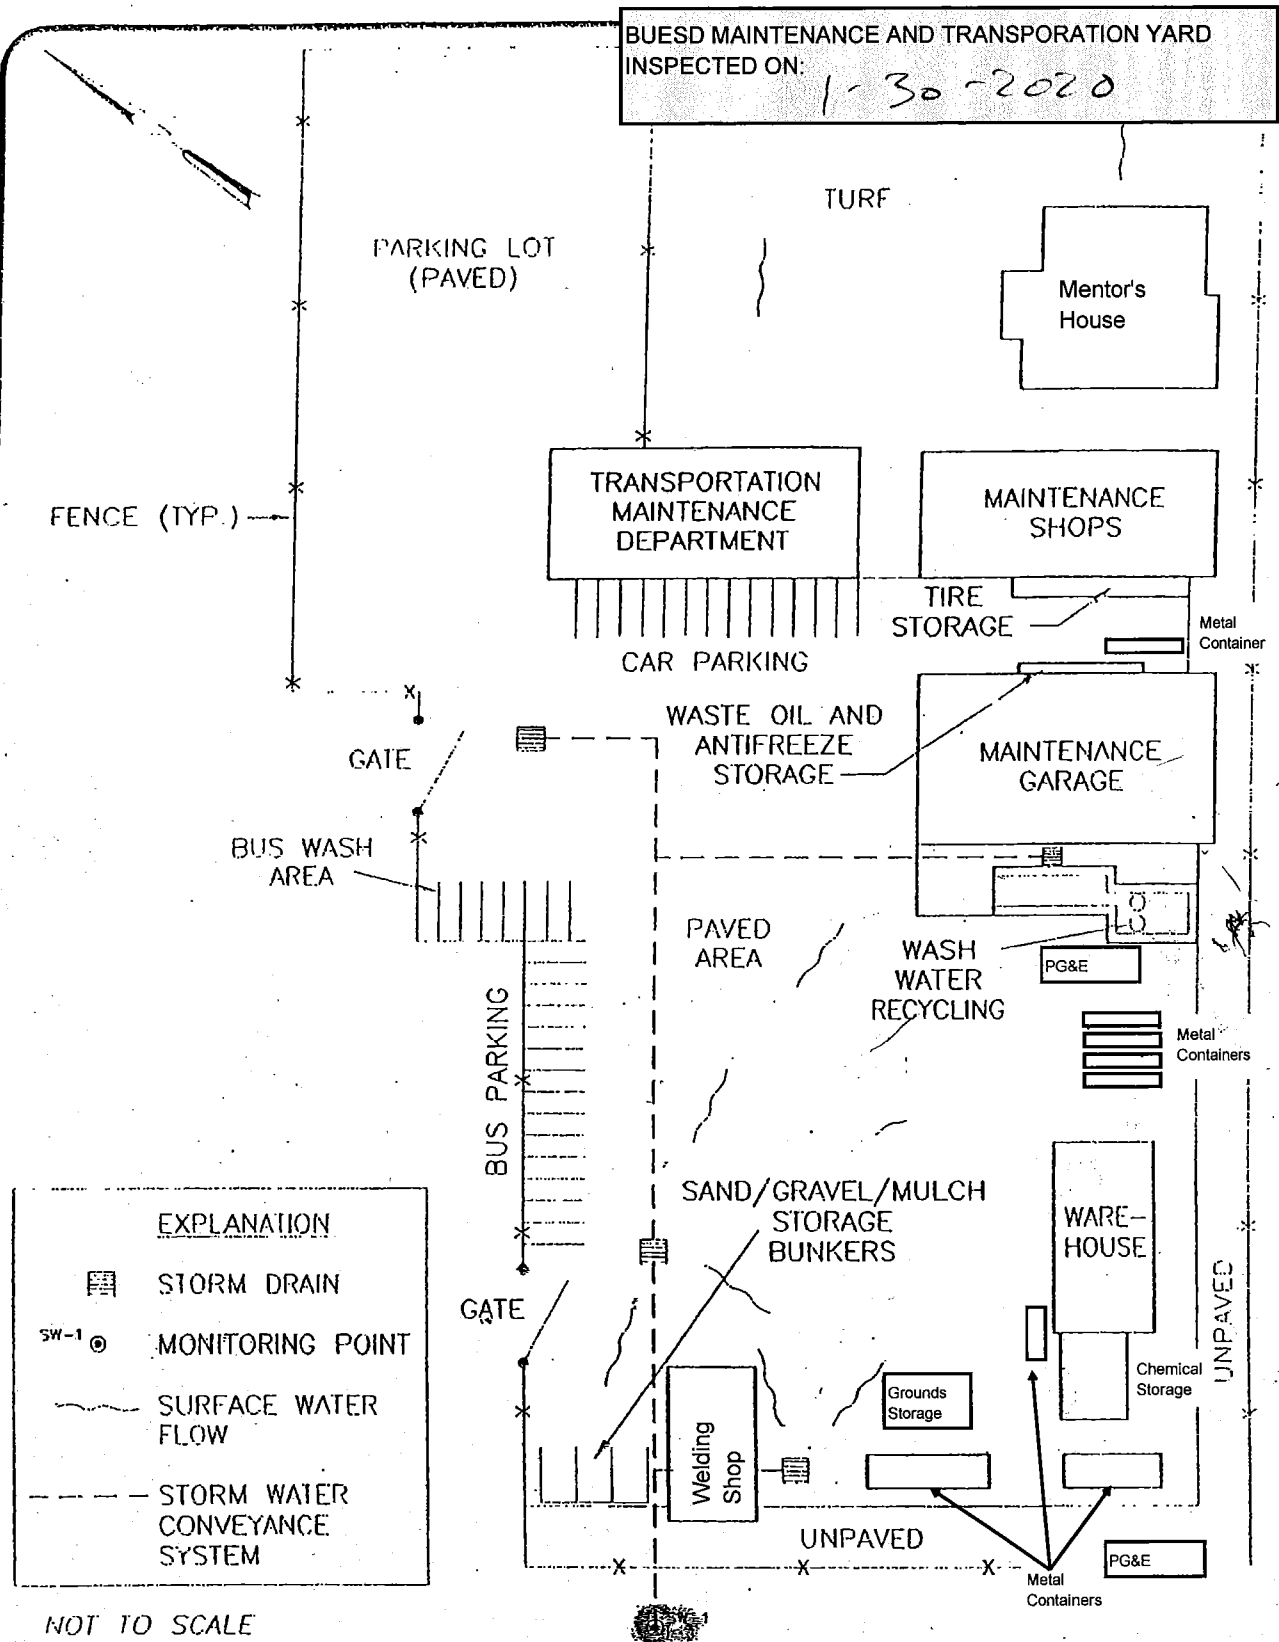
BUESD MAINTENANCE AND TRANSPORTATION YARD  
 INSPECTED ON: 1-30-2020

EXPLANATION	
	STORM DRAIN
SW-1	MONITORING POINT
	SURFACE WATER FLOW
	STORM WATER CONVEYANCE SYSTEM

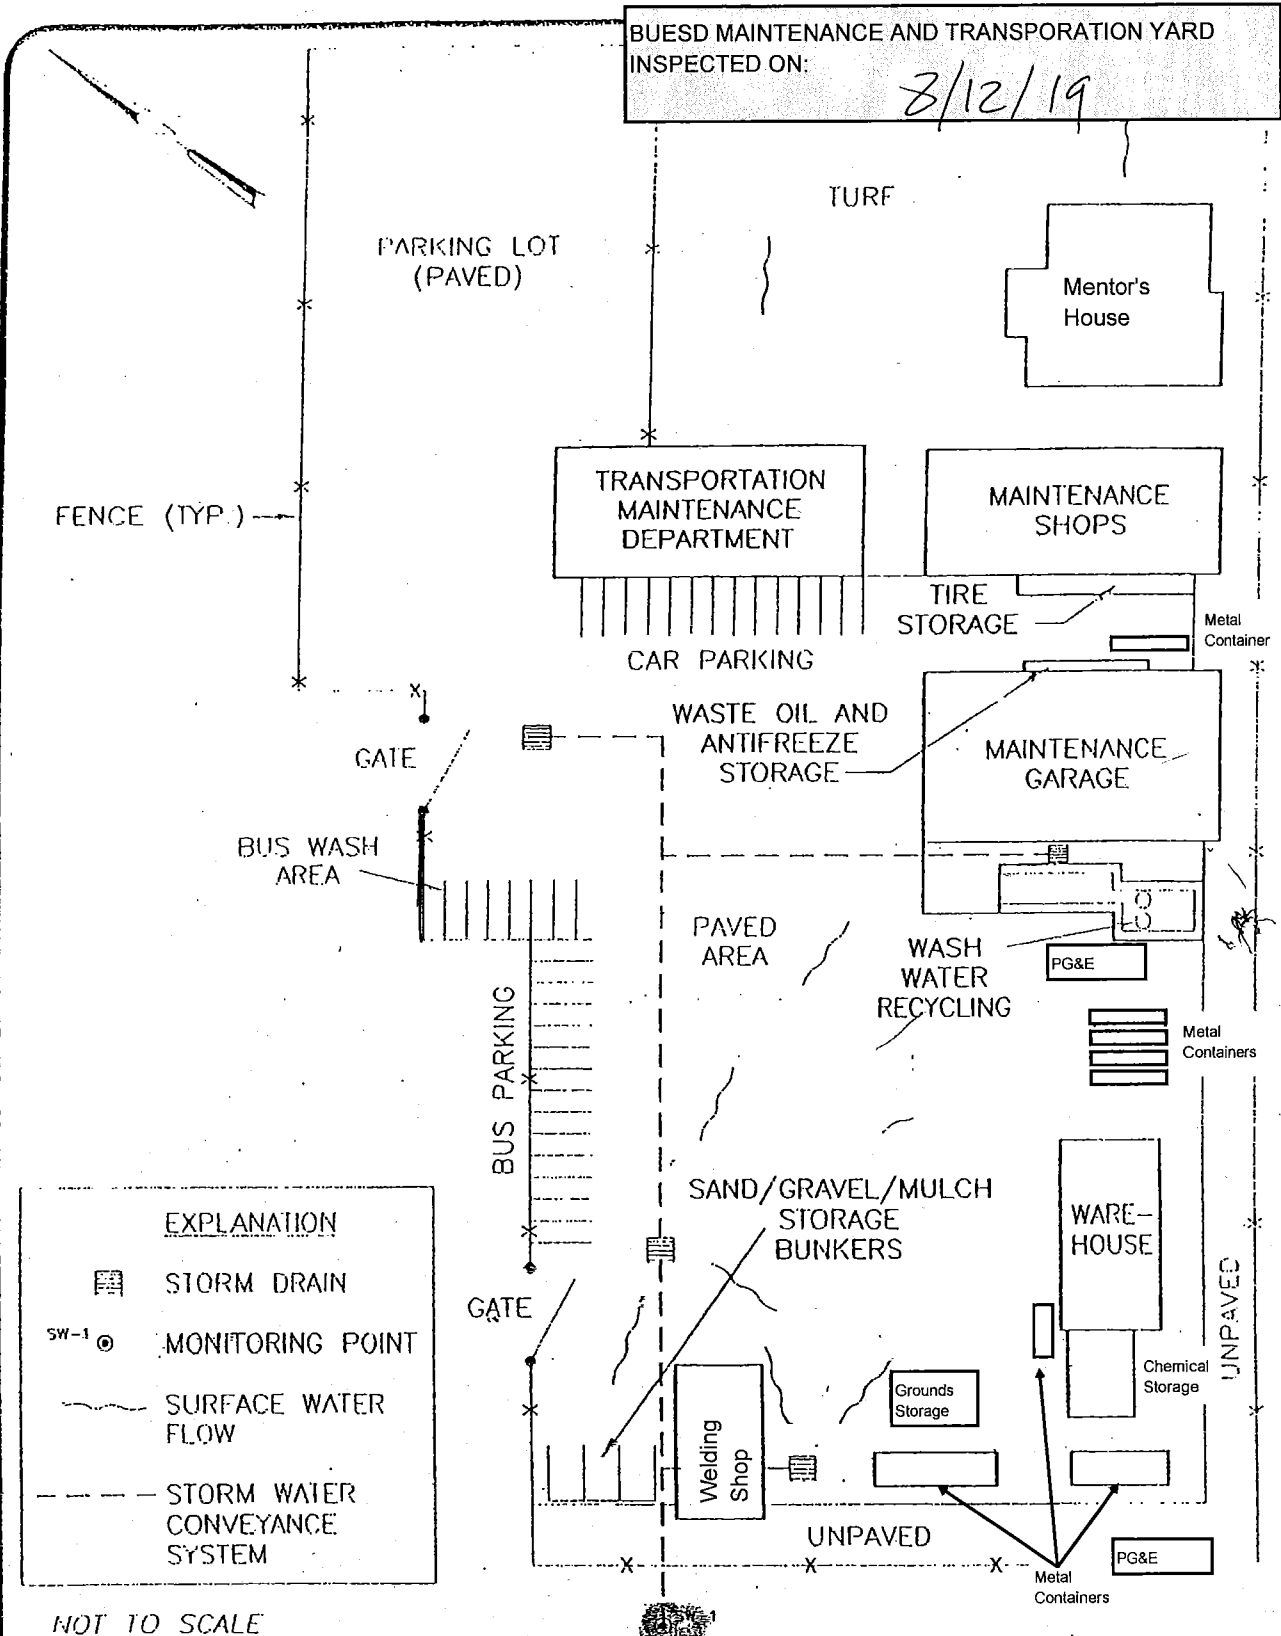
BUESD MAINTENANCE AND TRANSPORTATION YARD  
 INSPECTED ON: 8/12/19

EXPLANATION	
	STORM DRAIN
SW-1	MONITORING POINT
	SURFACE WATER FLOW
	STORM WATER CONVEYANCE SYSTEM

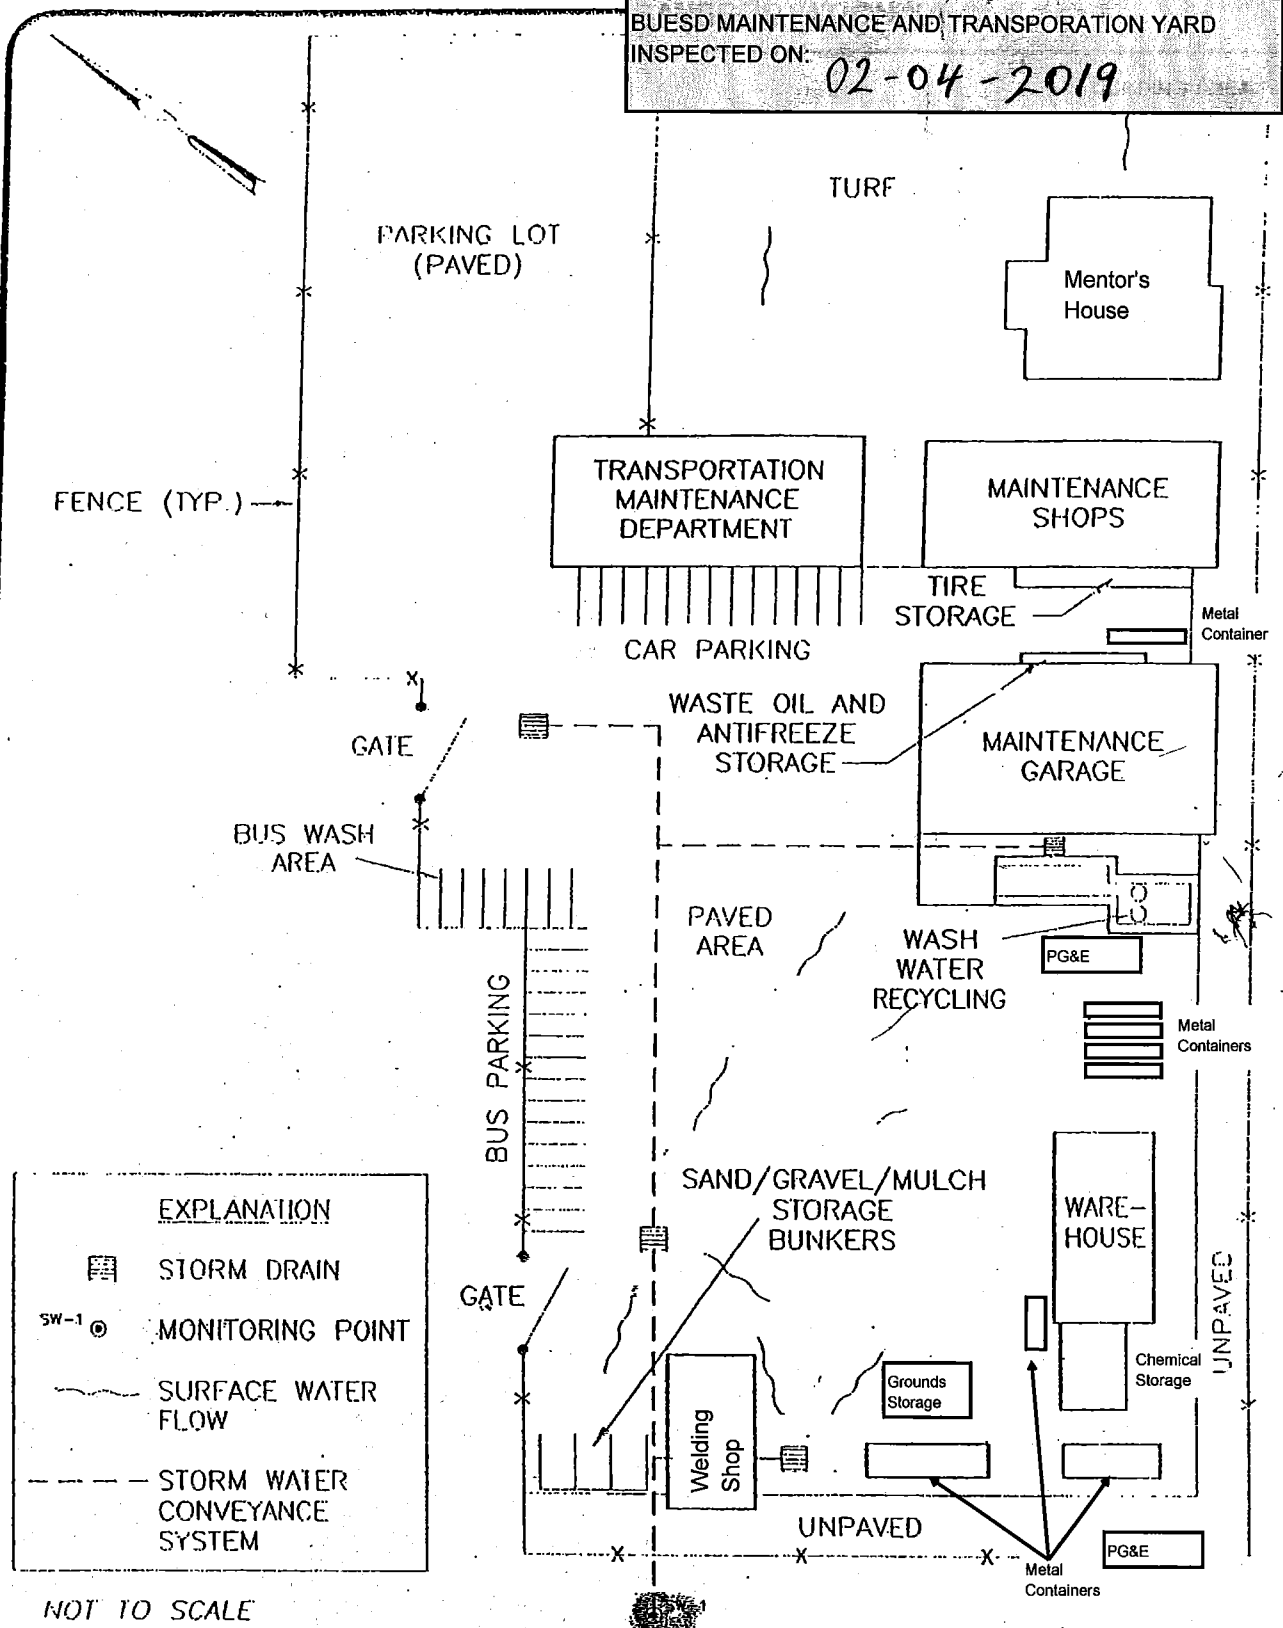
BUESD MAINTENANCE AND TRANSPORTATION YARD  
INSPECTED ON: 02-04-2019

EXPLANATION	
	STORM DRAIN
SW-1	MONITORING POINT
	SURFACE WATER FLOW
	STORM WATER CONVEYANCE SYSTEM

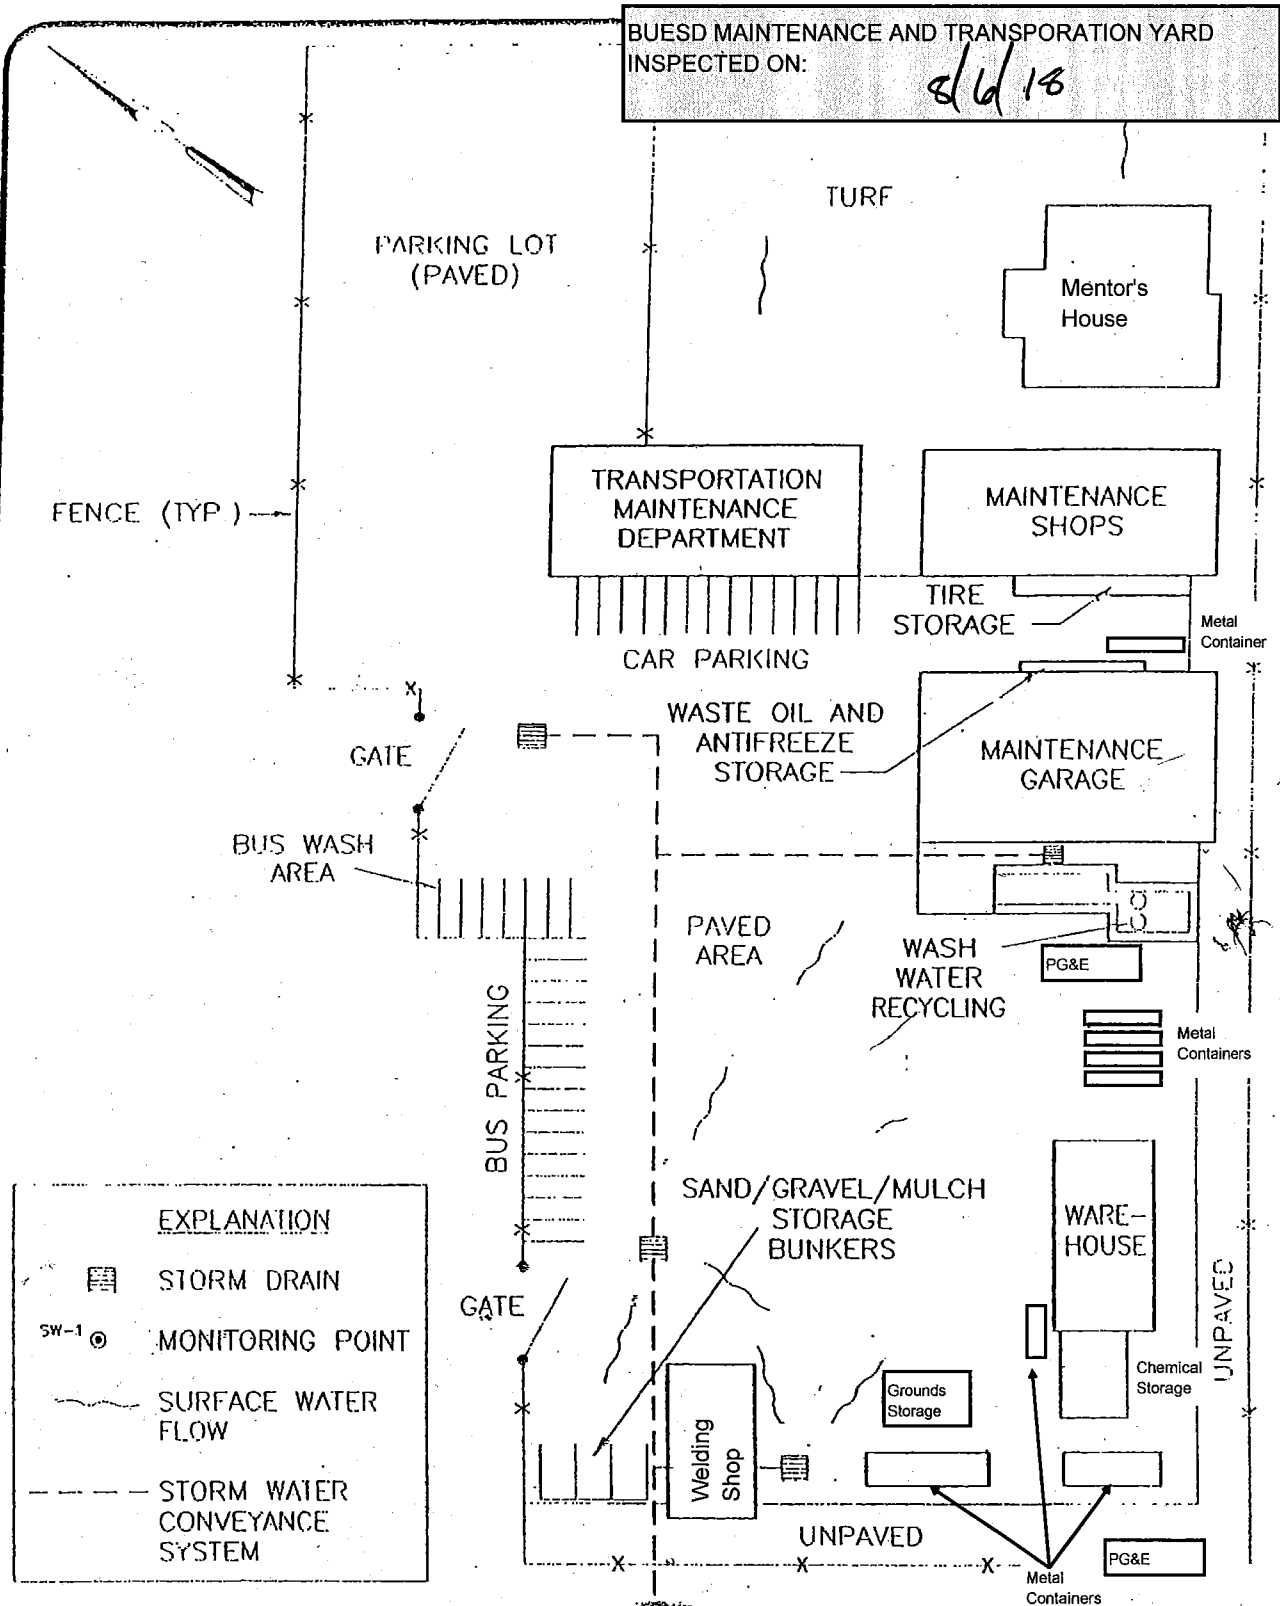
BUESD MAINTENANCE AND TRANSPORTATION YARD  
 INSPECTED ON: 8/6/18

EXPLANATION	
	STORM DRAIN
	MONITORING POINT
	SURFACE WATER FLOW
	STORM WATER CONVEYANCE SYSTEM

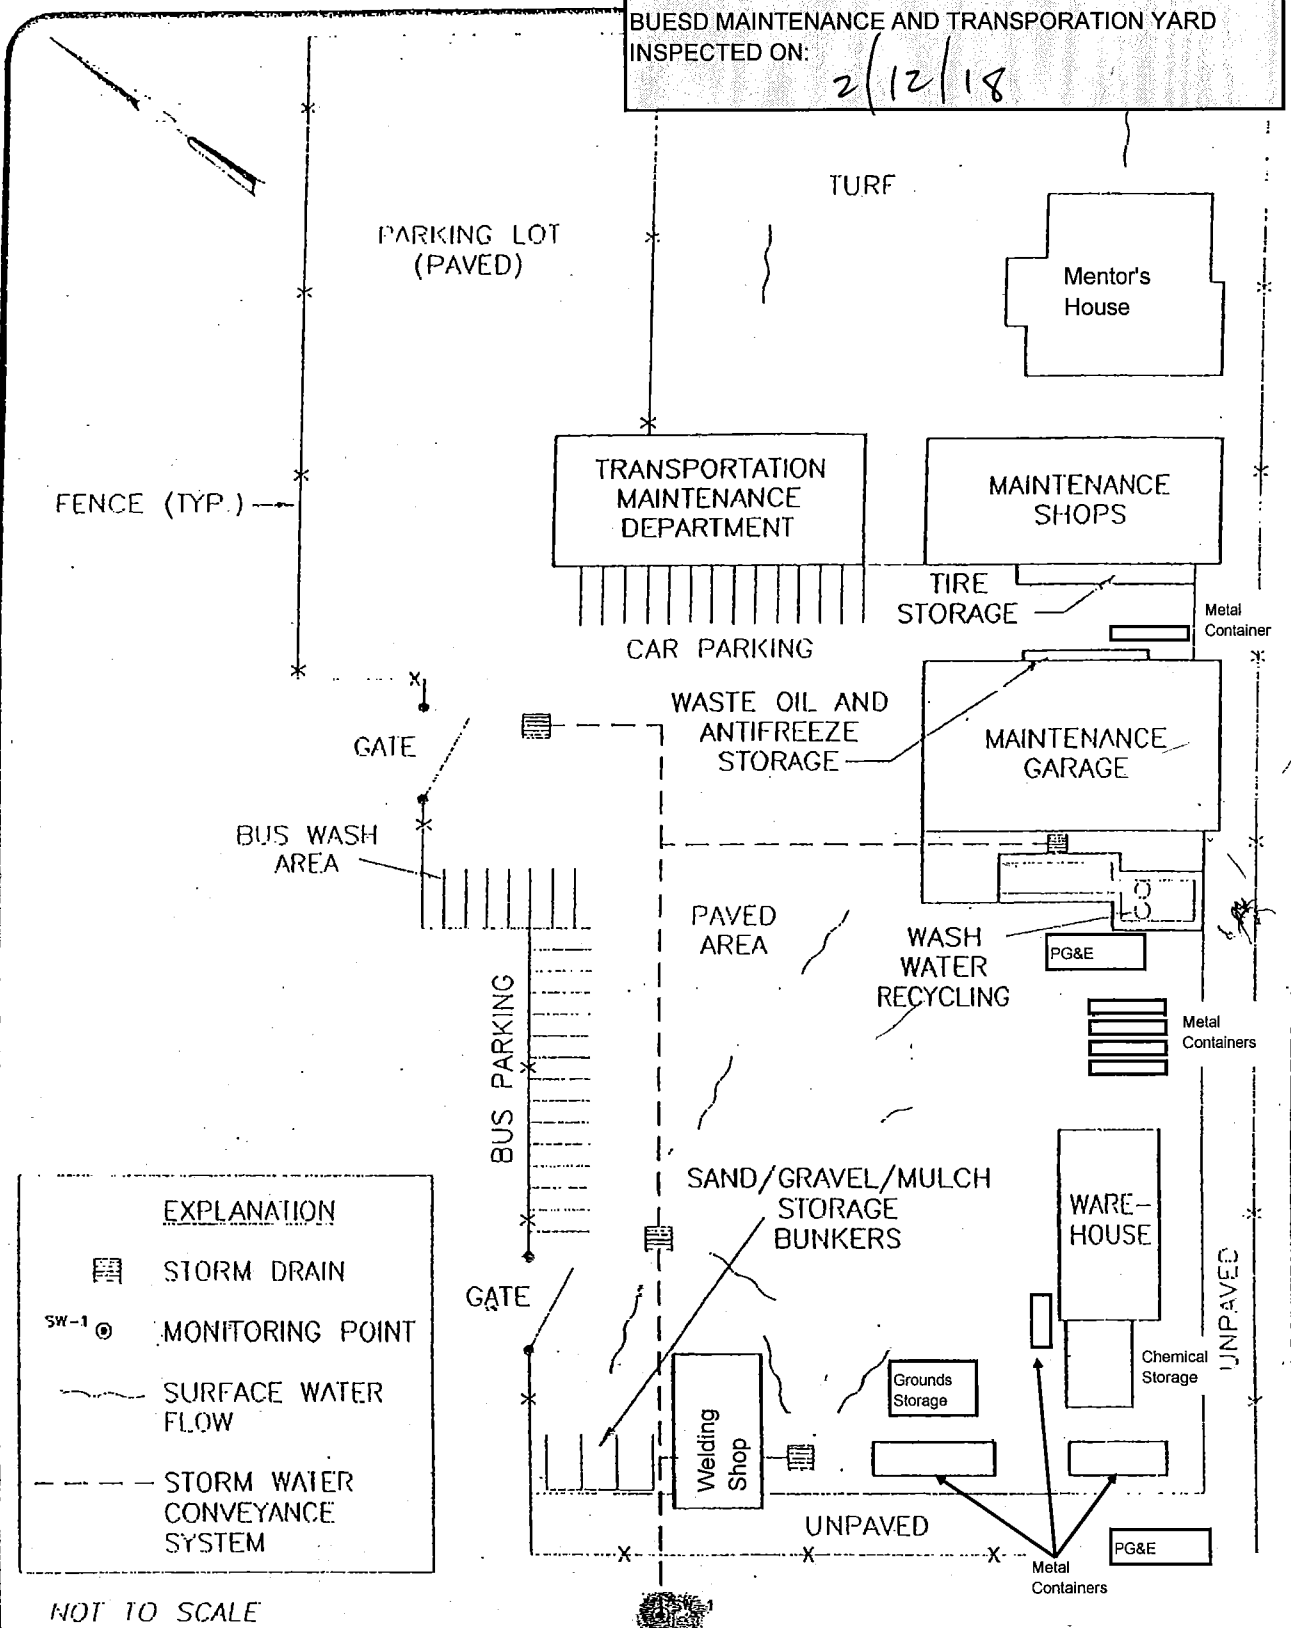
BUESD MAINTENANCE AND TRANSPORTATION YARD  
 INSPECTED ON: 2/12/18

EXPLANATION	
	STORM DRAIN
SW-1	MONITORING POINT
	SURFACE WATER FLOW
	STORM WATER CONVEYANCE SYSTEM

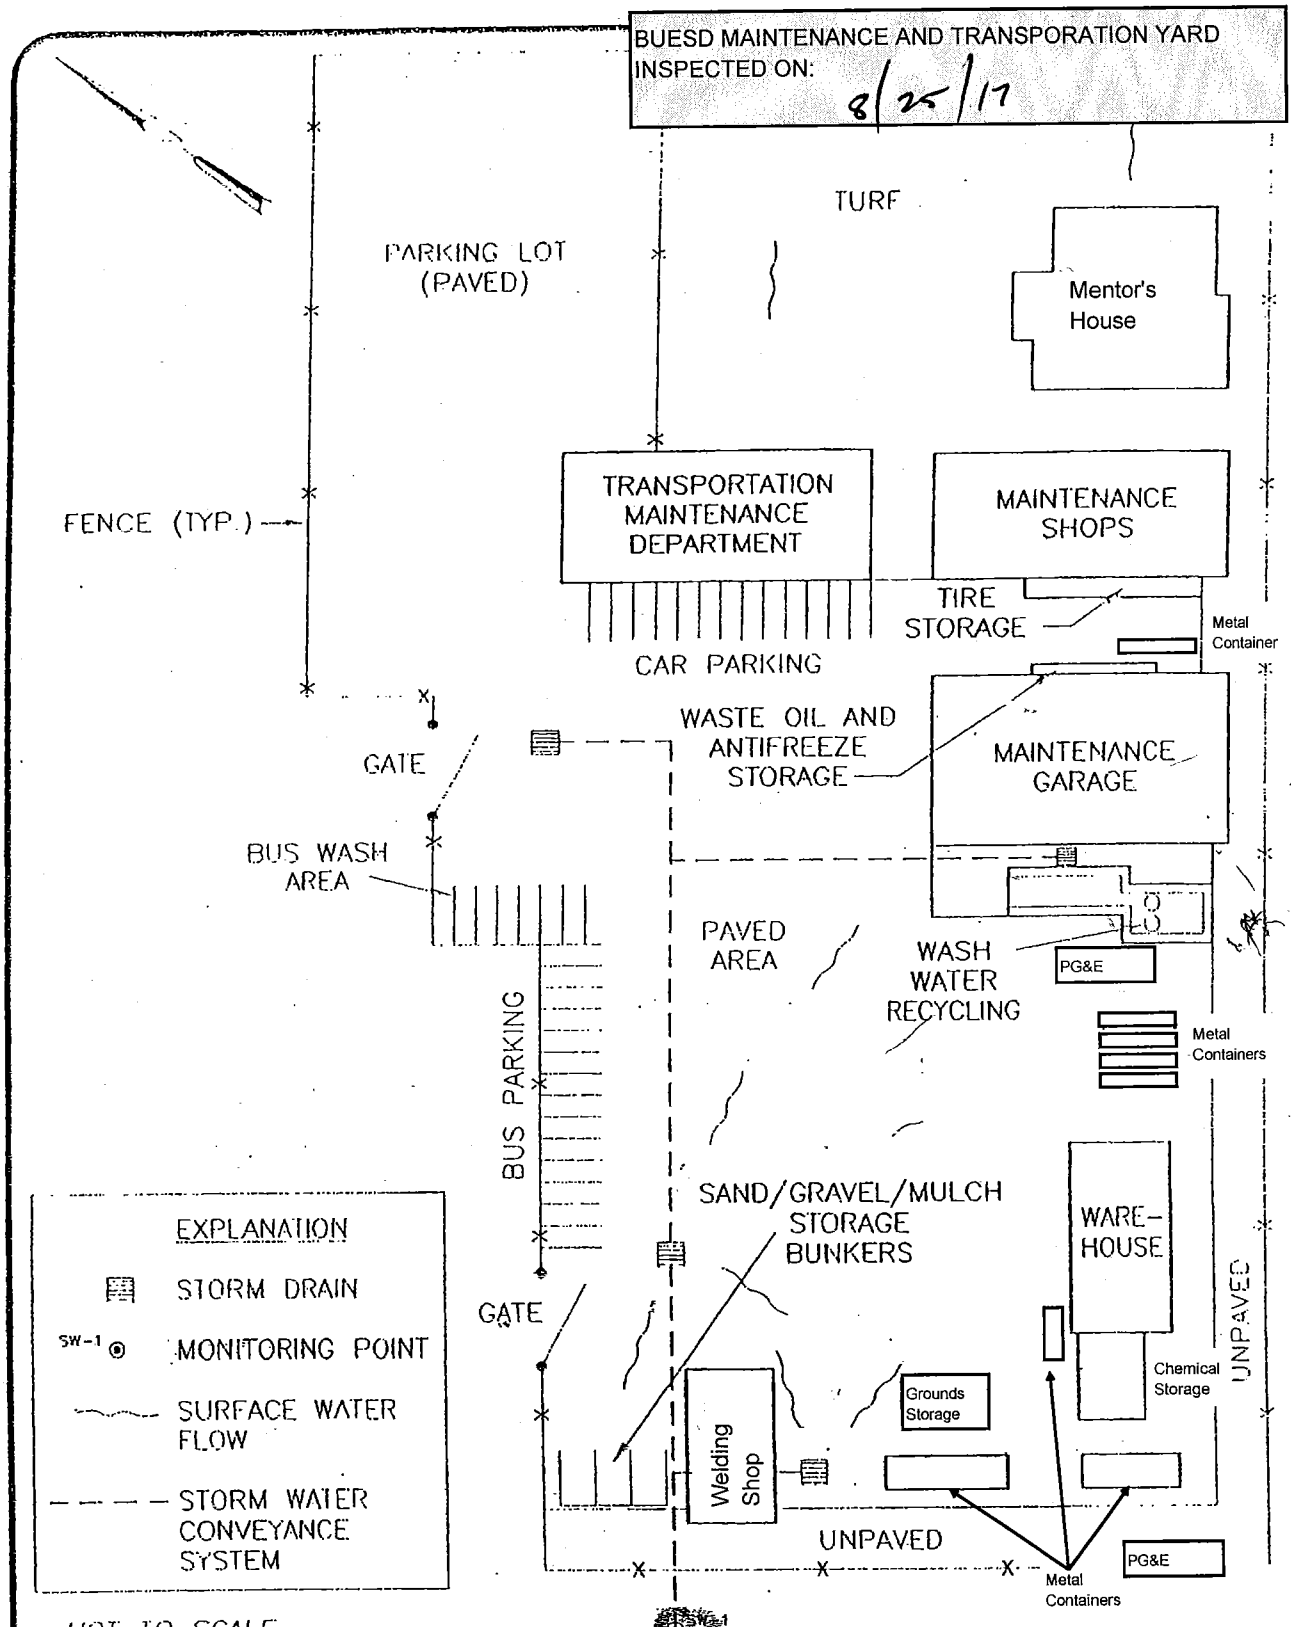
BUESD MAINTENANCE AND TRANSPORTATION YARD  
INSPECTED ON:

EXPLANATION	
	STORM DRAIN
SW-1	MONITORING POINT
	SURFACE WATER FLOW
	STORM WATER CONVEYANCE SYSTEM
