## **SIX-MONTH SURVEILLANCE AHERA REPORT**

**BUESD MAINTENANCE AND TRANSPORTATION YARD  
945 PIEDMONT ROAD  
SAN JOSE, CA 95132**

**PREPARED FOR:  
BERRYESSA UNION ELEMENTARY SCHOOL DISTRICT  
1376 PIEDMONT ROAD  
SAN JOSE, CA 95132**

**HAZMAT DOC PROJECT #22-025**

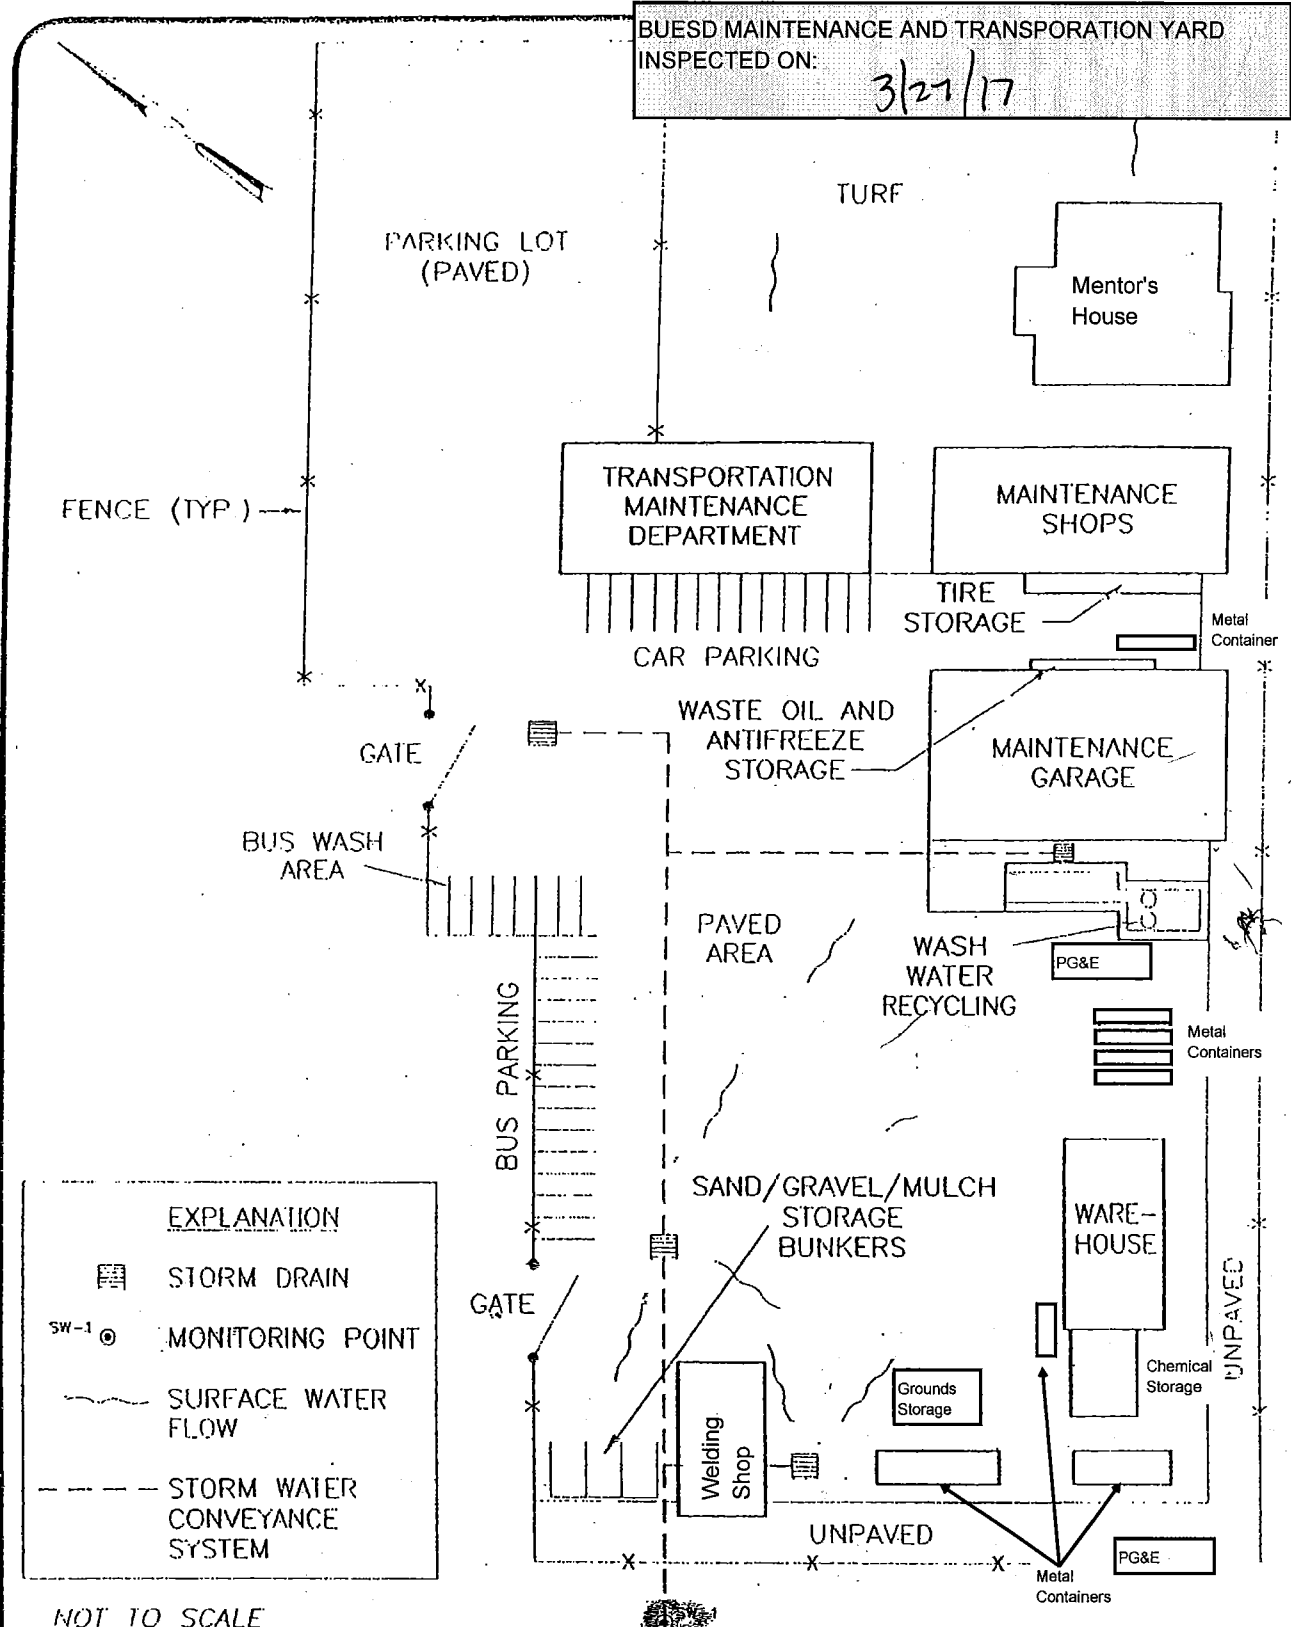
BUESD MAINTENANCE AND TRANSPORTATION YARD  
 INSPECTED ON: 3/27/17

EXPLANATION	
	STORM DRAIN
SW-1	MONITORING POINT
	SURFACE WATER FLOW
	STORM WATER CONVEYANCE SYSTEM

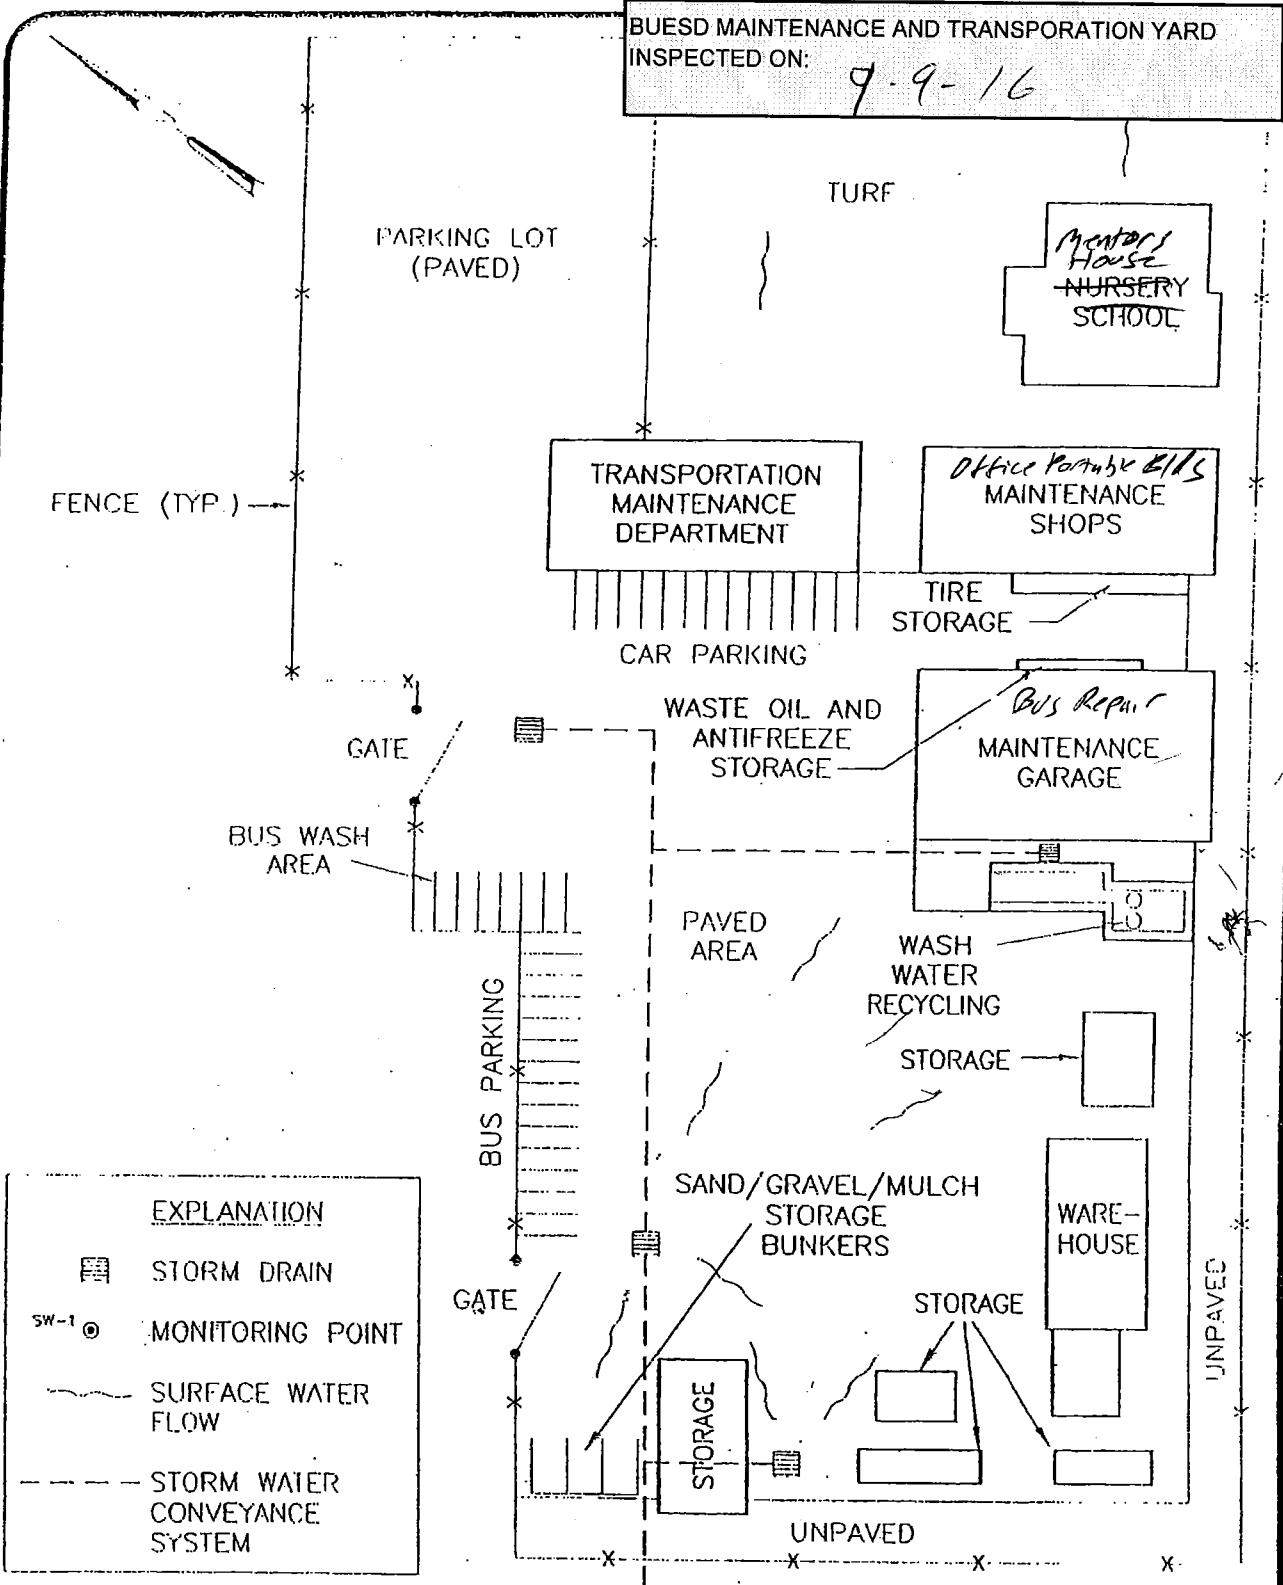
BUESD MAINTENANCE AND TRANSPORTATION YARD  
 INSPECTED ON: 7-9-16

EXPLANATION	
	STORM DRAIN
SW-1	MONITORING POINT
	SURFACE WATER FLOW
	STORM WATER CONVEYANCE SYSTEM

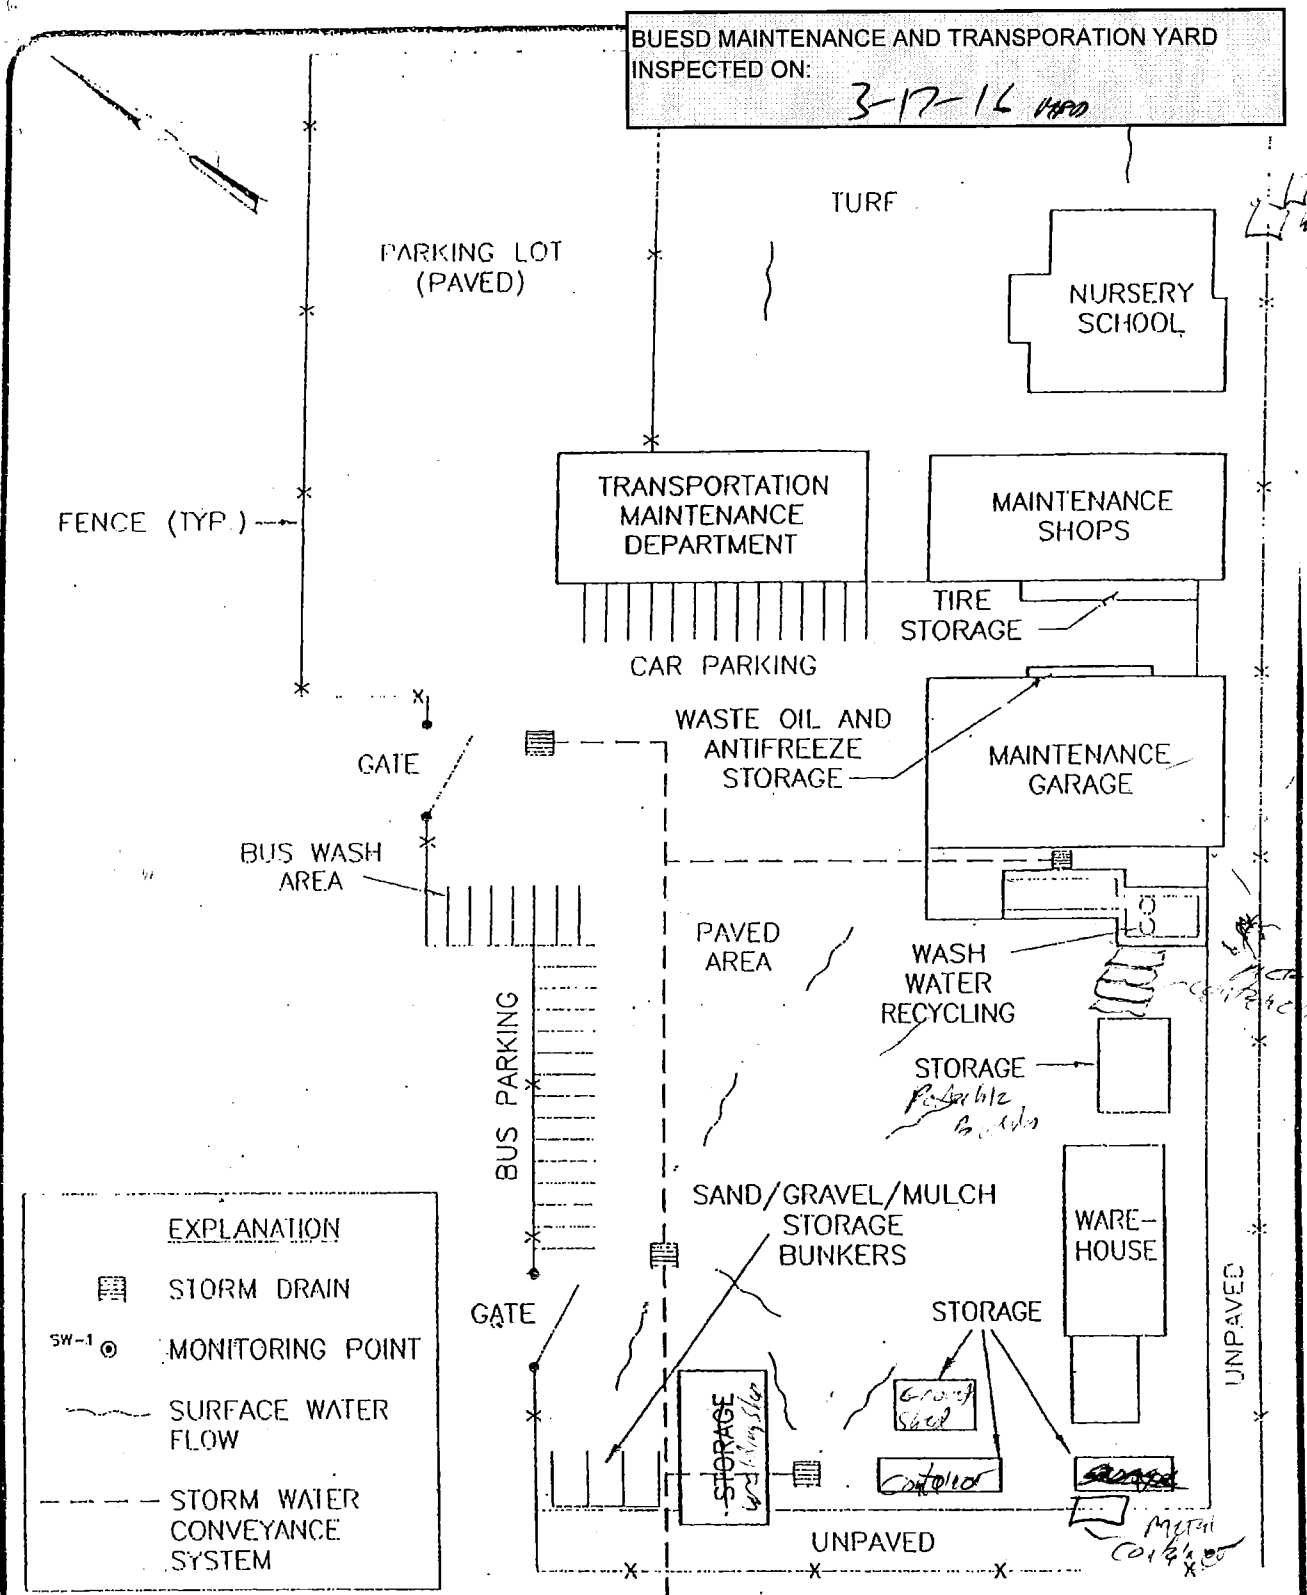
BUESD MAINTENANCE AND TRANSPORTATION YARD  
INSPECTED ON:

EXPLANATION	
	STORM DRAIN
	MONITORING POINT
	SURFACE WATER FLOW
	STORM WATER CONVEYANCE SYSTEM
