SIX-MONTH SURVEILLANCE AHERA REPORT

**BUESD DISTRICT OFFICE
1376 PIEDMONT ROAD
SAN JOSE, CA 95132**

**INSPECTED ON:
Mar. 28, 2017**

HAZMAT DOC PROJECT #17-059

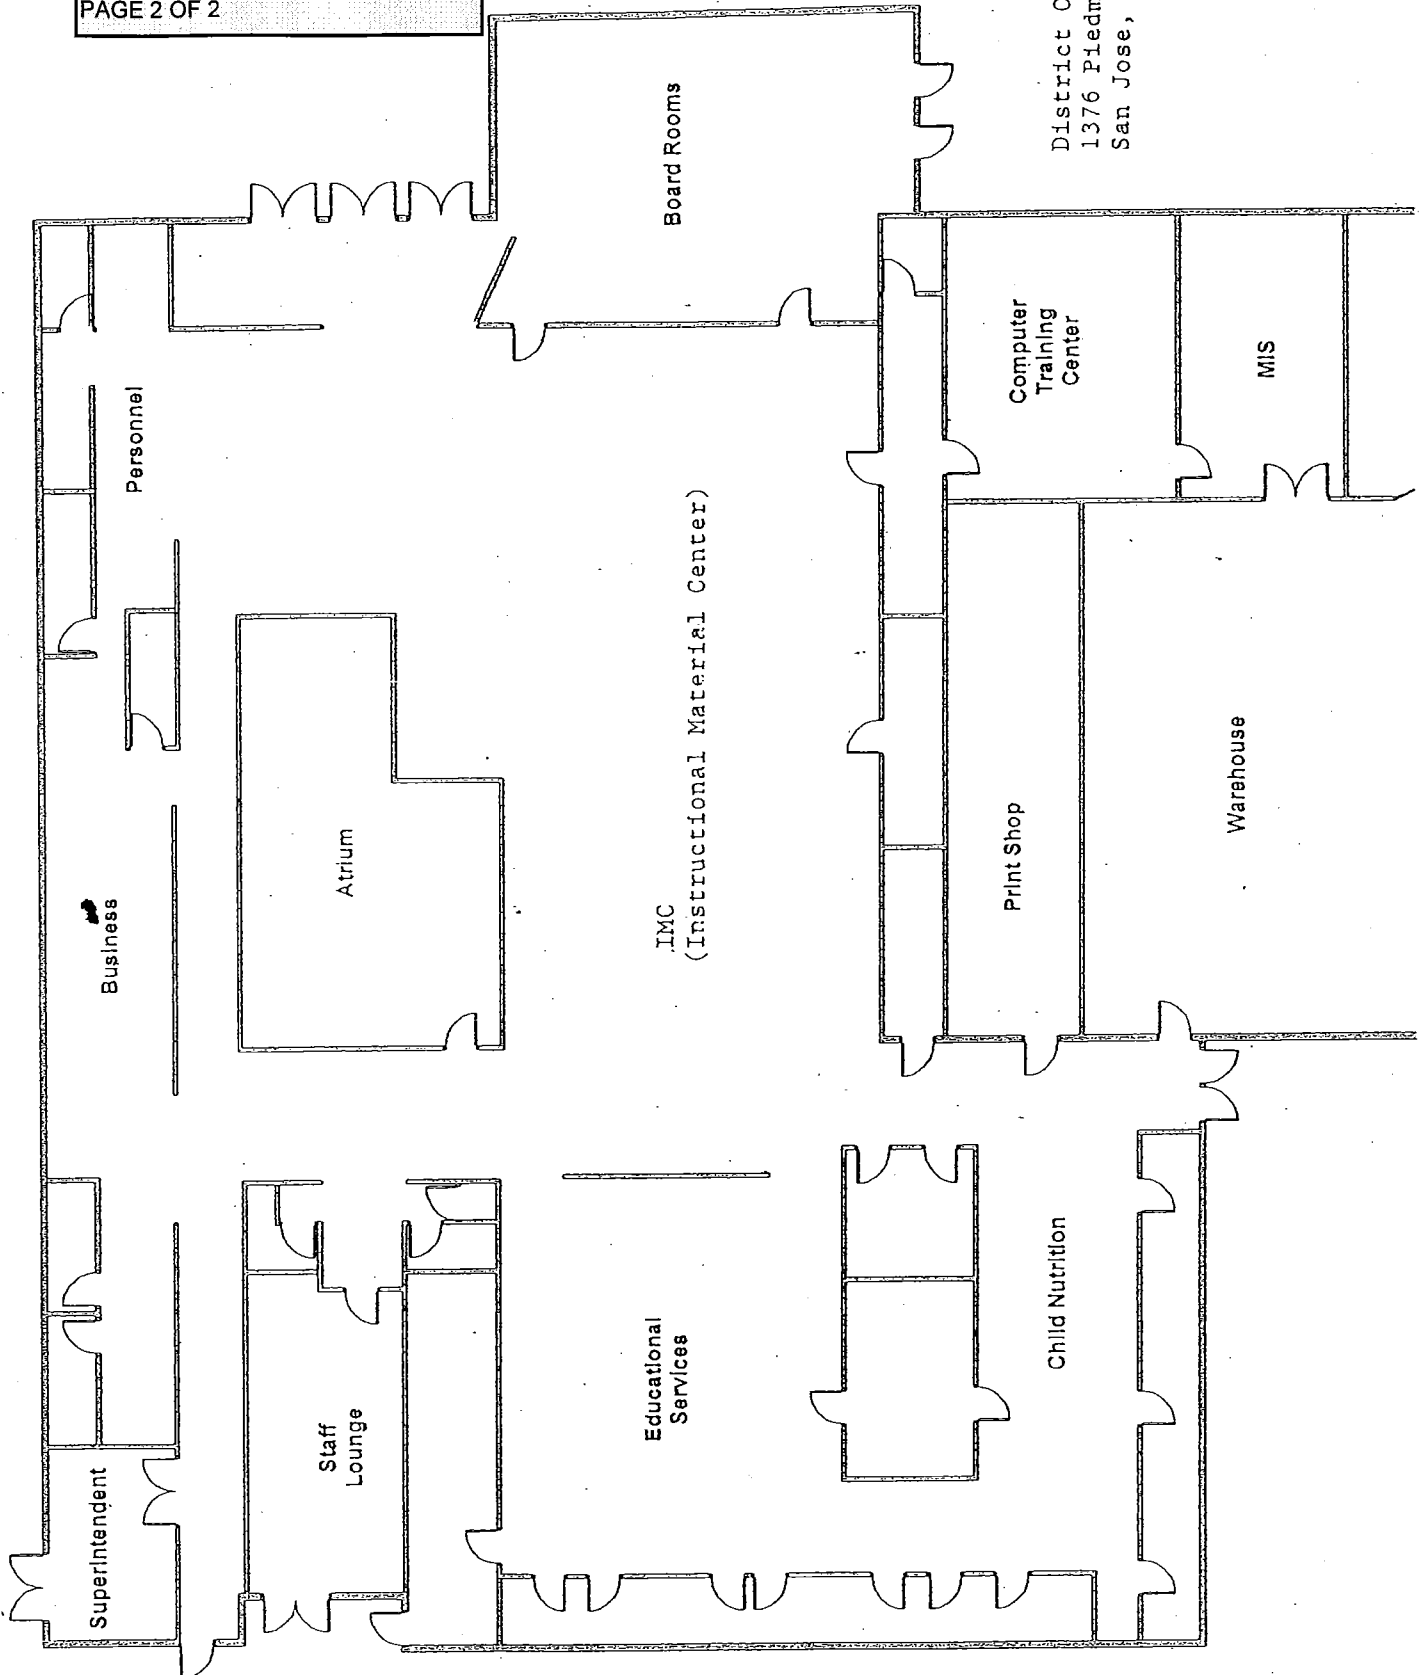
BUESD DISTRICT OFFICES
PAGE 2 OF 2

District Office
1376 Piedmont Rd.
San Jose, Ca. 95132

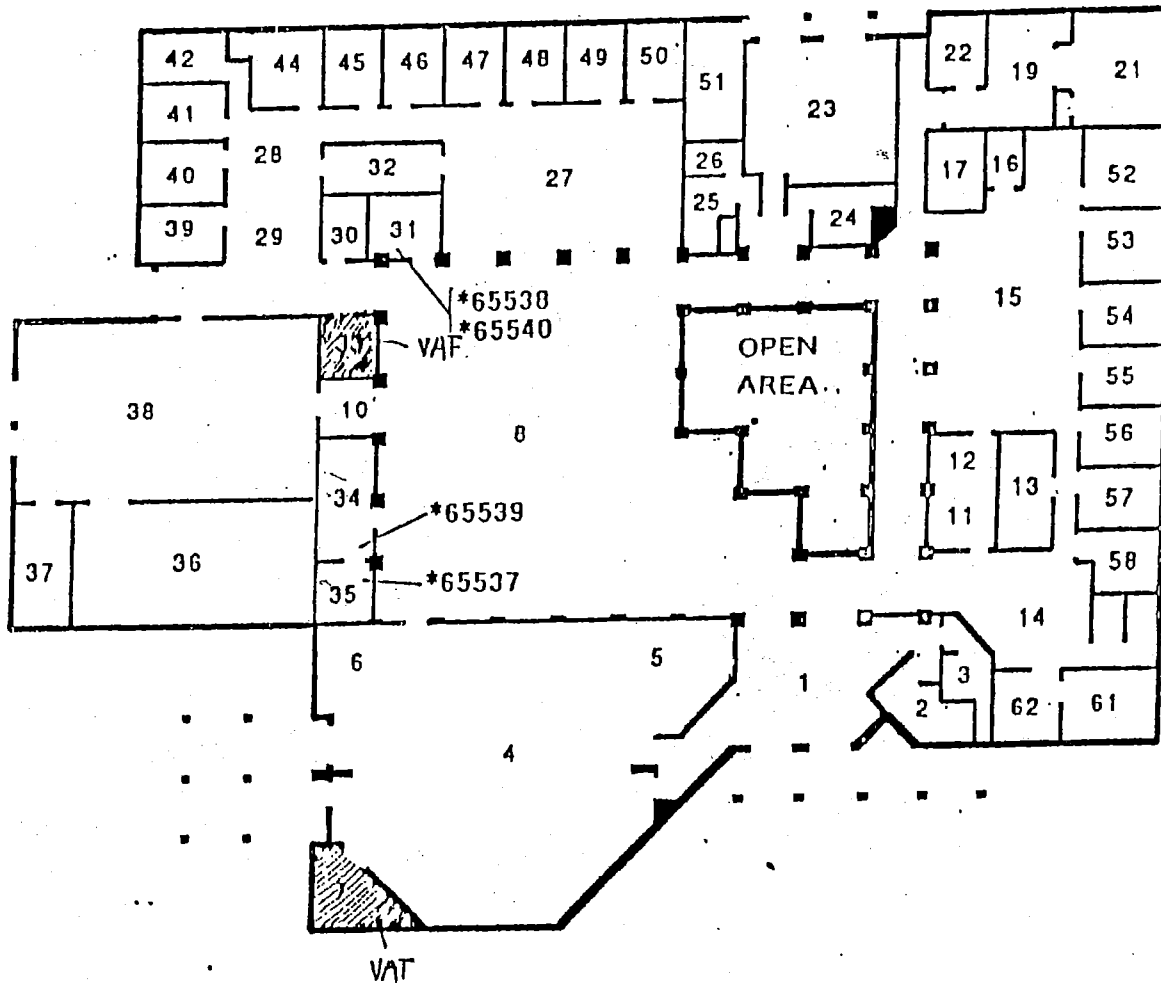
BUESD DISTRICT OFFICES

PAGE 1 OF 2

INSPECTED ON: 3/28/17

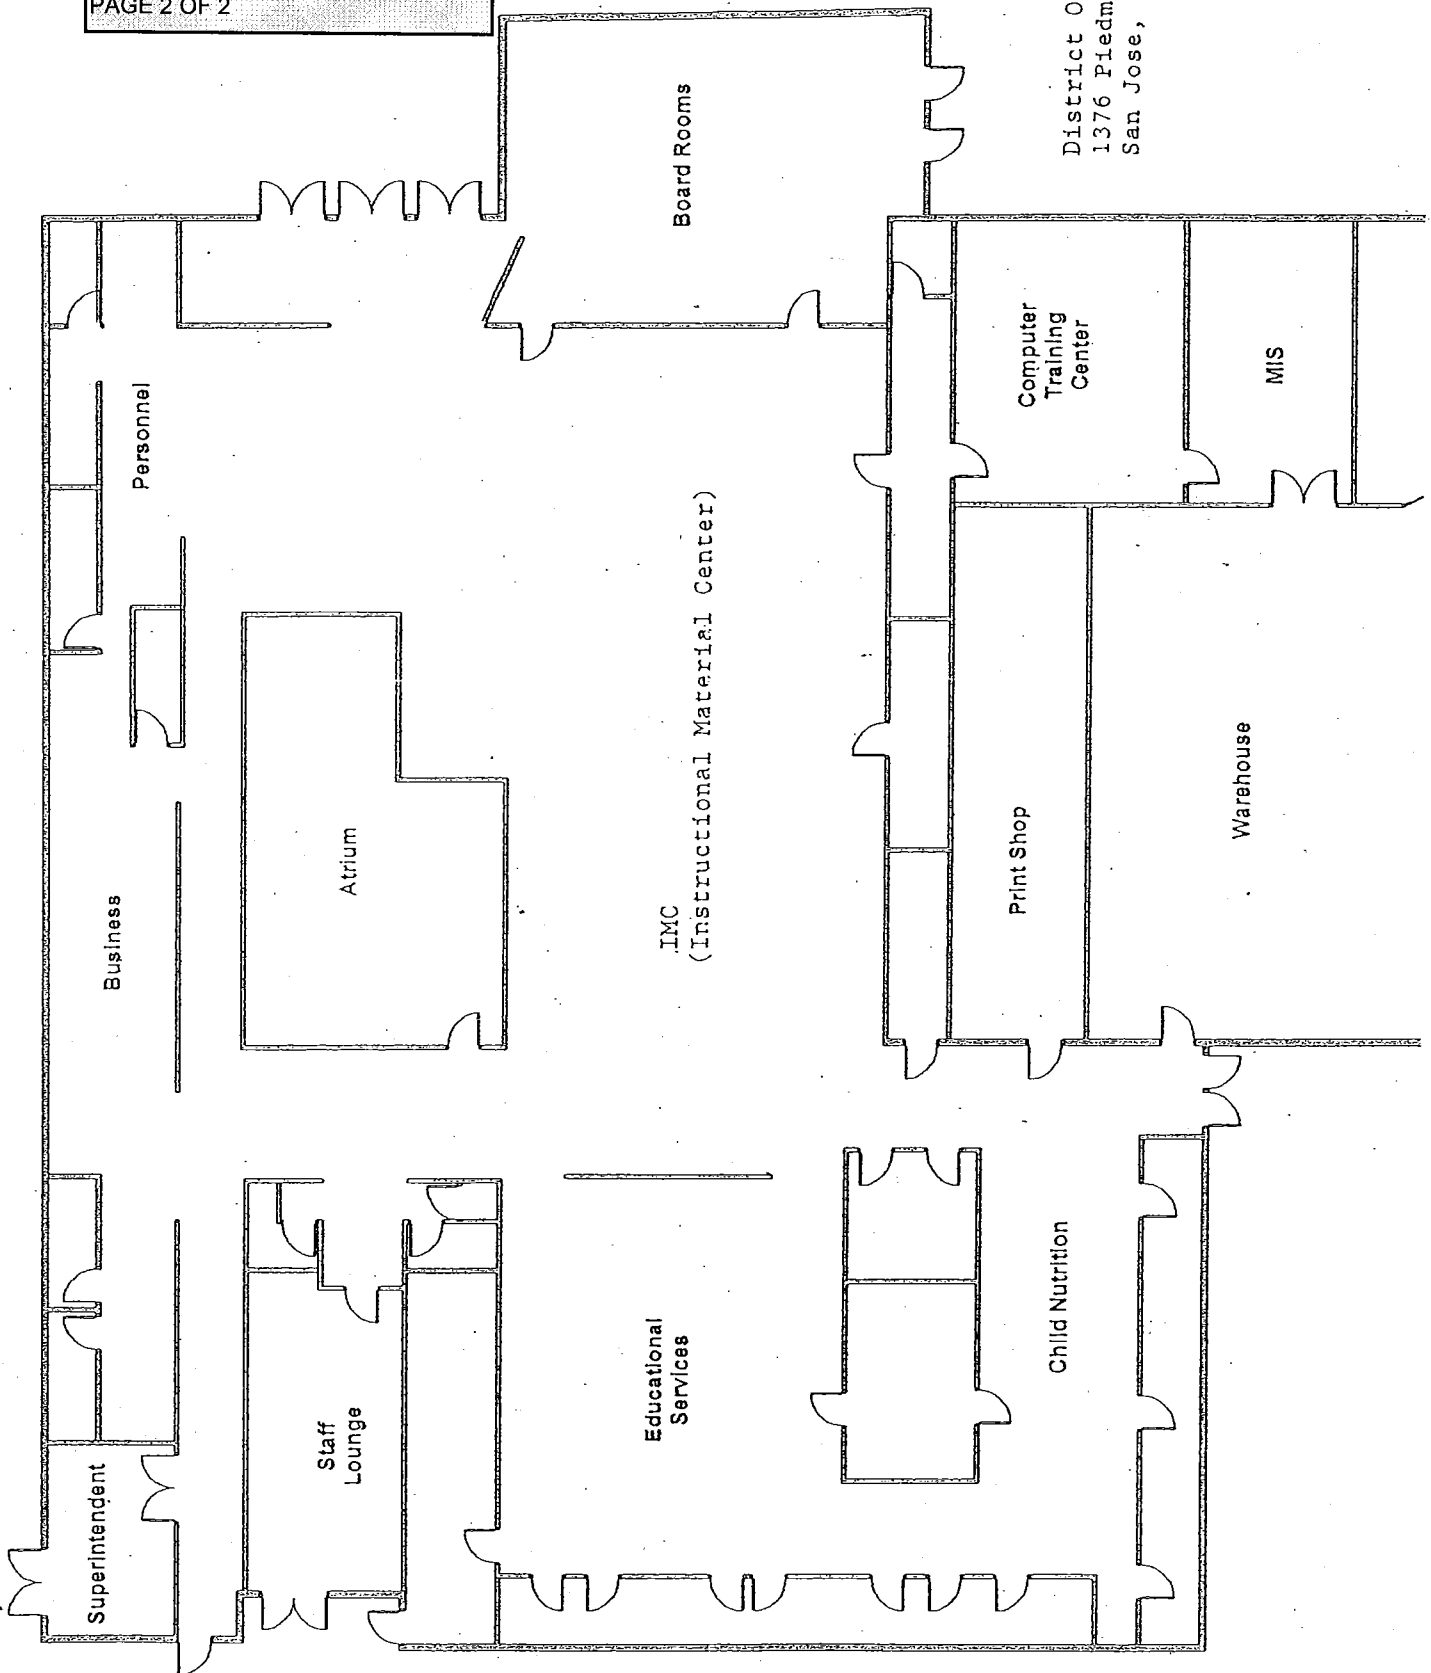
FIGURE #1

DISTRICT OFFICE
1376 Piedmont Road
San Jose, CA

District Office
1376 Piedmont Rd.
San Jose, Ca. 95132
