SIX-MONTH SURVEILLANCE AHERA REPORT

**BUESD MAINTENANCE AND TRANSPORTATION YARD
945 PIEDMONT ROAD
SAN JOSE, CA 95132**

**PREPARED FOR:
BERRYESSA UNION ELEMENTARY SCHOOL DISTRICT
1376 PIEDMONT ROAD
SAN JOSE, CA 95132**

**INSPECTED ON:
Mar. 27, 2017**

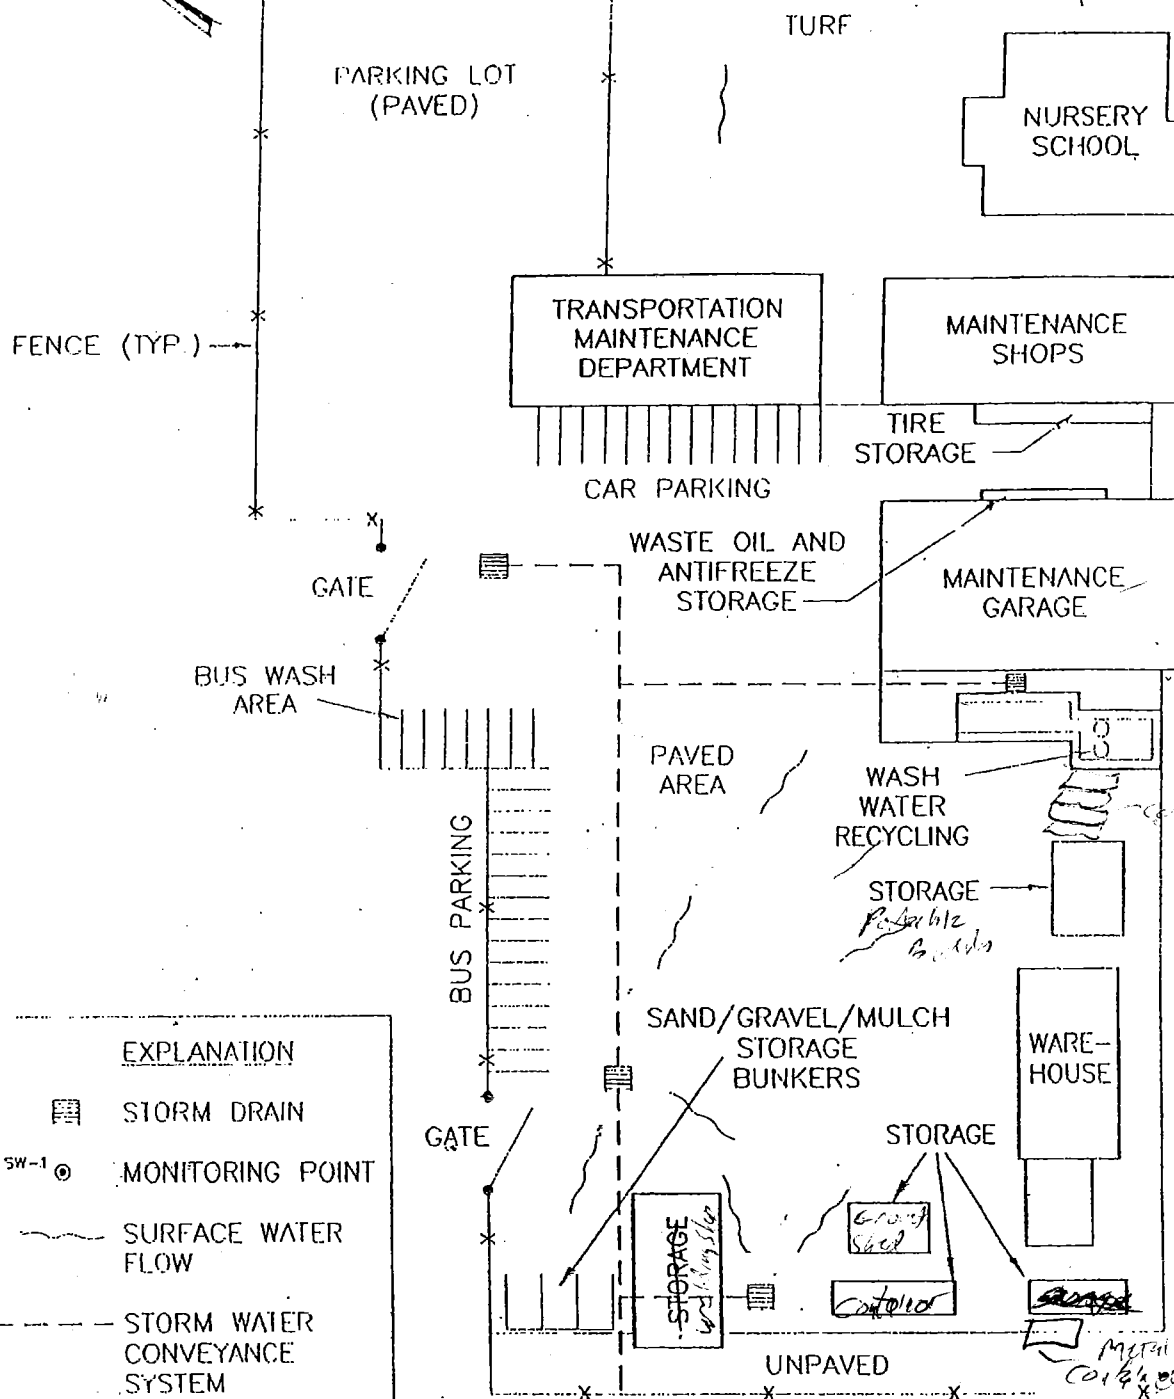
FIGURE 2
BERRYESSA UNION SCHOOL DISTRICT
945 PIEDMONT ROAD
SAN JOSE, CALIFORNIA
CORPORATION YARD
SITE PLAN

BUESD MAINTENANCE AND TRANSPORTATION YARD
INSPECTED ON:

3-17-16 *1990*

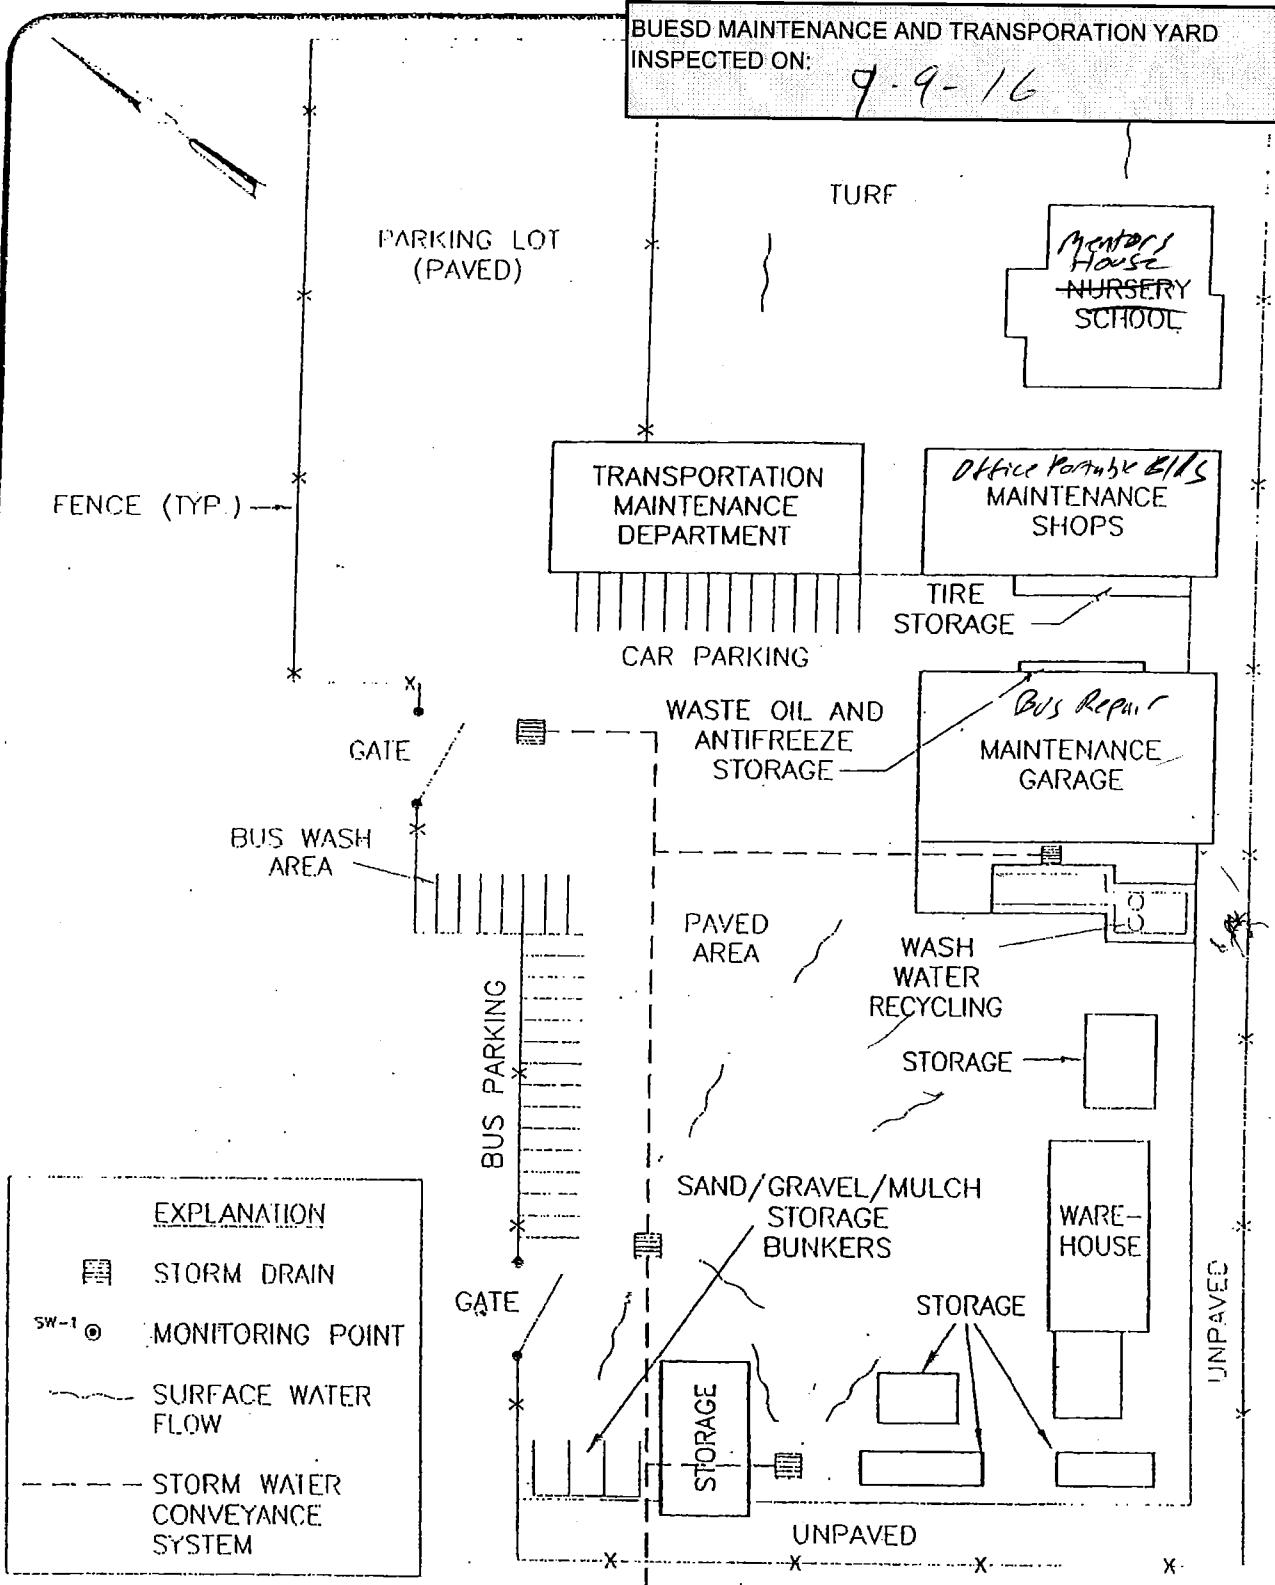
FIGURE 2
BERRYESSA UNION SCHOOL DISTRICT
945 PIEDMONT ROAD
SAN JOSE, CALIFORNIA
CORPORATION YARD
SITE PLAN

BUESD MAINTENANCE AND TRANSPORTATION YARD
INSPECTED ON: 7-9-16

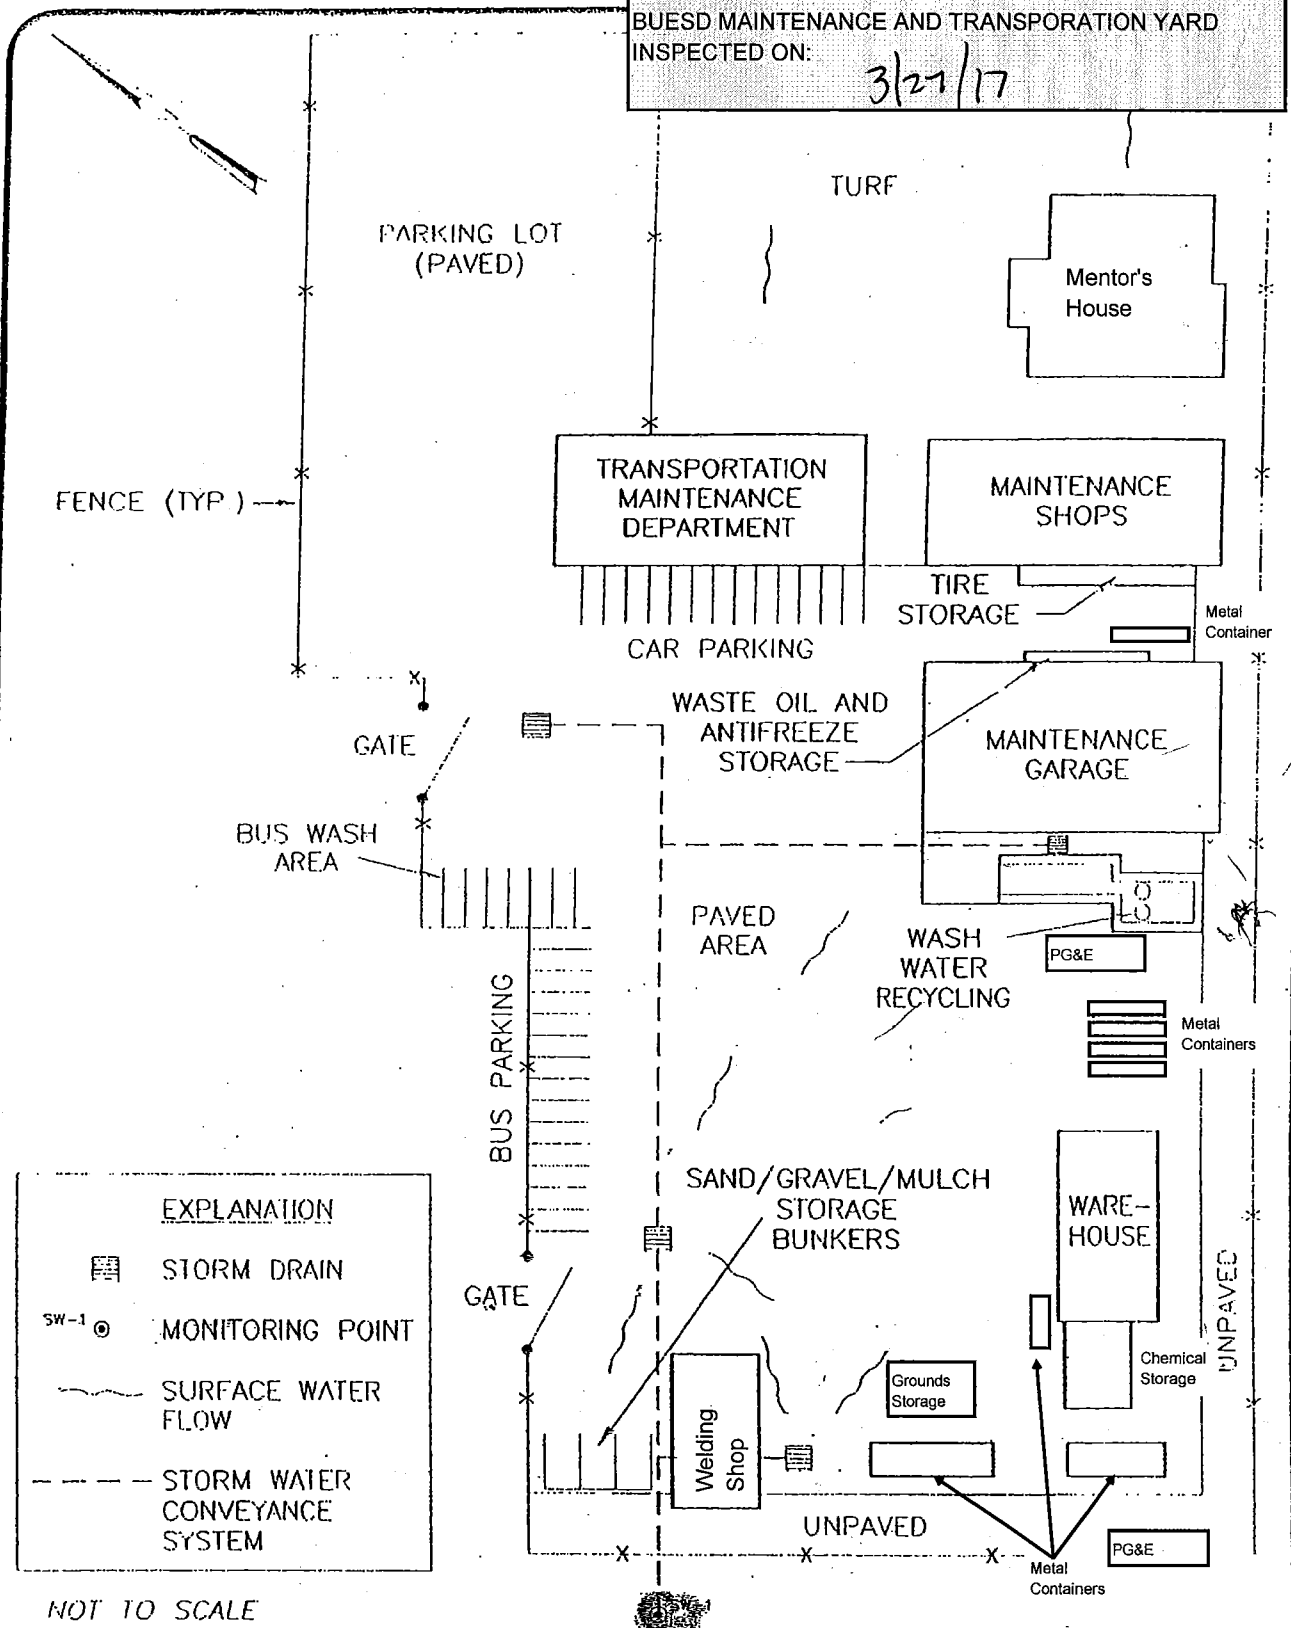
FIGURE 2
BERRYESSA UNION SCHOOL DISTRICT
945 PIEDMONT ROAD
SAN JOSE, CALIFORNIA
CORPORATION YARD
SITE PLAN

EA-SANJOSE-CAD. DRAWINGS. 2:150:1 SITE PLAN. Xrefs: NONE
Scale: 1" = 100' Date: 5/25/97 File: 01:2 AU Operator: AU

BUESD MAINTENANCE AND TRANSPORTATION YARD
INSPECTED ON: 3/27/17
