SIX-MONTH SURVEILLANCE AHERA REPORT

**MAJESTIC WAY ELEMENTARY SCHOOL
1855 MAJESTIC WAY
SAN JOSE, CA 95132**

**PREPARED FOR:
BERRYESSA UNION ELEMENTARY SCHOOL DISTRICT
1376 PIEDMONT ROAD
SAN JOSE, CA 95132**

**INSPECTED ON:
Mar. 30, 2017**

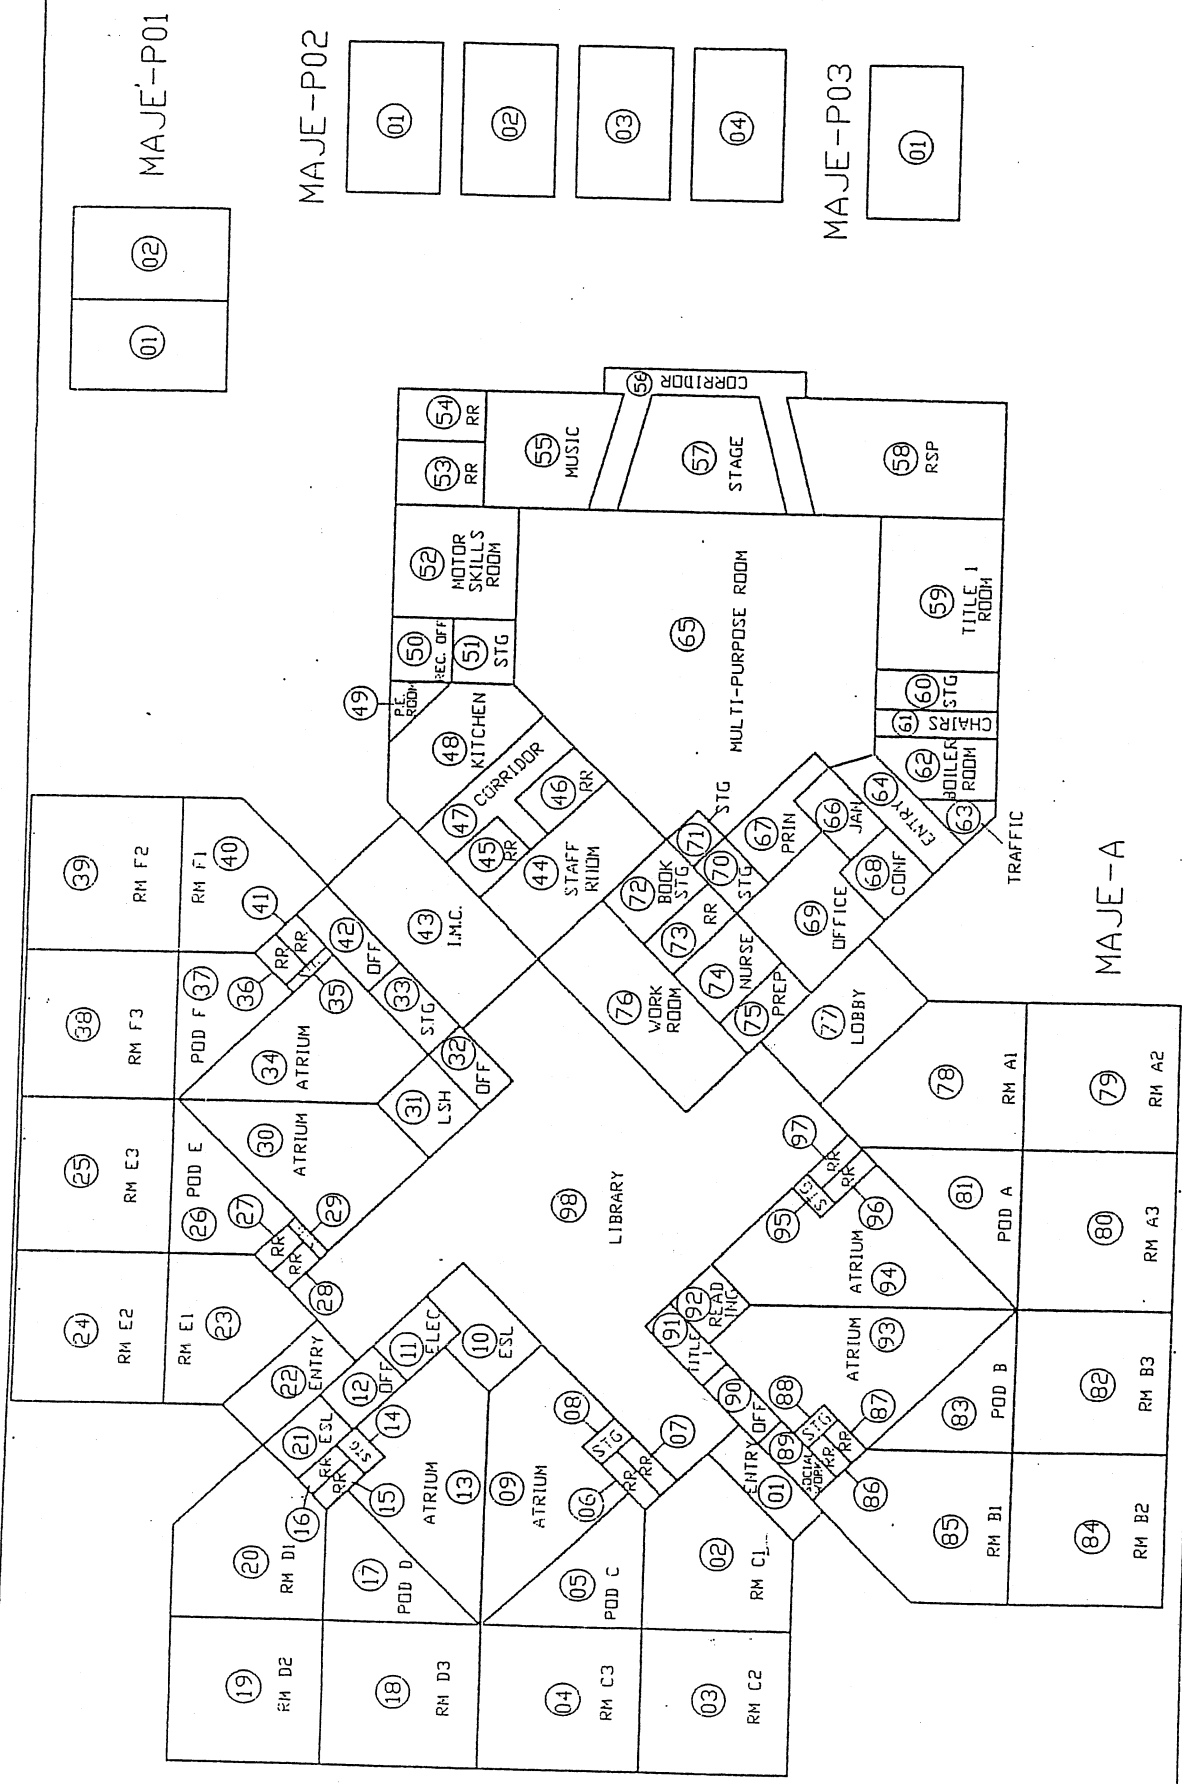
NAMING CONVENTION SITEPLAN

SCHOOL NAME: MAJESTIC WAY ELEMENTARY
 ADDRESS: 1855 MAJESTIC WAY
 COUNTY: SANTA CLARA
 ACREAGE: N/A
 SCHOOL DISTRICT: BERRYESSA UNIFIED
 REV. DATE: 01/25/99

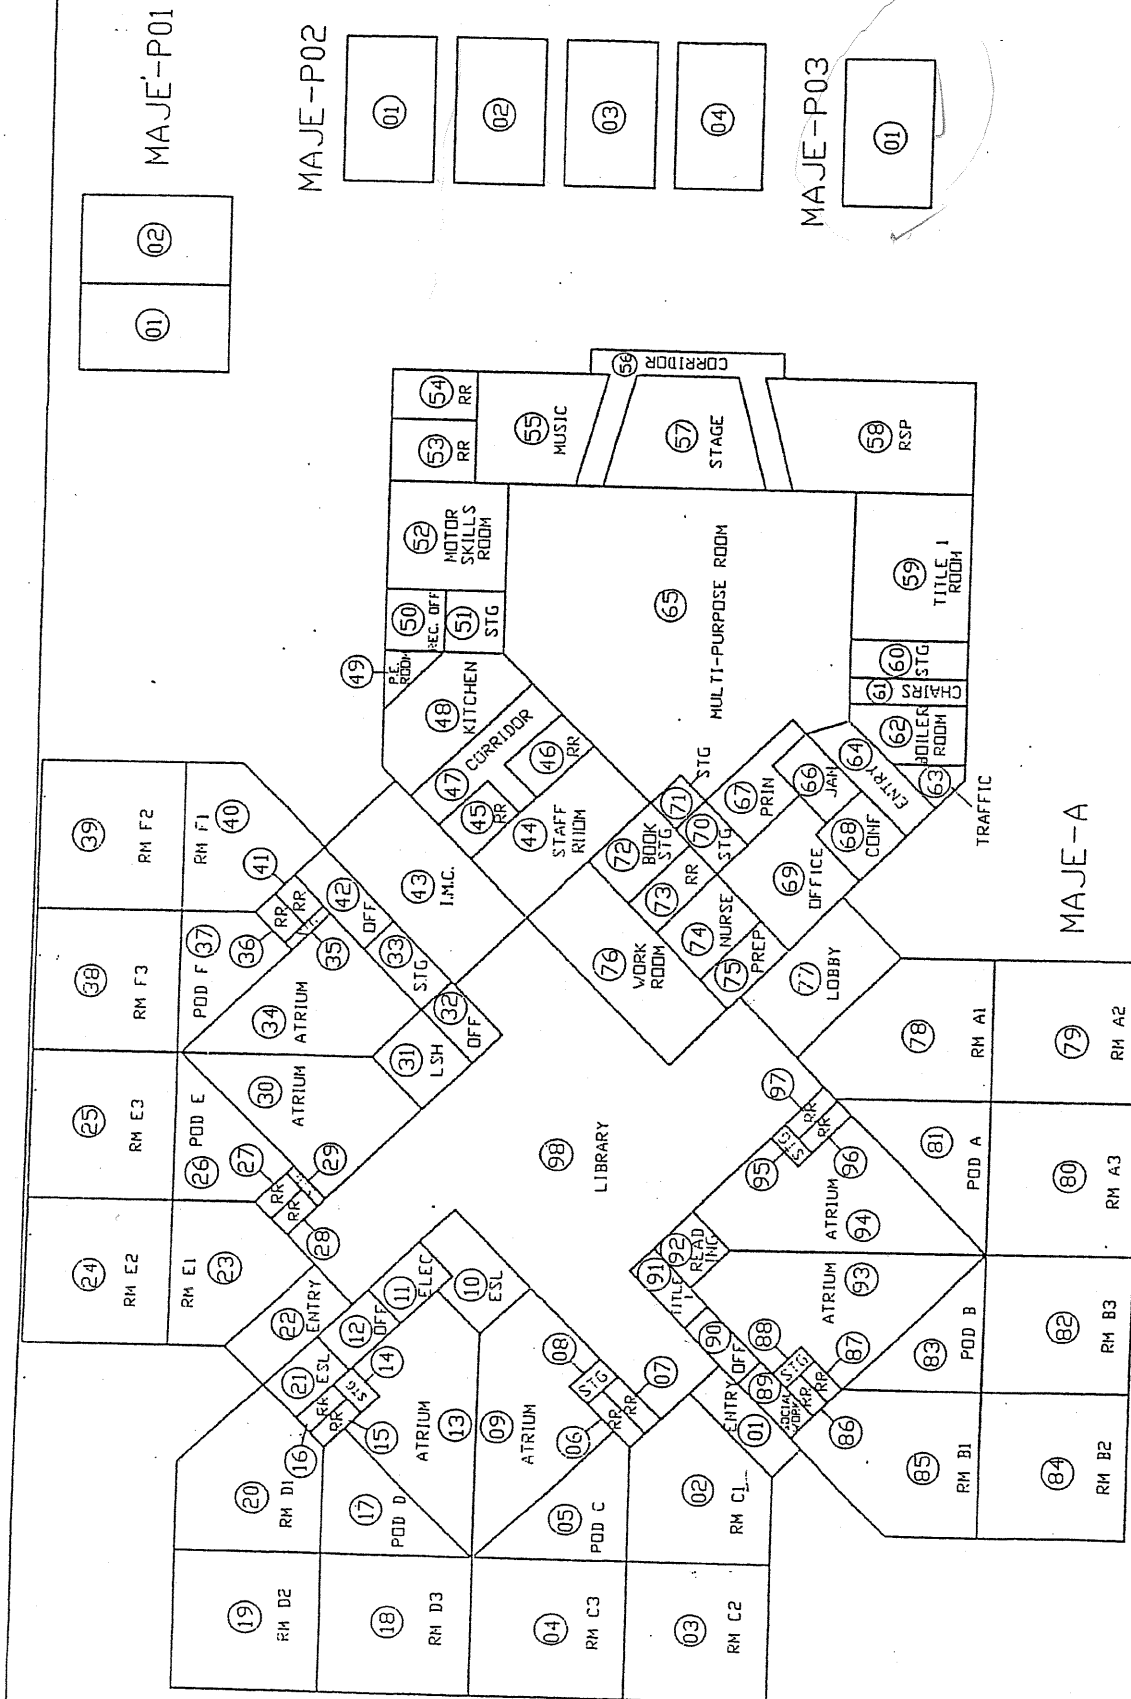
NAMING CONVENTION SITEPLAN

SCHOOL NAME: MAJESTIC WAY ELEMENTARY
 COUNTY: SANTA CLARA
 ADDRESS: 1855 MAJESTIC WAY
 ACREAGE: N/A
 SCHOOL DISTRICT: BERRYESSA UNIFIED
 REV. DATE: 01/25/99
